Cavitation research results of hydroturbine impeller blades and their analysis

Alexey Romanov¹, Sergey Evdokimov^{1,}, and Vladimir Seliverstov¹*

¹Samara State Technical University, Academy of Architecture and Civil Engineering, Molodogvardeyskaya St., 194, Samara, 443001, Russia

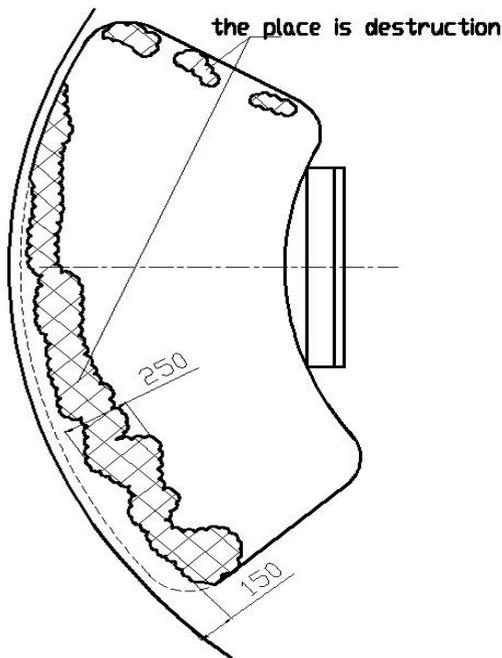
As a result of testing under different modes, erosion was showed to be in the outlet edge area (near the impeller blades peripheral edge) (Figure 1).

The total erosion zone reached 0.071 m^2 . Thus, even at cavitation free operation mode of turbine the effects of cavitation erosion appeared on the blades.

Fig. 1. The destruction areas of impeller blades peripheral edges.

Studies of other modes showed an increase in cavitation erosion, and the intensity of cavitation erosion remained the same, but its area increased to 0.225 m², and additional erosion areas were added.

The cavitation study results of hydro turbine impellers have shown that blades made of 20X13low-alloy stainless steel, which can work for the entire period between cavitation repairs of the hydraulic unit, are the most resistant to erosion. The areas of destruction of impeller blades peripheral and trailing edges up to 150 mm deep may occur during this

period. These destructions are repaired in the impeller chamber when the blades are deployed. If the gaps between the blades and the impeller acquire a saw tooth shape, and repair by surfacing is impossible, then a special insert can be used to restore them. The section of the blade is cut off and an insert is welded to the blade at this point.
