Non-invasive tests of precast cantilever balcony in OWT-67 system

Abstract. This article presents a non-invasive tests report of precast cantilever balcony support in OWT-67 large-panel system. During field testing, the balcony's reinforced concrete structure was subjected to radiometric analysis in the context of thermal energy distribution as well as from the point of view of mycology - to the possible presence of spores of domestic fungi. The temperature distribution tests carried out by means of the electromagnetic wave detection in the infrared spectrum clearly confirmed the significant losses of thermal energy caused by the effect of the thermal constructional bridge located in the balcony. Mycological diagnosis was carried out using the rapid test of the Mycometer bacterial meter, which allows fluorimetric evaluation of the presence of the enzyme presence in filamentous fungi. In the conducted study, no spores of the house mushroom were found on the inside surface of the Z-type balcony supporting beam as a place where condensation of water vapor may occur. The summary also presents a design solution that allows to eliminate this physical problem.

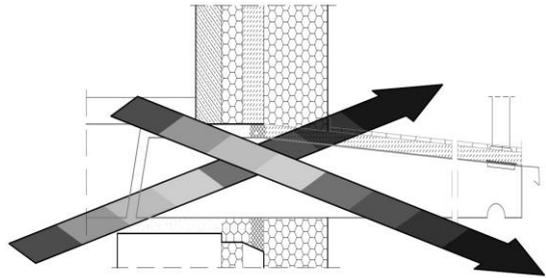
Fig. 2. Heat transfer by cantilevered balcony

Due to the heat loss from the building, the cantilever elements are the most important façade elements (Figure 2). This type of connection in the described OWT-67 system creates a bringing technical problems linear thermal bridge (structural). The tests of the structural thermal bridge of the prefabricated system of the balcony slab of the system were carried out as a thermographic quality assessment [10,14–17].

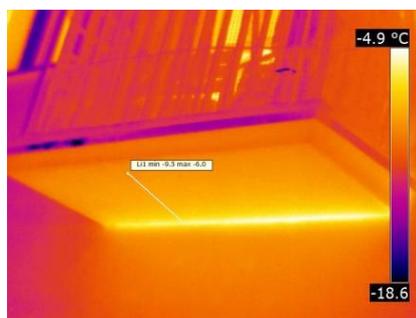
The results of in-situ thermovision tests - a linear thermal bridge, which is located in the structural system of the balcony of the large-panel system OWT-67, are shown below (Figures 6, 8 and 10).

Fig. 6. Slab thermogram

The conducted tests with the help of wave detection in the infrared spectrum confirmed the significant losses of thermal energy within the linear power bridge. On the external plane of the building envelope, the average temperature difference $\Delta\theta_e = 4$ K was found - within the interactions and outside the thermal impact area of the thermal bridge (Figure 6). In the aspect of the internal surface of the external wall, the difference was on average $\Delta\theta_{e1} = 8$ K on the longitudinal wall in the level of the floor (Figure 8) and $\Delta\theta_{e2} = 3$ K within the prefabricated "Z" lintel beam (Figure 10) - in the level of the roof slab over ground floor.

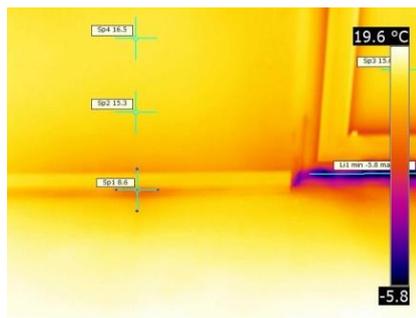
Fig. 8. Thermogram

It is worth emphasizing at this point how important are the acceptance of window joinery with the use of thermovision diagnostics. The lack of this type of thermal technical analysis results in insufficiently good assembly and unnecessary losses of heating energy (Figure 8).

It is also recommended to wider the implementation of thermovision diagnostics to receive assembly of window frames in buildings.

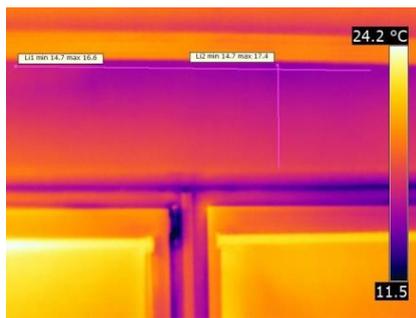
Fig. 10. Thermogram

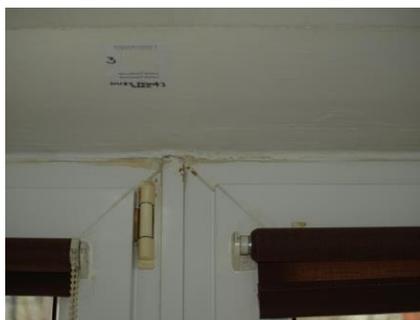
Examination of the fungus potential was done in a large room (Figure 11), for rooms in a small room and kitchen. The results were obtained at the level of category A, which clearly means no spores. The method has three levels of results A, B and C.

Fig. 11. Measuring point (author`s archive)

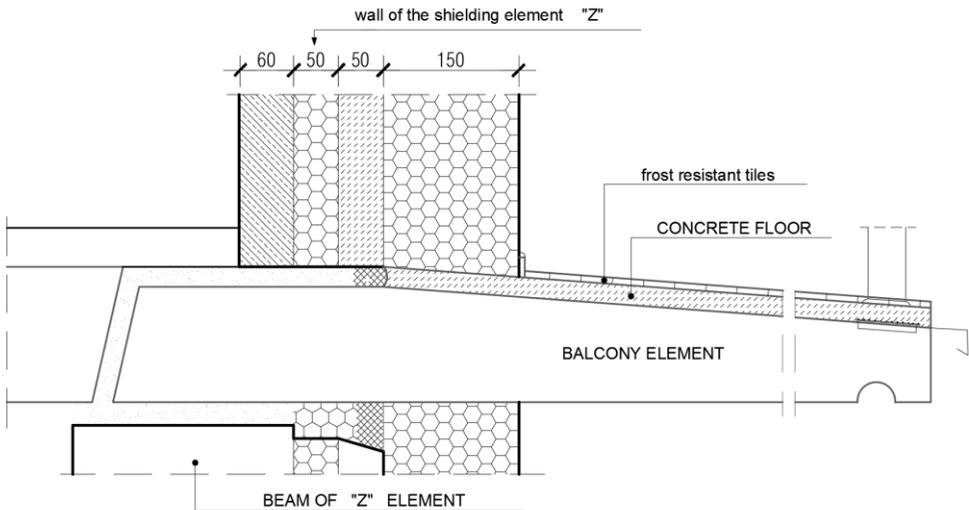
Fig. 13. Existing structure (author`s archive)

A possible alternative solution to the problem discussed above (Figure 13) is the use of the structural system as on Figure 14 [7]. The light balcony system is characterized by a combined steel and reinforced concrete structure, largely independent of the building structure. The structure consists of steel columns, suitably ribbed under the balcony reinforced concrete slab (in order to form a support), supported in four points on the columns. The reinforced concrete slab can be made on the construction site or prefabricated. Due to the amount of work that can be done in the workshop system, work on the construction site while erecting is limited to the assembly minimum. Anchoring to the building structure ensures stability.

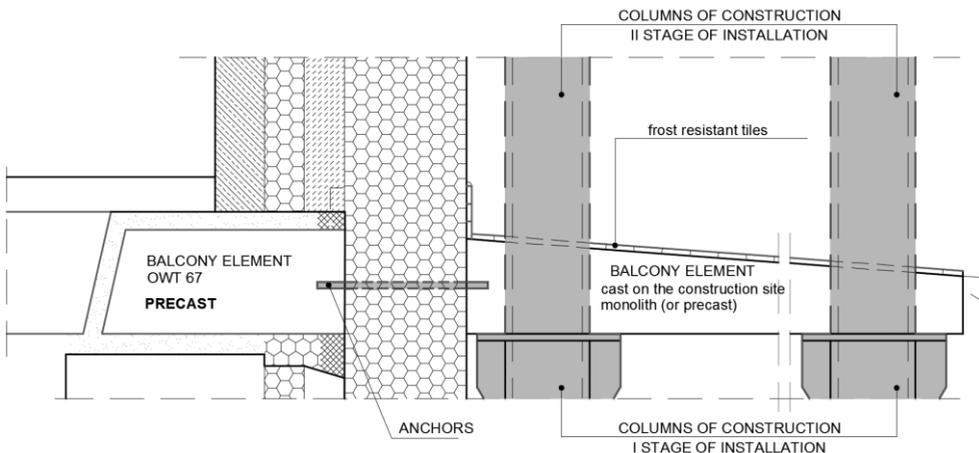
Fig. 14. Convertible project (author`s archive)
