Evaluation of fire damage to the steel structure of an industrial shed

Abstract. The study concerns an analysis of fire damage to the steel structure of an industrial shed. The shed was used as storage for woodchips, which are an easily inflammable material. Despite the fact that the fire did not affect the entire structure, it resulted in an excessive deformation of the roof elements, damage to curtain walls, and the conveyer. The state of safety of the remaining structure was evaluated based on the performed investigation, study of the archive documentation and static calculations. The critical temperature for steel structural elements was estimated. The structure elements requiring replacement were identified.

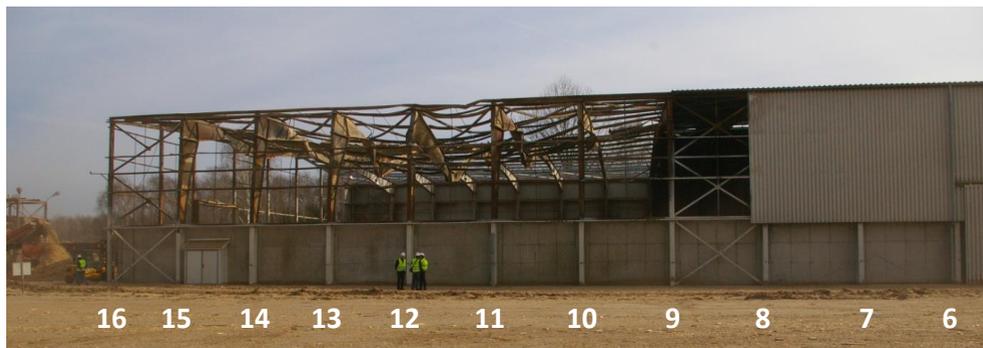
Fig. 1. West elevation of the damaged industrial shed in the axis C.

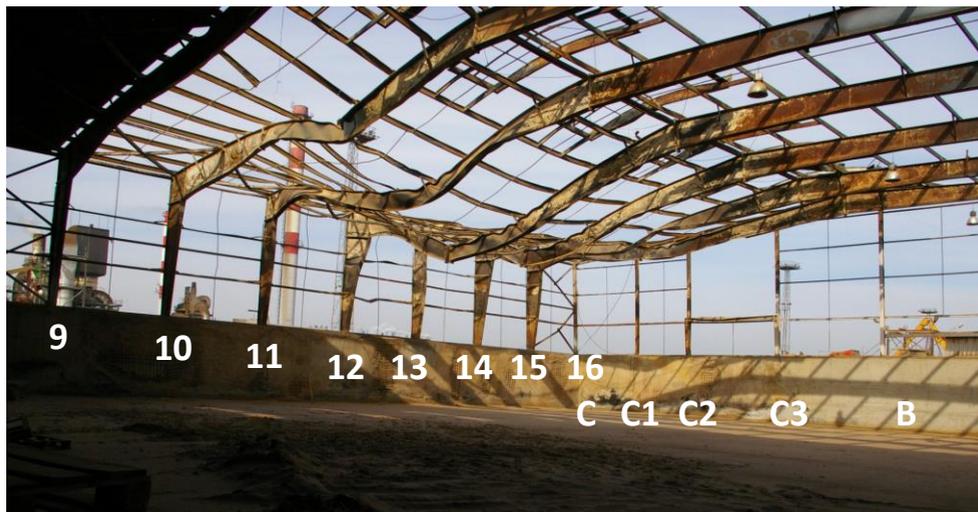
The fire started from woodchips on the conveyor belt. The distance between the source of the fire and the roof was smaller than 1 m. The woodchips, the conveyor belt and the electrical installations were easily inflammable materials. The source of fire was identified quickly. However, extinguishing of the burning heaps of woodchips took more time. Application of water on the heated steel elements led to thermal shock and damages. The most extensive fire damage was identified between axes B - C and 9 - 16 (Fig. 2 and Fig. 4). Damage to the adjacent structure between axes A - B and 9 - 16 is significantly smaller (Fig. 5).

Fig. 4. Deformation of the steel structure between axis B - C and 9 – 16.

Despite very high thermal conductivity, after cleaning of the structure, no blisters, no blackening nor changes in the paint colour in the vicinity of the vertical convection column were observed (the region A2-A and 9-16). It means that the temperatures were lower than the critical temperature of the structural steel coating (which is about 420⁰C) and the fire lasted a relatively short time. Also the bottom parts of the columns did not deform (Fig. 6). Based on the observation of damage to the styrofoam between columns and the retaining wall, it was estimated that the temperature in this region slightly exceeded 100⁰C. Styrofoam starts to shrink at temperatures above 100⁰C, then it melts. It burns at temperatures over 350⁰C. The frames without fire protection coatings (Fig. 4 and 5) lost their load bearing capacity.

Load bearing capacity utilization for the frame μ_{0w} was evaluated at the level of 0.2 – 0.3. Therefore the critical temperature could be close to 700⁰C. The most damaged elements were those located close to the source of fire and exposed to fire from three sides (Fig. 4 and 5).

It was evaluated that the central part of the roof structure between axes 6 and 16 (strip width about 20 m) is permanently damaged and requires replacement. Also part of the cladding and ring beams should be replaced (along the axis C between axes 8 and 16 and along the axis 16 between axes C and A3). The columns in axis A and one of four segments of the ring beams are not damaged. As far as regarding columns in the axis C, only their bottom part (up to 3.7 m) was not damaged. Therefore, it would be possible to cut the profile and replace only the top part of the column. However, that is the cross section of the highest load bearing capacity utilization factor and it may seem more reasonable and convenient to replace the entire column.

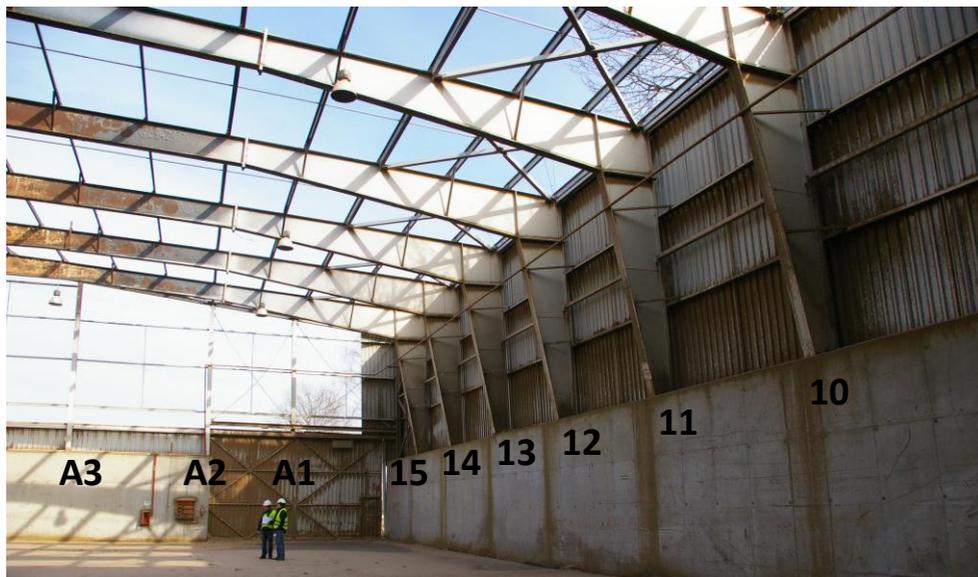
Fig. 5. Shed’s structure between the axis A - B and 10 – 16.

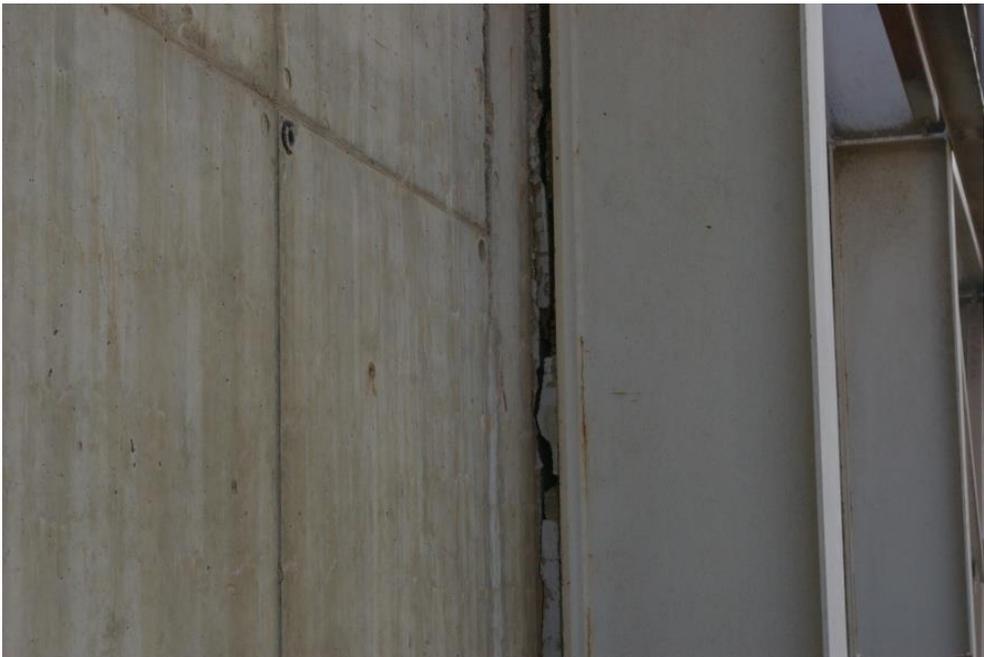
Fig. 6. Bottom part of the column in the axis C-14 .

All the columns along the axis 16 between the axes C and A3 should be disassembled and replaced. The frames in axes 6-8 are not significantly deformed. They could be straightened up by local heating, if it was economically justified. They could be also left for further exploitation without repair, since the deformations would not significantly influence their load bearing capacity.
