# Investigation of transformer failure in Indonesia

Brian Bramantyo S.D.A. Harsono<sup>1,\*</sup>, Aristo Adi Kusuma<sup>1</sup>, Buyung Sofiarto Munir<sup>1</sup> and Nur Widi Priambodo<sup>1</sup>

<sup>1</sup>PLN Research Institute, Transmission and Distribution Department, Jakarta

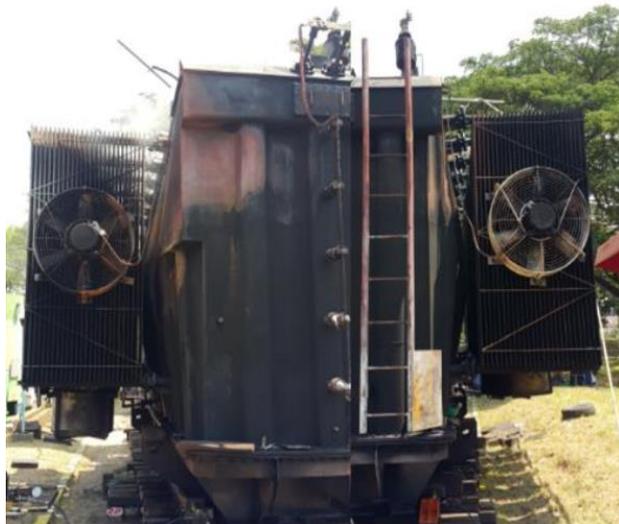
As explained in introduction, several apparatus was severely damaged during the fault. Therefore, individual visual inspection was performed to obtain valuable information needed for the analysis. The specification of the transformer according to the nameplate was shown in Table 1. The neutral side of the transformer was connected to 29  $\Omega$  Neutral Grounding Resistor (NGR). During visual inspection on the transformer, it was found that both primary and secondary bushing were shattered (Fig. 1). Visible white smoke was spotted flowing out from bushing turret which indicated the presence of hot spot inside the tank. For safety reason, further visual inspection such as climb up inspection was cancelled. As shown in Fig. 1, transformer tank was deformed which indicated the increase of internal pressure.

**Fig. 1.** Transformer condition after failure.

Based on recorded fault data from 2016-2017, there were total 11 faults happened on the transmission line which connected to the transformer. High magnitude current generated by the fault gave mechanical stress to the winding of the transformer, hence the insulation between windings or between winding and tank would be compromised due to structural shift inside the transformer. The winding structure shift due to previous fault on the transformer was proven in SFRA test result as shown in Fig. 6 and Fig. 7. The compromised insulation inside the transformer might increase the possibility of phase to phase or even phase to ground short circuit. Since the simulation waveform result in Fig. 11 and Fig. 12 was identical to the DFR record, it's predicted that the possible cause of transformer failure was internal arcing on phase R of primary winding (150 kV). According to the reference [10-14], internal arcing during fault could deform transformer tank which was similar to what happened in Fig. 1. Internal arcing vaporized the oil which increased the volume of flammable gasses inside the transformer.

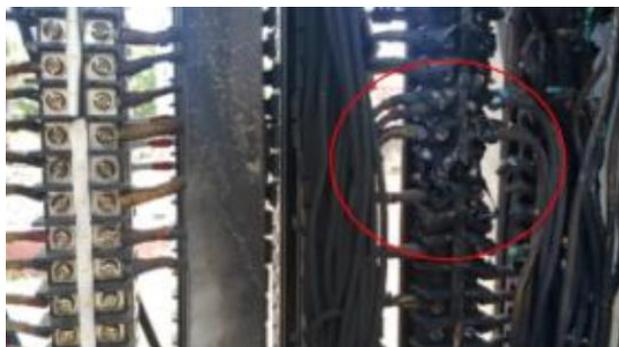
Marshalling kiosk of the transformer bay had burning mark on terminal 1 – 100. The most severe damage could be seen on terminal 82 as shown in Fig. 2. According to the wiring diagram, terminal 82 was connected to 150 kV CT on the primary side of the transformer.

**Fig. 2.** Transformer condition after failure.

The most damaged terminal in transformer bay marshalling kiosk was terminal 82 which connected to

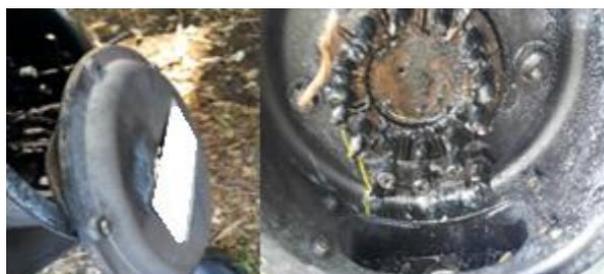
Further visual inspection on 150 kV CT on the primary side of transformer revealed arcing mark on CT's core terminal cover (Fig. 3). All of the core

terminal was burnt and some of them were melted as shown in Fig. 3.

**Fig. 3.** 150 kV CT terminal cover and core terminal condition.

the wiring of phase R 150 kV CT. The 150 kV CT had 3 core and the third core was shorted using wire for future instalment of Bus Protection. Judging the arcing mark on CT terminal cover (Fig. 3), there's a possibility that the wire used for shorting the redundant third core was loose which accidently made the CT become open circuit. Open circuited CT created very high voltage difference between CT terminal to ground, resulting electrical arc on CT terminal and also on terminal 82 in marshalling kiosk. The burning on terminal 82 damaged the other terminal above it. Terminal 76-79 on marshalling kiosk was dedicated for phase S and phase T 150 kV CT wiring, therefore the burning on terminal 82 also created open circuit in phase S and phase T 150 kV CT. Arcing from 150 kV CT wiring to ground created voltage transfer which initiated short circuit between control cable in relay panel inside the control room to the ground. The arcing damaged whole CT wiring and rack which result in complete malfunction of transformer protection system. Malfunctioned protection system could not interrupt internal arcing fault on phase R winding, which created prolong arc resulting rapid increase of transformer oil pressure. Rapid increase of oil pressure might rupture the tank and shatter the lead bushing. Shattered bushing caused short circuit between high voltage lead with the tank which caught transformer on fire. The flame damaged the arrester next to the transformer as shown in Fig. 4.

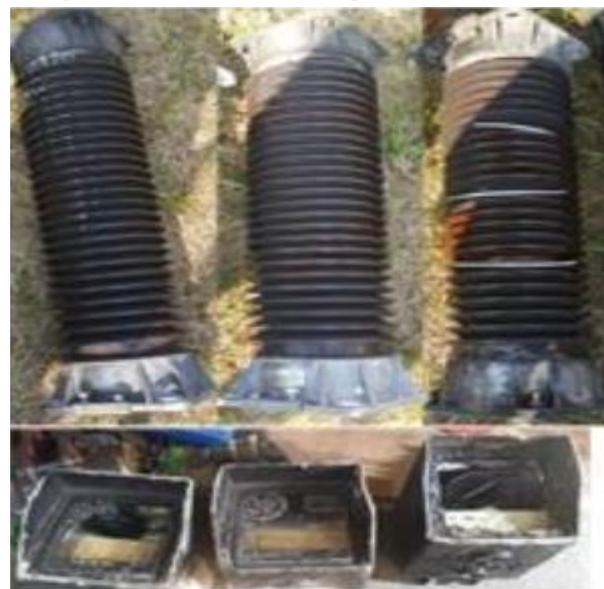
High voltage lightning arrester on secondary side of the transformer had several-ruptured sheath and damaged counter as shown in Fig. 4.

**Fig. 4.** Arresters on secondary and primary side of the transformer condition.

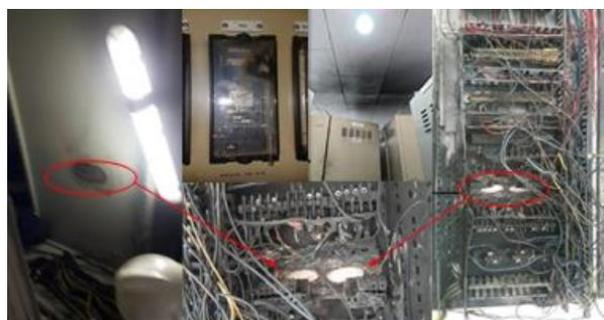
Visual inspection on relay panel of transformer bay showed arcing mark on the wall side (Fig. 5). Further investigation revealed that the arcing mark on the wall side was located next to 150 kV CT module rack.

**Fig. 5.** Transformer bay relay panel condition.

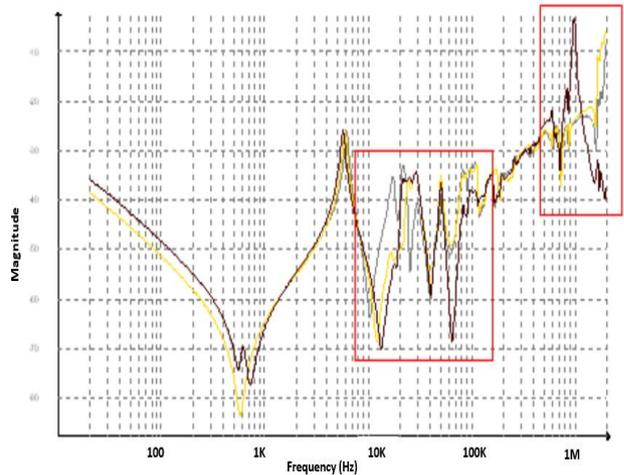
SFRA test result showed severe deformation of primary and secondary winding as shown in Fig. 6 and Fig. 7. According to the reference, the frequency region for interaction between winding ranges between 2 kHz and 20 kHz while the frequency region for winding structure ranges between 20 kHz and 1 MHz [5]. For both region, the SFRA result for each phase was different one to another on primary and secondary winding.

**Fig. 6.** SFRA result for primary winding (Phase R =grey, phase S=yellow and phase T=brown).

Severe deformation on winding structure might indicate any clearance change or shift between primary and secondary winding and also between each winding toward transformer tank. This clearance shift affected the insulation strength resulting in possible insulation breakdown below the proposed design.

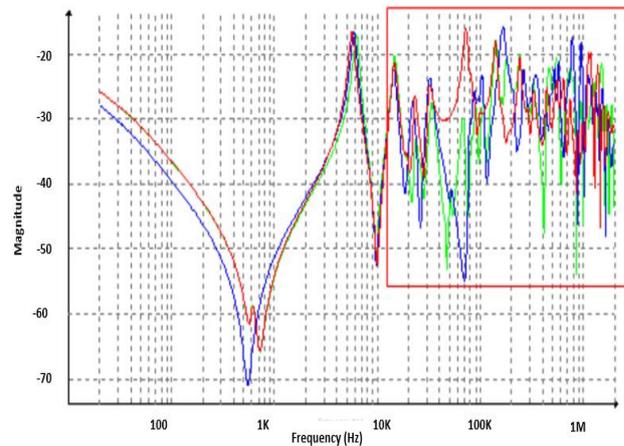
**Fig. 7.** SFRA result for secondary winding (Phase r=green, phase s=blue and phase t=red).
