Demolition of Old Oak Bridge B4113: Condition of a 54-year old prestressed concrete bridge

Abstract. The extension of the 3rd lane on Trunk Road 9 Section 1 (N1) at Bellville in the Western Cape necessitated the demolition and replacement of the Old Oak Road Underpass Bridge B4113. This bridge had insufficient vertical clearance as well as insufficient horizontal clearance for the widening of the road. Furthermore, the existing precast beam and slab deck has suffered from repeated vehicular impact damage over the years, resulting in continued costly repairs. This paper describes the condition of this bridge after a 54-year service life. The primary objective is to report and comment on the condition of this bridge in order for other engineers who have to rehabilitate, raise or widen similar bridges built at the same time, to have an indication of the quality of materials, workmanship, condition and behaviour. During and after the demolition operation, a visual inspection of the rubble was undertaken to evaluate the condition of this bridge which was constructed in 1963. Concrete cores taken before the demolition revealed higher concrete strengths of 50% and more. Carbonation and d

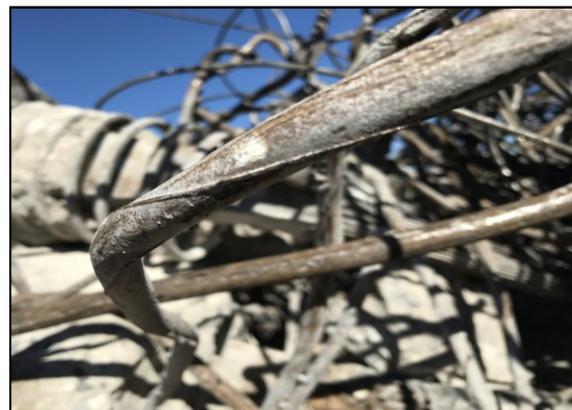
The reinforcement in the substructure consisted of only mild steel with diameters up to 40 mm. The superstructure consisted of both mild steel and high tensile steel, mostly in small diameters. The high tensile steel can be distinguished from the mild steel by having one thin spiral across the bar (**Fig. 6**).

Fig. 6. High tensile steel (note the thin spiral around bar).

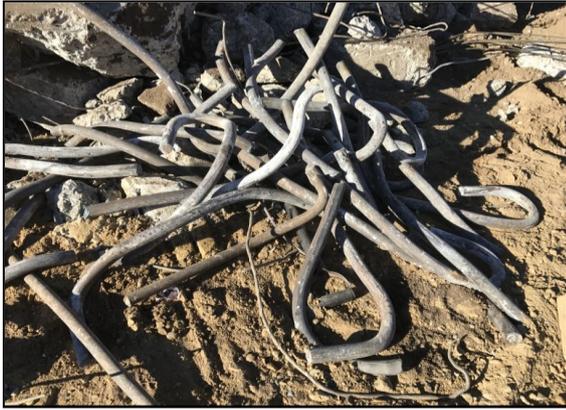
The reinforcement is in impeccable condition with hardly any corrosion visible after a 54-year service life:

Fig. 7. Bunch of R40's. Notice the absence of corrosion after 54 years.

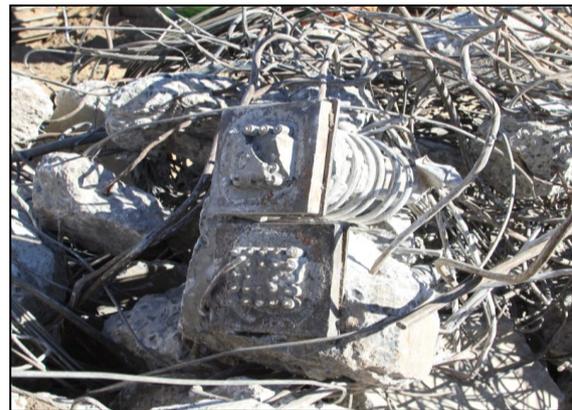
Fig. 8. Anchor blocks displaying prestressing system in precast beams.

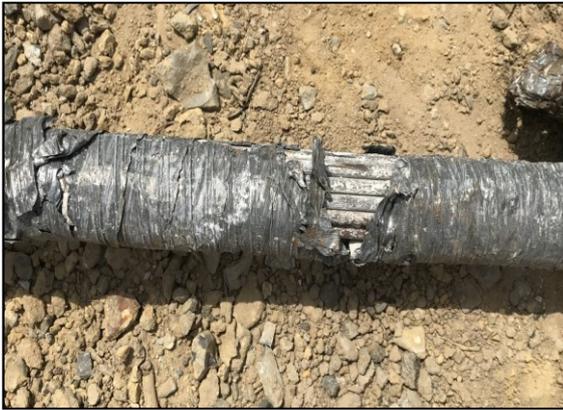
Fig. 9. Corrugated aluminium duct around steel cables.

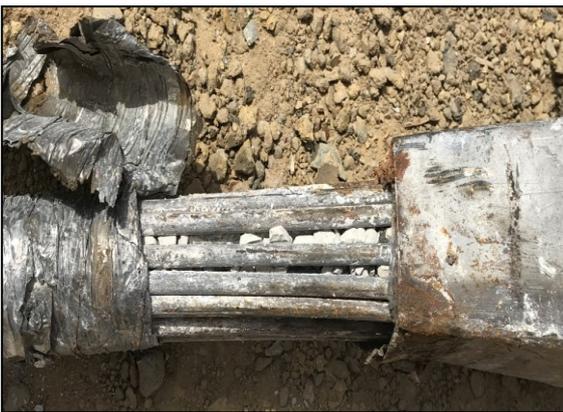
The prestressing ducts were not fully grouted: grout was only found at the end of each beam.

Fig. 10. Grout in prestressing ducts only at the beam's end.

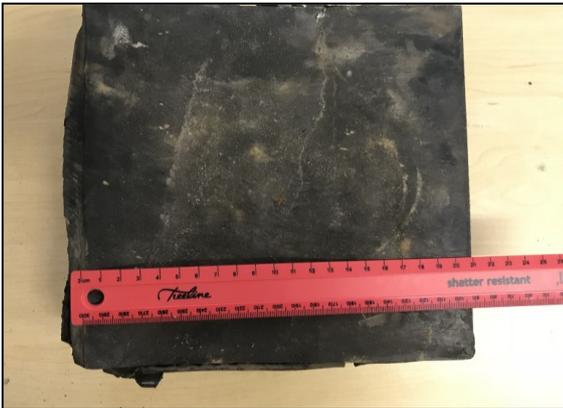
All the bearings were laminated elastomeric rubber pads at each support. The original bearings were damaged to some extent during the demolition procedure, but still intact (**Fig 11** and **Fig 12**):

Fig. 11. Original laminated elastomeric bearing salvaged from an outer pier after demolition (dimension 210 mm).

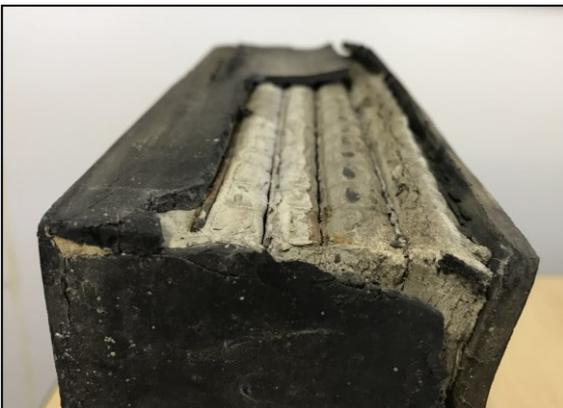
Fig. 12. Original laminated elastomeric bearing salvaged from an outer pier with a partial view of the elastomer and steel plates.

The outside rubber had not deteriorated at all and showed no signs of brittleness. The rubber between the steel plates is in an impeccable condition with very little bulging noticeable only on the edges (**Fig. 12**). The steel plates are still intact and have not delaminated from the rubber and show no signs of corrosion (**Fig 13**):

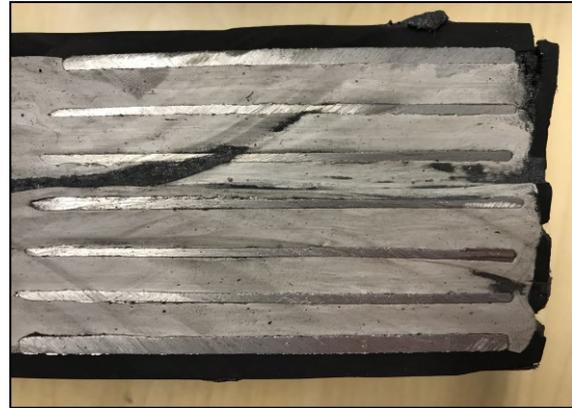
Fig. 13. Bearing cut in half (partial view). No delamination of steel plates to the rubber.

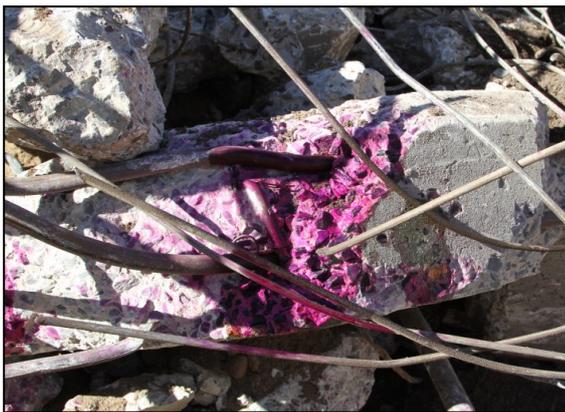
About 7 hours after the demolition a 1% phenolphthalein solution was applied on various fragments of the bridge to assess the effect of carbonation. In most instances carbonation ingress up to 10 mm was the norm, but some sections showed it infiltrating up to 60 mm, especially near expansion joints (**Fig 14 – Fig 16**).

Fig. 14. Carbonation less than 2 mm.

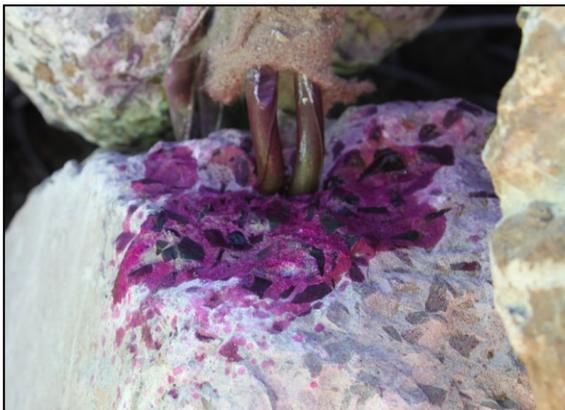
Fig. 15. Carbonation less than 10 mm.

Where the depth of carbonation is about 10 mm after 54 years, the structure will easily have reached its design life of 100 years without the carbonation front reaching the reinforcement with a 40 mm concrete cover. However, at areas such as the leaking expansion joints, the depth of carbonation had already reached the reinforcement. Although no significant corrosion was seen on the reinforcement, it is a matter of time before this would have happened with the associated concrete spalling.

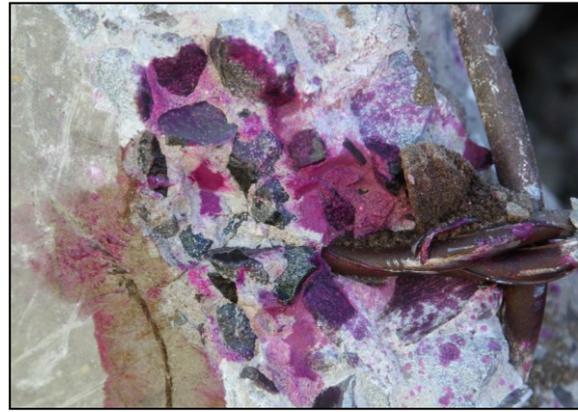
Fig. 16. Carbonation up to 60 mm near expansion joints.

detailing of expansion joints or elimination of expansion joints will reduce the maintenance requirements and increase the durability of bridges.

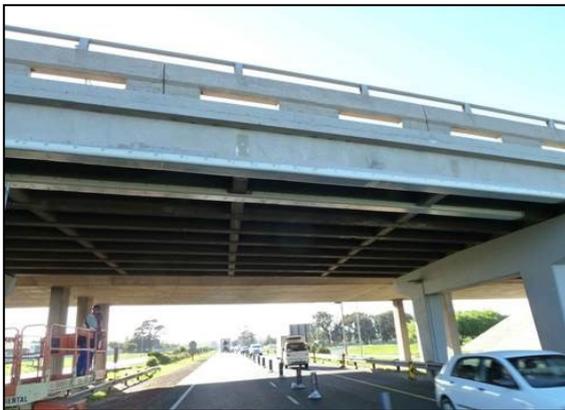
Subsequent to these repairs, vehicular impact again damaged the same 4 beams with the outer beam in the area of the previous repair being the worst affected. The impact broke out a relatively large portion of the patch repair material and existing concrete, exposing the prestressing duct and reinforcing. The reinforcement sheared and bent in places although the prestressing duct remained undamaged. Damage to the 2nd, 3rd, and 4th beams were mainly limited to the bottom flanges of the beams.

Fig. 17. Steel plate installation (completed July 2011).

Under Contract No. C861.1, the beams were repaired and steel protection plates were installed over the full width of the carriageway on the outer and second beams. Due to the need to maintain traffic flow on TR9/1, the plates were installed in 2 separate sections on each beam and welded together on completion, under single lane closures (**Fig. 17**).

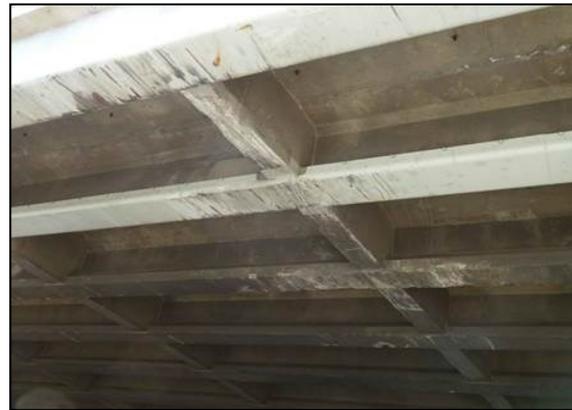
At the site inspection undertaken in February 2014 evidence of vehicular impact damage was again noted as shown in **Fig. 18** below. The steel protection plates have remained intact with superficial damage to their protective coatings. There was no visible evidence of cracking in the beams which would compromise the strength or durability of the beams.

Fig. 18. Impact damage to steel plates (February 2014).

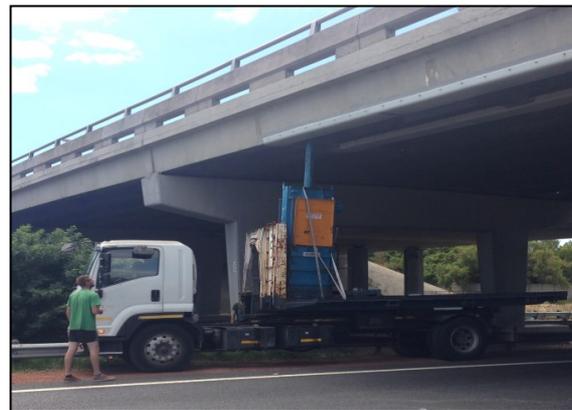
The widening of TR9/1 in Cape Town required the demolition and replacement of Bridge B4113 at the Old Oak Interchange. The first reason for its demolition is its inadequate vertical clearance. Bridge B4113 suffers impact damage to its soffit regularly. As a matter of fact, during the construction period for the widening of TR9/1 a truck got wedged between the beams. In March 2017, 2 months before its demolition, one of the authors took a photo of this truck trying to get out from between the beams:

Fig. 19. Truck wedged between beams (notice steel strengthening plates on beams).
