# Mitigating natural events to avoid disaster in public school buildings: seismic retrofitting of SDN 42 Korong Gadang

### 3 Seismic Retrofits of SDN 42 Korong Gadang

The single class building A of SDN 42 Korong Gadang, Padang, Indonesia was retrofitted following evaluation of seismic deficiencies for both structural and non-structural building components. The Indonesia National Standard specifications [4-9] were used so were the other school building design guidelines from the Ministry of Education [2],[10-14].

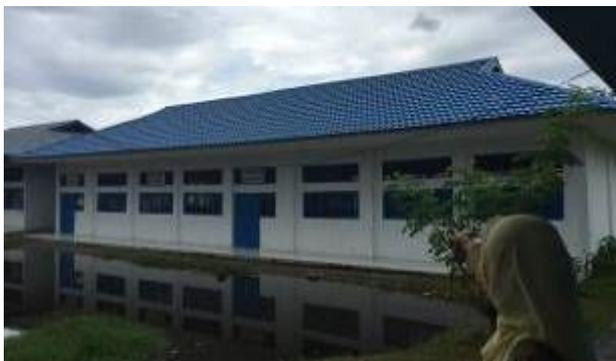
Schools located in low lands lacking adequate drainage are prone to flooding and interruption to educational activities as seen in Fig. 8.

Fig. 8. Flooding at the school site

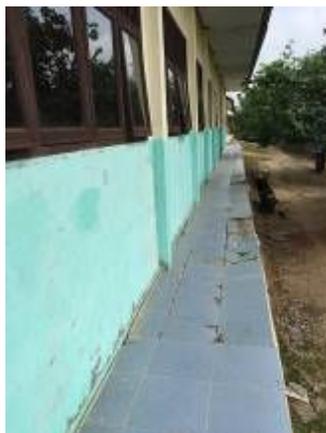
Geotechnical conditions at school sites are not adequately addressed lead to liquefaction and settlement related building failures as seen in Fig. 9. This can lead to building collapse and wall failure due to differential settlements.

Fig. 9. The settlement at the school building

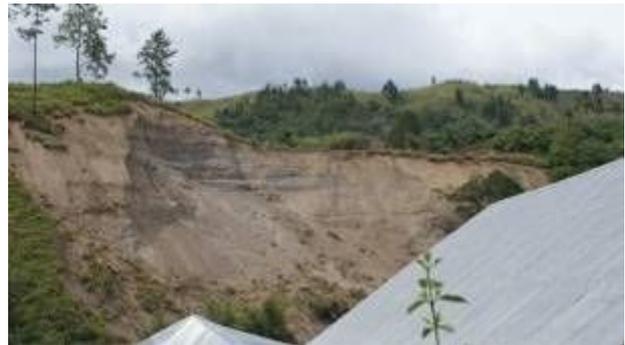
Other sites related hazards to school buildings include earthquake caused landslides as seen in Fig. 10.

Fig. 10. Landslide at the school site

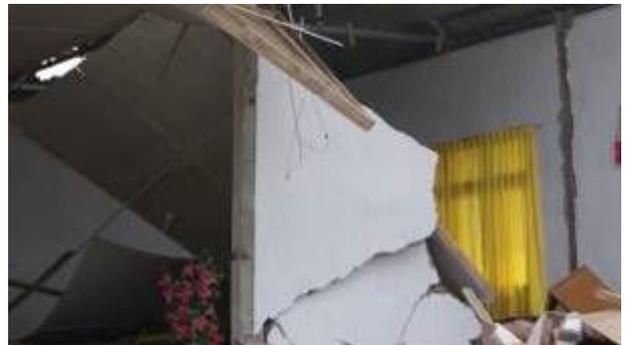
Damage to school buildings can be separated between structural and non-structural elements. Non-structural failures in ceiling framing and heavy balcony guardrail walls have been observed as seen in Figs. 11. and 12.

Fig. 11. The Ceiling collapse at the school building

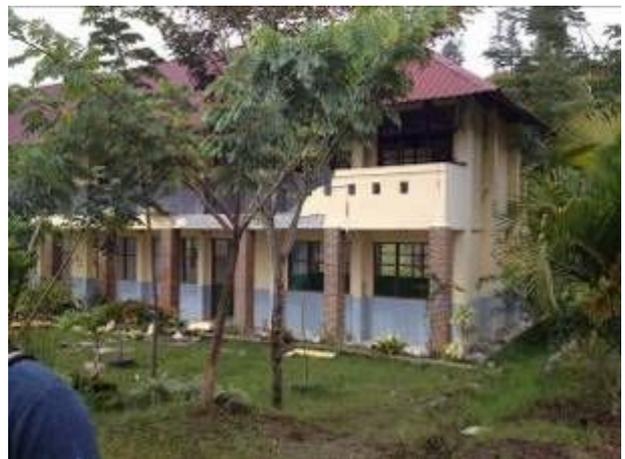
Fig. 12. Heavy balcony guardrail wall failure at the school building

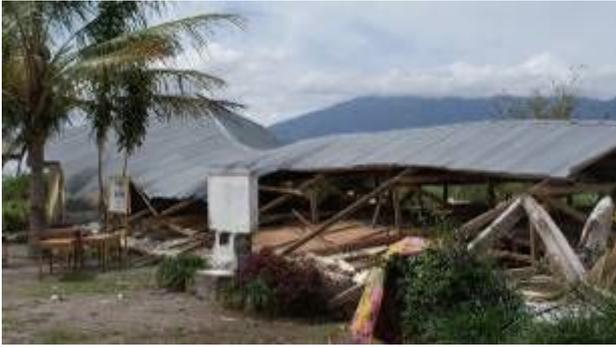
Observed school building structural failures include total collapse as seen in Fig. 13. Other partial collapse failures occur as individual walls fail out-of-plane as seen in Fig. 14. or failure of the upper part of high heavy gable walls as seen in Fig. 15.

**Fig. 13.** Total collapse of the school building (Source: Dinas Pendidikan Aceh Tengah)

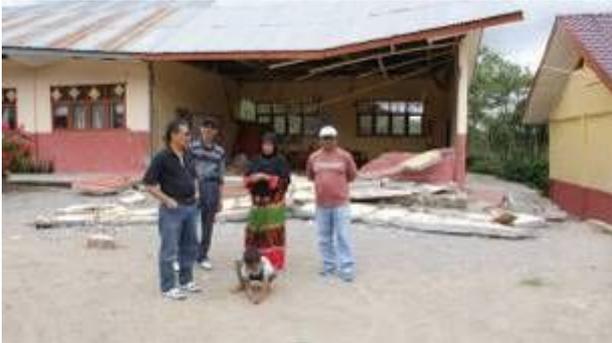
**Fig. 14.** Total wall collapse and failure at the school building (Source: Dinas Pendidikan Aceh Tengah)

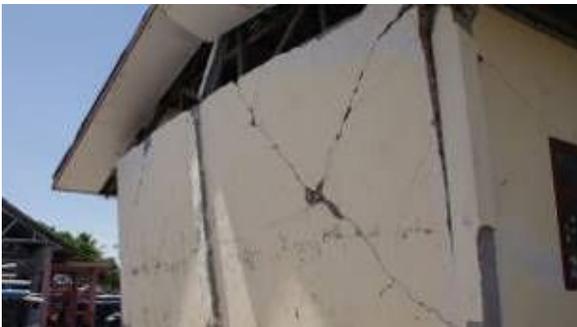
**Fig. 15.** Gable wall failure at school building (Source: Dinas Pendidikan Aceh Tengah)

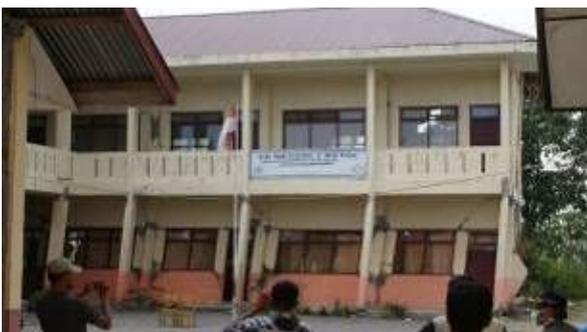
Weak story-initiated failure of two-story school buildings has been observed as seen in Fig. 16.

**Fig. 16.** Two-story school building failure (Source: Dinas Pendidikan Aceh Tengah)

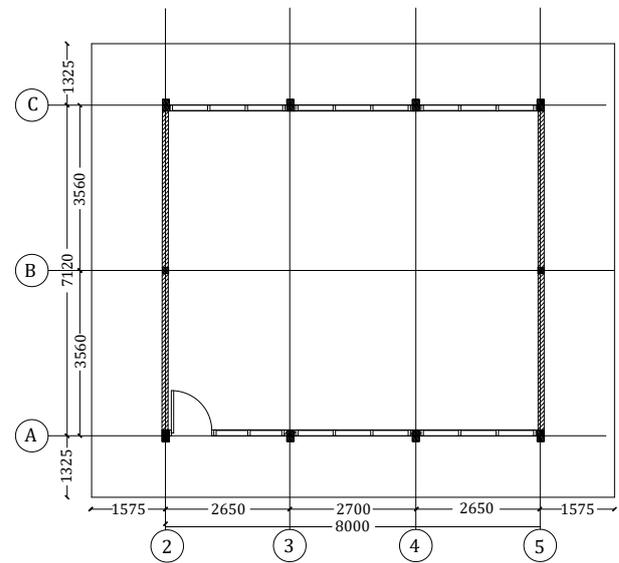
**Fig. 17.** Existing building A plan

The existing school building plan is as shown in Fig. 17. which conforms to a required class layout. The roof is built of corrugated iron sheets over wood trusses. The walls are built of brick and reinforced concrete columns. Besides the two solid gable walls in the transverse direction, all the walls in the longitudinal directions have window and door openings as seen in the building elevations in Fig. 18.

The building was found to lack of adequate shear walls in the longitudinal direction for the design earthquake loads. All the walls were also found to be inadequate for out-of-plane loading. The gable walls are susceptible to fall out due to out-of-plane loading. It was found that there is not an adequate diaphragm from the

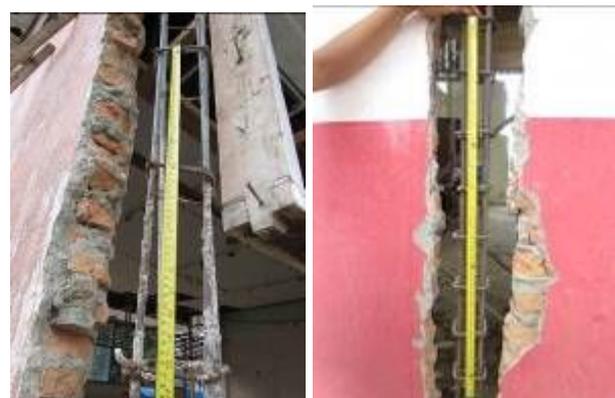
3. *Seismic ties:* Existing columns and beams use smooth round main structural reinforcements in both beams and columns. The lateral ties terminate with 90° hooks. The ties are not suited for structural elements subjected to reversal loading. New details use deformed steel reinforcement longitudinal bars with lateral ties with 135° hooks as seen in Fig. 22. in conformance to SNI requirements.

**Fig. 22.** Existing ties (left) and new seismic ties (right)

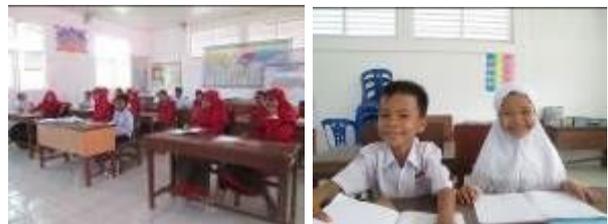
**Fig. 27.** Inside retrofitted classroom

8. *New safe classroom for a new generation:* The completed and retrofitted classrooms meet current building code and Ministry of Education requirements for safety, lighting, and ventilation as seen in Fig. 27. The rooms are brighter and safe. The only left aspect is to provide a second exit and access ramps in order to make the building accessible to all students including those with physical disabilities.
