Flood-induced Bridge Failures in Papua New Guinea

Gibson Ali HOLEMBA^{1*}, and Takashi MATSUMOTO²

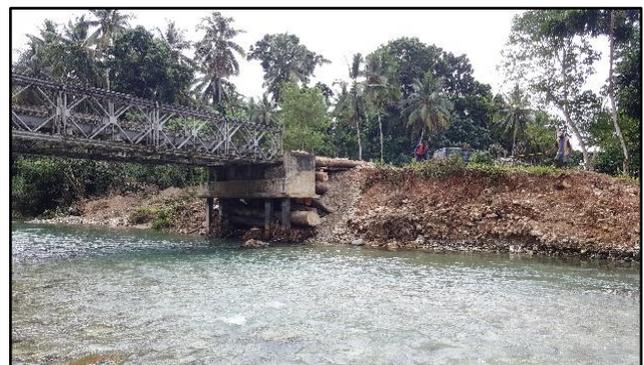
Figure 1. Flood-damaged Himutu Bridge, Boluminski Highway, New Ireland Province, Papua New Guinea. Photo Credit: Gibson HOLEMBA (2016).

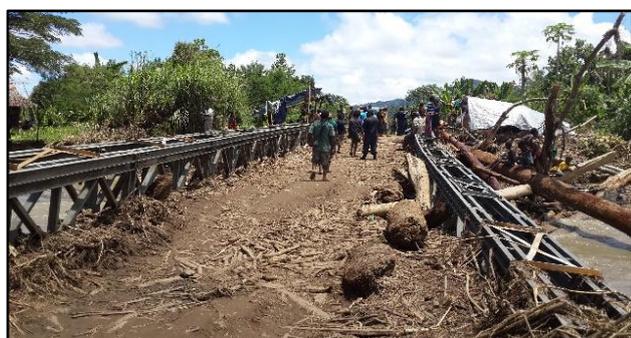
Figure 2. Flood-damaged Asas Bridge, Madang Province, Papua New Guinea. Photo Credit: Solomon Pela (2015)

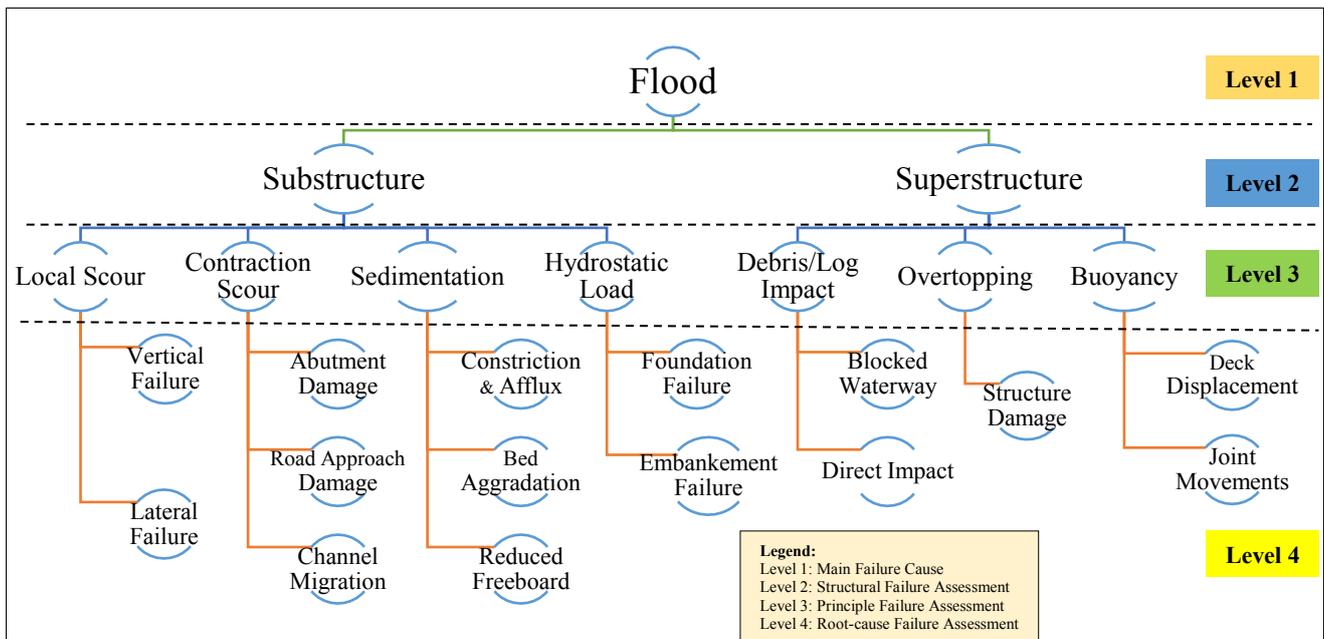
Figure 9. Bridge Failure Analysis

Finally, the root element of bridge damage was sorted into respective damage factors as per the field assessments and inspection records observed on site. Blocked waterway area, direct impact, deck displacement, joint movements, parapet/safety barrier damage, roadway damage were some of the common superstructure damages at the twenty-one bridge sites investigated as presented in Figure 9.

While, foundation settlement, abutment damage, road approach damage, channel migration, constriction flow, afflux, sediment deposition, reduced freeboard, slip failure and embankment failure were observed to be at the substructure level.

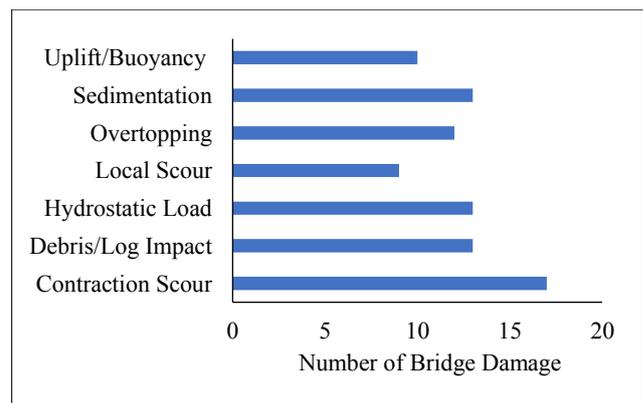
Figure 12. Summary of Bridge Failure Cases

Figure 12 presents the bridge failure cases in the third level category based on the bridge failure analysis given in Figure 9. The figure describes the number of bridges that were subjected to bridge damage caused by the flood. The major cause of bridge failure according to this figure is contractor scour, flood debris and log impact on the structure, sedimentation, and hydrostatic load.

opportunity for log and debris impact in flood event which damaged Aumea Bridge, Asas Bridge, Kesuai Bridge, Surinam Bridge, Waterbung Bridge, Punam Bridge and Wara Pita Bridge. Huge logs were observed to be part of the flood debris generated from heavy logging, subsistence farming, alluvial mining, landslide and plantation agricultural activities along the coast.
