# Measurement of RC slab surface shape and investigation of local water stagnation

**Abstract** In a road bridge, drainage facilities are installed to discharge the water on the bridge surface. For each drainage facility, installation spacings are exemplified by waterproof manuals and others, but the quantitative sharing and drainage capacity of each facility and bridge surface have not been clarified. Also, it is thought that water will be stagnant due to bridge surface irregularities generated during construction or during service. However, no regulations on the concavities and convexities about the slab surface are clearly shown in construction standards. Therefore, in this study, surface shape measurement and water sprinkling test on unpaved actual bridge slab were carried out. From the results, we confirmed the possibility that irregularities on the slab surface affect the tendency of local water stagnation. Since only one bridge was studied in the current study, we have not confirmed the influence of gradient magnitude on the drainage capacity of uneven slab surface. It is a future task to clarify the relation between surface gradient and allowable irregularity size and to d

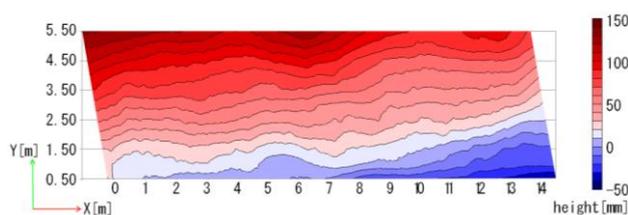
**Fig. 7.** Contour plot of slab surface shape

From the measurement results for the total of 11 measurement lines, the surface of the slab is shown in the contour plot (Fig. 7). In the figure, the high part is represented by red, and the low part by blue.

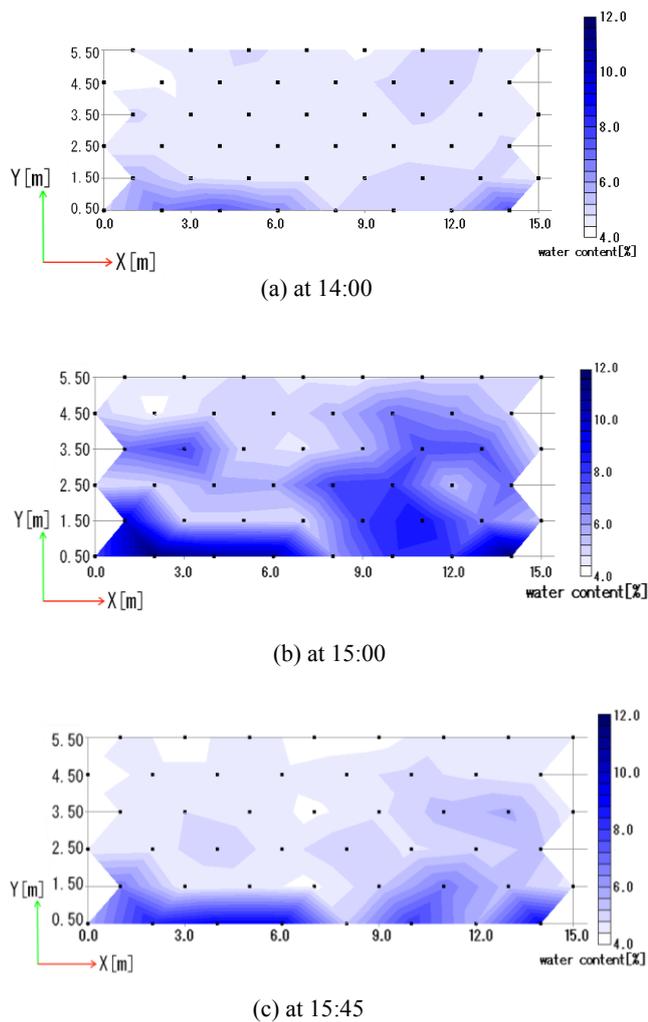
**Fig. 8.** Water content

Fig. 8 shows the change of water content after the sprinklings in the measurement area.

in this slab design, and the water content increases at the lower side of the gradient ( $Y = 0.5 \sim 1.5$  m).

Especially, paying attention to  $Y = 0.5$  which is the end portion, it is understood that the water content tends to increase at the position where drainage does not occur. This indicates that the water arriving at the intersection along the transverse gradient can not be drained in the longitudinal direction. As a result, water tends to accumulate between the drainage devices. This can be a deterioration factor after service. The average longitudinal gradient of L1 on the kerb side satisfied the

design longitudinal gradient (Table 3). However, because there are irregularities on the line, it seems that it causes local water stagnation.

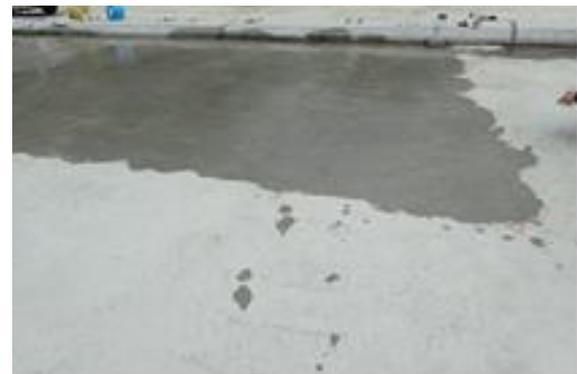
**Fig. 9.** Immediately after water sprinkling

Fig. 9 is a photograph of the slab taken immediately after sprinkling, and Fig. 10 is a photograph taken at 14:00 which is 120 minutes after sprinkling water.

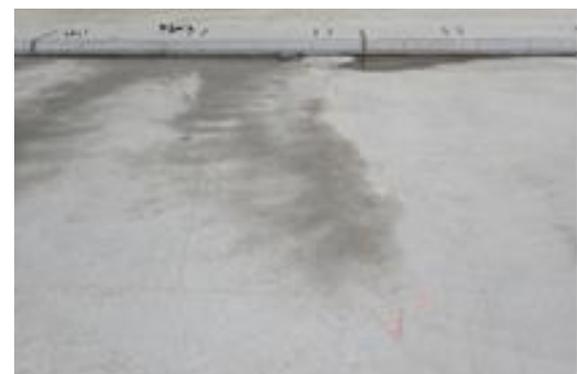
**Fig. 10.** 120 minutes after water sprinkling

There are multiple places where the water content is larger than the surroundings in all three measurements. This means that there is a part where stagnant water is likely to occur locally. This is consistent with the fact that local wetting points are confirmed in the observation of the surface of the slab after sprinkling (Fig. 10).

In the photograph, it is also understood that the back is the kerb, and it is found that the water is stagnating around the kerb.

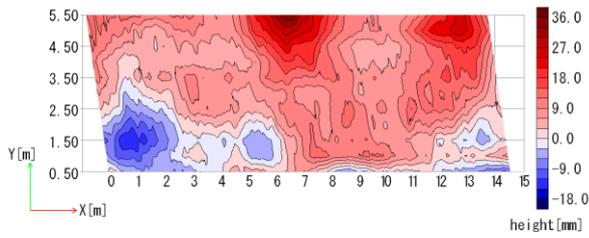
**Fig. 11.** Difference from design slab surface

Next, the difference between the actual measured value of the surface shape and the design slab surface where the transverse gradient and the longitudinal gradient are 2% and -0.33825% are shown in Fig. 11.

As can be seen from the figure, there are several places higher and lower than the design surface in the measurement area. The maximum value of the difference

from the design slab surface is about 36 mm at the convex portion and about 15 mm at the concave portion.

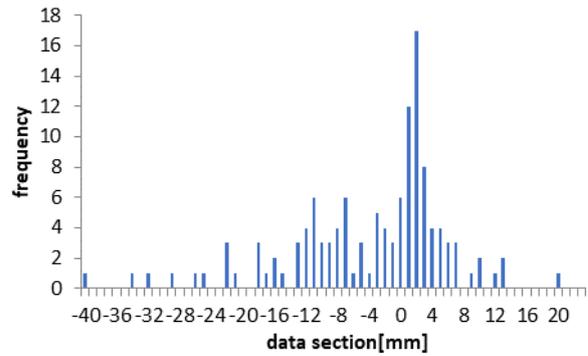
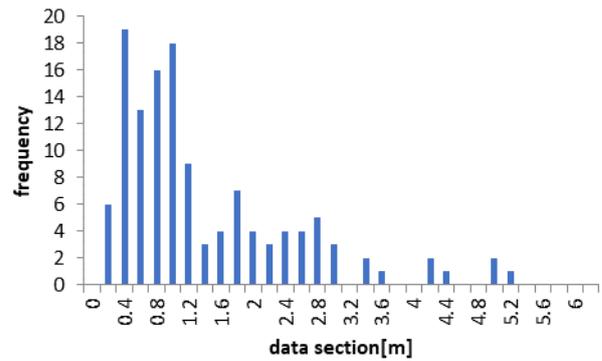
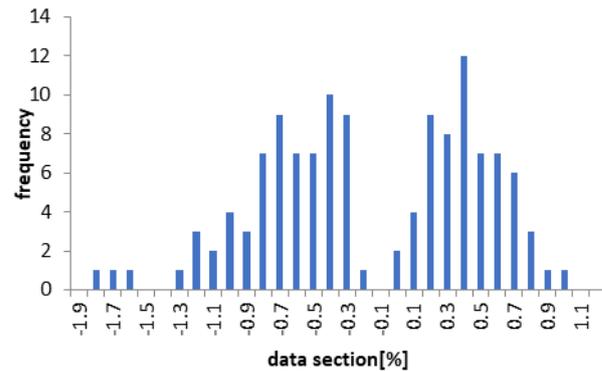
**Fig. 13.** Histograms about unevenness

As can be seen from Fig. 13 (a), the height difference between the top and the bottom along the longitudinal direction is mostly within the range of -4 to 7 mm, and secondly within -18 to -7 mm. As can be seen from Fig. 13 (b), there are few cases with width exceeding 3.5 m. When looking at the whole, it is thought that unevenness within the width of 1 m contributes to forming irregularities on the surface. There are also a certain number of unevenness having the width of 1 to 3 m. The histogram of the local gradient shown in Fig. 13 (c) has 126 data points. Among them, there are 58 pieces of data as local gradient in the upward direction which may inhibit drainage. Considering Fig. 13 (a) and Fig. 13 (c) together, it is conceivable that many uneven locations with the width of 1 m or less has the height difference of -4 to 7 mm, and with the width of 1 to 3 m has the height difference of -18 to -7 mm.

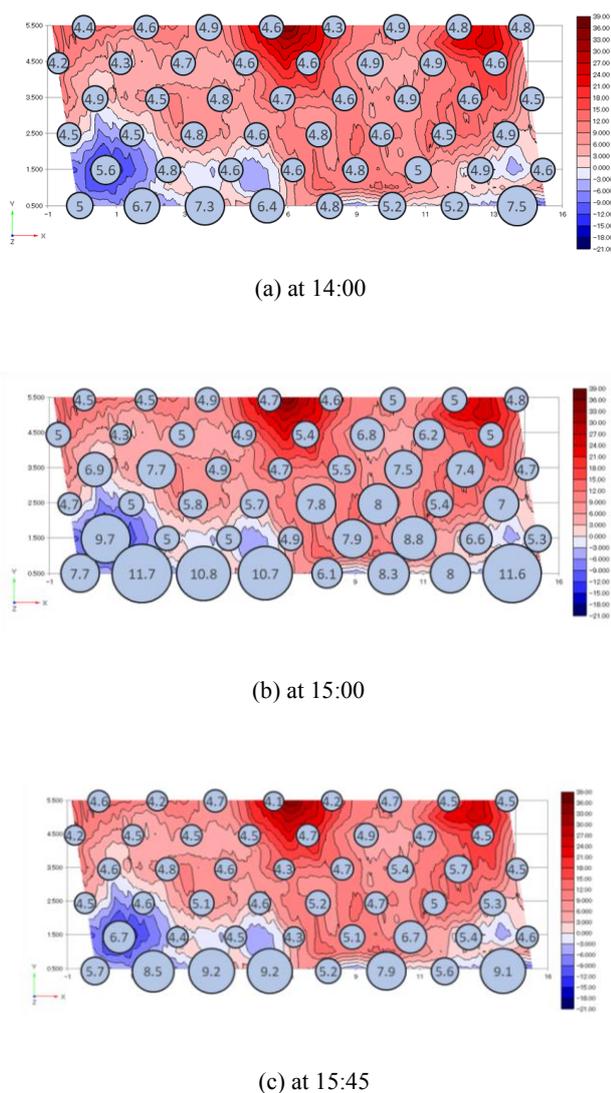
**Fig. 14.** Change of surface water content and slab surface shape

From the above, there is a tendency for local water stagnation to occur, so the relationship with the surface shape is considered specifically. Fig. 14 shows the

measured values of water content in bubbles with the surface shape of Fig.11 superimposed.

From this figure, it can be seen that the water content in the concave portion is higher than in other portions. The water content of the concave portion decreases with the lapse of time, but the remaining position does not change. Therefore, it can be understood that the decrease in the water content is due to evaporation, not due to drainage by the gradient. Also, at the convex portion, the water content is lower than that of the surrounding area. In addition, there is a portion where the water content is high at the upper part of the slope of the convex portion, which means that the convex portion hinders the drainage. The above shows that irregularities on the surface of the slab surface cause local water stagnation. There are also parts where water content is not so high in concave portions. This is considered to be because relatively shallow depressions do not hinder water drainage because of the design gradient.

Although it is ideal to flatten the construction surface completely as designed, it is not realistic. On the assumption that unevenness will occur, it is necessary to investigate to what extent the undulation can be accepted when constructing the gradient. Based on such a study, it will be a future task to study irregularities management method that does not inhibit drainage function.
