# Flaking of PEEK under one-point rolling contact fatigue using Al<sub>2</sub>O<sub>3</sub> ball

**Abstract.** The growth of flaking as tribological fatigue failure in PEEK was investigated through the one-point type rolling contact fatigue test between a machined PEEK polymer shaft and an alumina bearing's ball. Due to Hertzian contact of cyclic compressive stress, the subsurface fatigue cracks in the PEEK shaft propagated in rolling and axial directions. When the rolling fatigue life of the PEEK shaft reached 10<sup>6</sup> fatigue cycles, many narrow angled cracks occurred in the near-surface of the rolling track without flaking. On the other hand, when the flaking occurred on the PEEK shaft before 10<sup>6</sup> fatigue cycles, semicircular surface and subsurface crack propagations were observed. From these observations, it was found that micro-flaking occurred due to the linkages between subsurface and surface cracks. Flaking developed due to the accumulation of these micro-flakings.

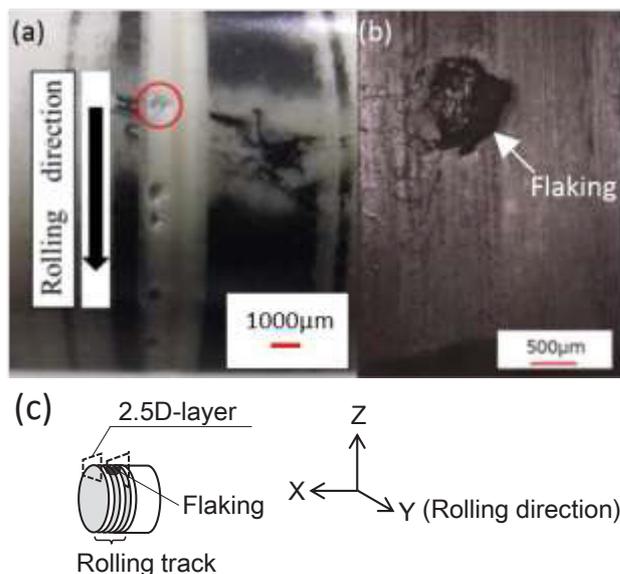
**Fig. 2.** Test specimen after one-point RCF test; (a) flaking on the rolling track, (b) close-up of flaking, (c) illustration of 2.5D layer observation (in Fig. 5).

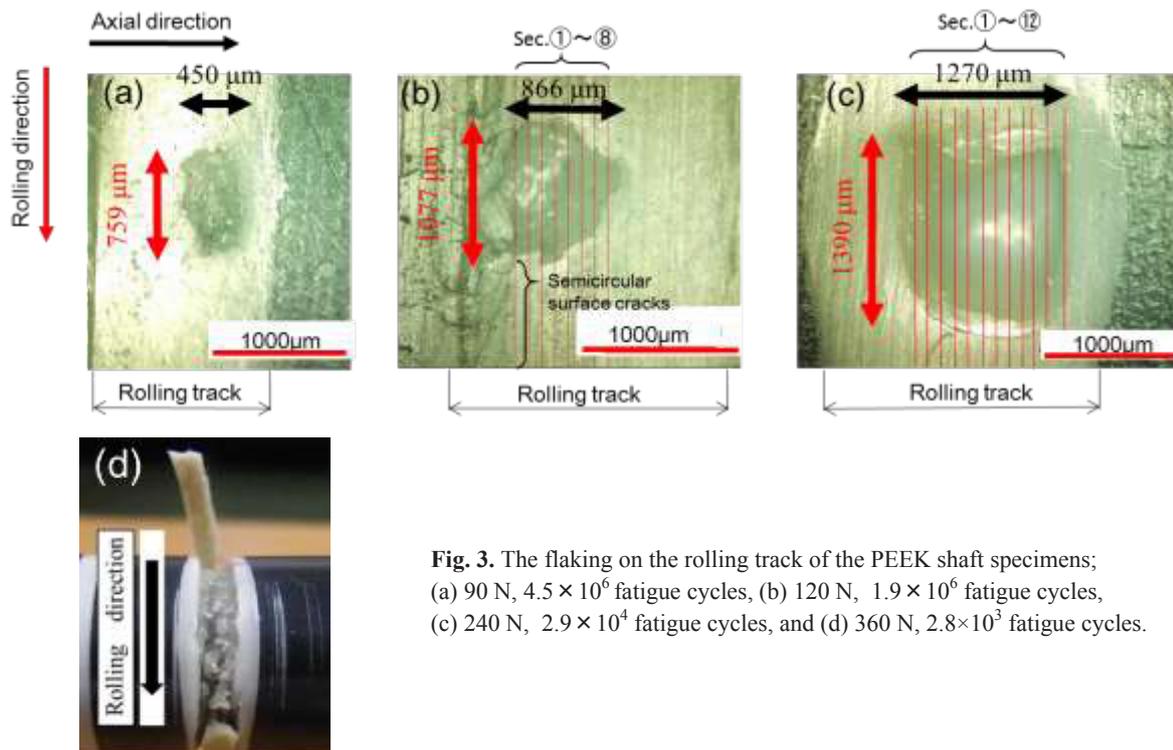
Figure 3 shows microscope images of the rolling track of the PEEK shaft after the one-point RCF tests. The higher the radial load, the larger the flaking size. As shown in Fig. 3(b), semicircular surface cracks like 'fishscale shape' were observed near the flaking. The rolling direction length ( $L_{ro}$ ) of flaking was longer than the axial direction width ( $W_{ax}$ ). This means that in flaking on the rolling track of the PEEK shaft the fatigue cracks propagated faster toward the rolling direction than toward the axial direction. When radial load was 360 N, the delamination occurred on whole rolling track (Fig. 3(d)). Therefore,  $L_{ro}$  and  $W_{ax}$  could not be measured. It was thought that subsurface cracks propagated due to internal shear stress. Table 2 shows the

**Fig. 3.** The flaking on the rolling track of the PEEK shaft specimens; (a) 90 N,  $4.5 \times 10^6$  fatigue cycles, (b) 120 N,  $1.9 \times 10^6$  fatigue cycles, (c) 240 N,  $2.9 \times 10^4$  fatigue cycles, and (d) 360 N,  $2.8 \times 10^3$  fatigue cycles.

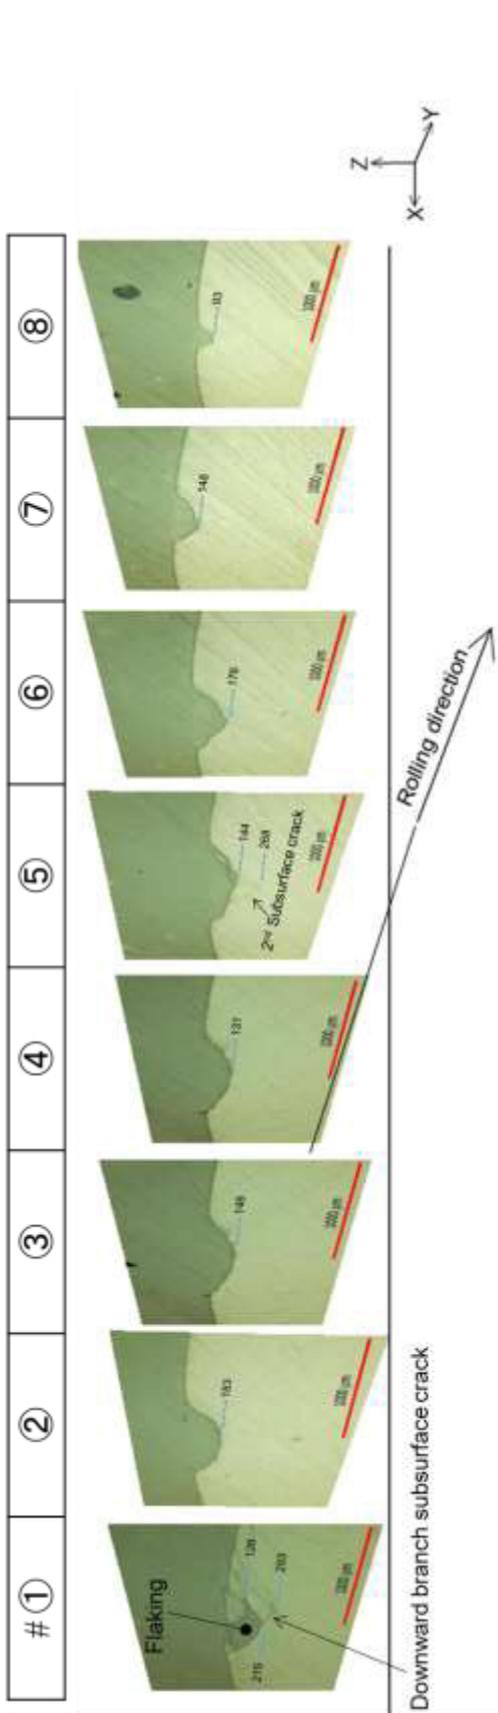
Figure 4 shows 2.5D layer images of the crosssection of the flaking area along rolling direction at  $1.9 \times 10^6$  fatigue cycles under a load of 240 N. The maximum depth of the flaking was approximately 215  $\mu\text{m}$ , and the downward branch subsurface crack propagated along the rolling direction (Fig. 4(#1)). The flaking bottom gradually rose upward along axial direction (Fig. 4(#1)~(#4)). Additionally, the downward branch subsurface crack from the flaking bottom was observed at 268  $\mu\text{m}$  depth as shown in Fig. 4(#5). This result shows that the downward branch subsurface crack influenced the growth of flaking.

Fig. 4. 2.5D layer images of crosssection of the PEEK shaft rolling track at 120N,  $1.9 \times 10^6$  fatigue cycles. Scale length is 1000  $\mu\text{m}$ .

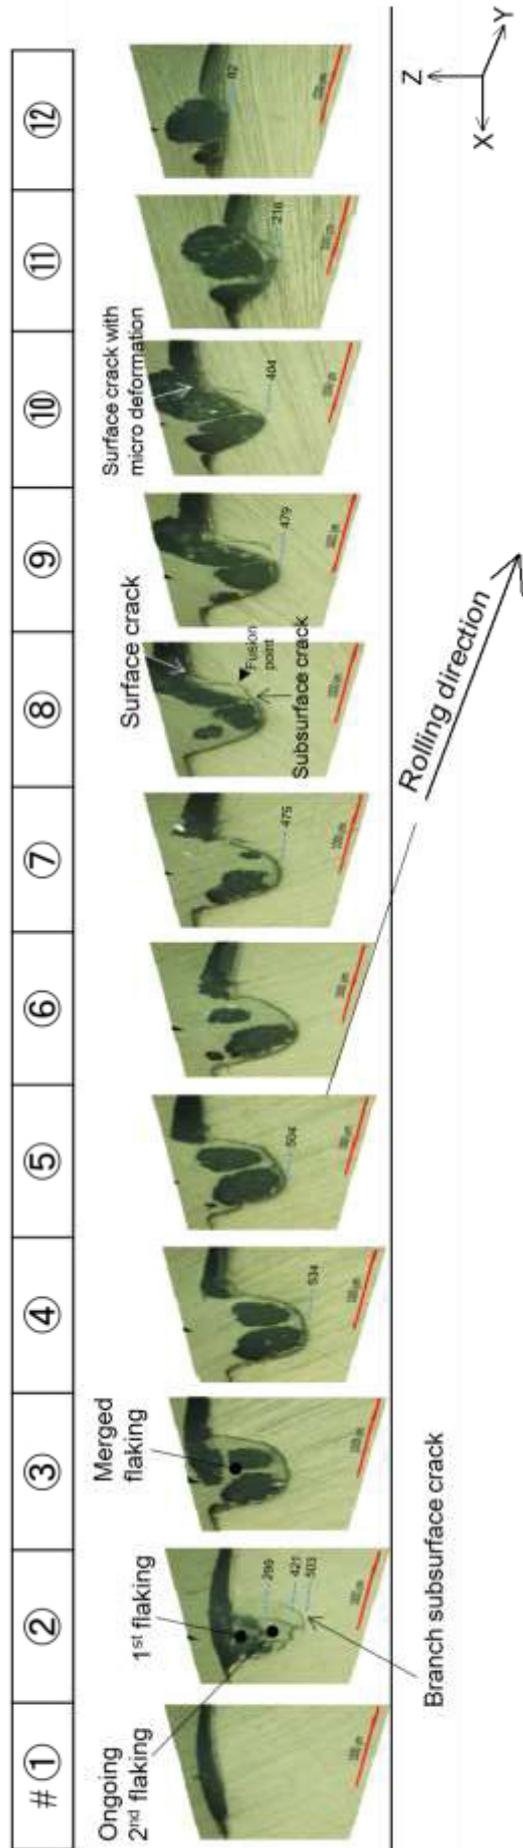
Figure 5 shows 2.5D layer images of the crosssection of the flaking at  $2.9 \times 10^4$  fatigue cycles under 240 N radial load. As shown in Fig. 5(#2), downward branch subsurface crack was observed below the 2<sup>nd</sup> flaking. By

the propagation of subsurface cracks, the first flaking merged with the second (Fig. 5(#2 and #3)). At this time the maximum depth of the flaking was 534  $\mu\text{m}$ . As shown in figure 5(#8), the flaking grew due to the fusion of subsurface crack and surface crack.

Fig. 5. 2.5D layer images of crosssection of the PEEK shaft rolling track at 240N,  $2.9 \times 10^4$  fatigue cycles. Scale length is 1000  $\mu\text{m}$ .

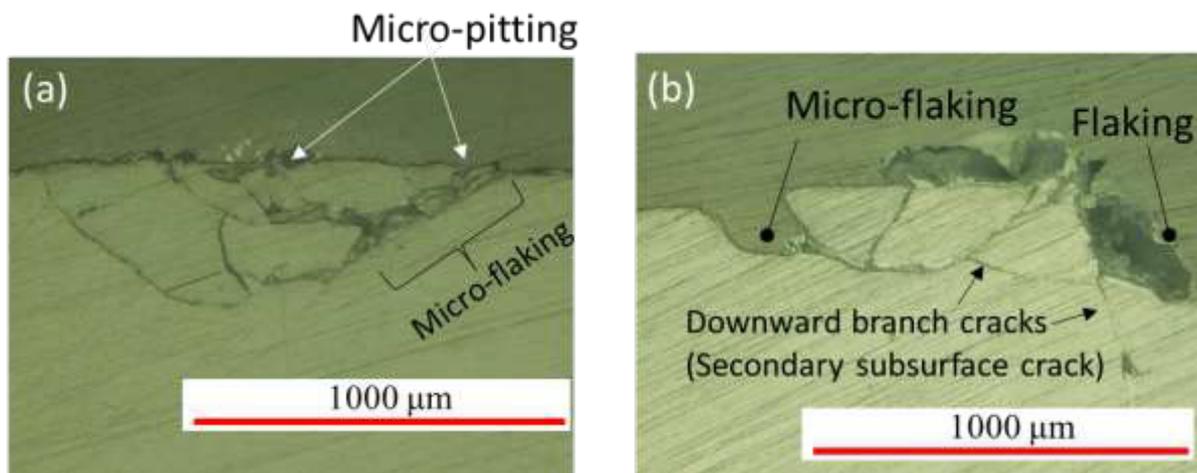
Figure 6 shows the close-up of the flaking origin in the nearsurface of the PEEK shaft. In early stage of flaking, micro-pitting or micro-flaking occurred in the nearsurface of the rolling track. The first micro-flaking occurred within 200  $\mu\text{m}$  depth from the rolling track surface due to the fusion of some subsurface cracks (Fig. 6b). It was found that flaking grew gradually with the linkages of the micro-flakings.

Fig. 6. Detail of the flaking origin at 120 N at  $1.9 \times 10^6$  fatigue cycles; (a) micro-pitting, (b) micro-flaking and branch crack.

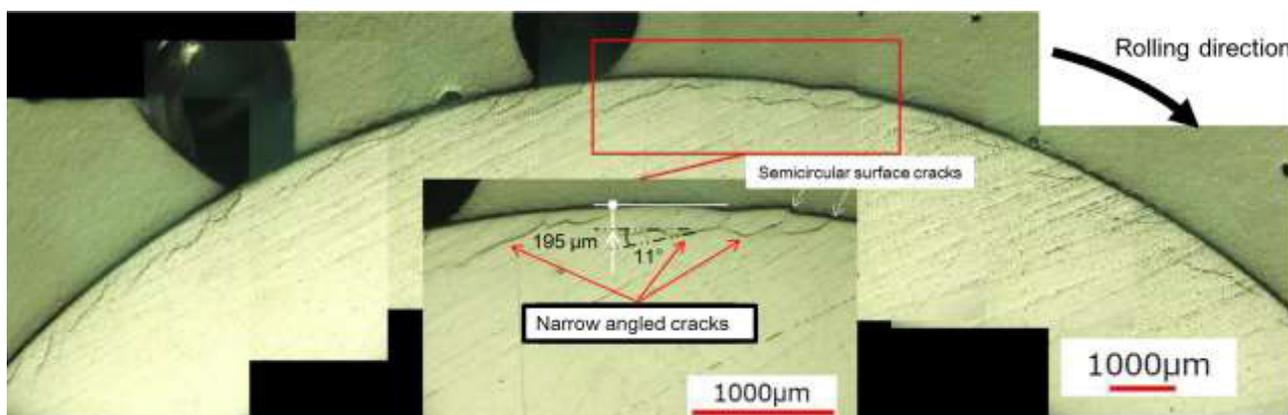
Figure 8 shows the microscope image of the cross-section around non-flaking area on the rolling track of the PEEK shafts at  $1.9 \times 10^6$  cycles under 120 N. Many narrow angled cracks were observed on the subsurface. The narrow angled cracks propagate along the rolling direction at around 200  $\mu\text{m}$  depth from the shaft surface. These cracks caused micro-flaking.

Fig. 8. Cross-section of near-surface cracks before fatigue fracture at 120 N ( $1.9 \times 10^6$  cycles).
