Hazardous hydrogeological processes in deep road trenching on the section of the Khekhtsir ridge

Abstract. During the construction of the motorway bypass of Khabarovsk on the northern outskirts of the Khekhtsir block rise, composed of strongly dislocated Mesozoic and Paleozoic rocks, on the section of the Khekhtsir ridge watershed crossing in deep road trenching of rock formations, dangerous hydrogeological manifestations, threatening the normal construction and operation of the road, were revealed. By the special tests (well drilling, geophysical studies using the VES survey method, hydrometric measurements of the groundwater discharges in excavated cuvettes and wells slug-out test), it is determined that the hydrogeological conditions of the site are very complex, as the groundwater supply area is located in the watershed part of the Khekhtsir Range that is crossed by the road. According to the specific electrical resistance test in the upper part of the massive and to the depth of the geological section low resistances blocks corresponding to the fragmented rocks and watered zone were fixed.

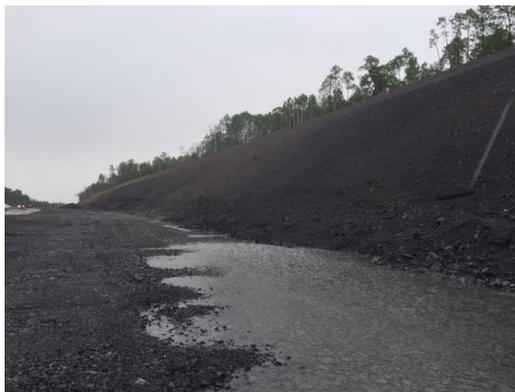
The object of research is a deep road through cut on the constructed motorway from Khabarovsk to Vladivostok (Fig. 1). Dangerous hydrogeological manifestations arose during its construction: small fountains (griffins) of underground water were fixed from the west cut slope and through not pavement covered roadbed in summer, and underground water ice covers were formed on the western slope during winter time. Also, there were outcrops of groundwater at the base of the cut slopes on the left and right sides (Fig. 1). These phenomena would inevitably cause engineering and geological processes threatening reliable and safe operation of the road - active erosion, shedding of slopes, deformation of the base of the pavement. In these conditions, additional to the pre-project geotechnical and hydrogeological studies that were performed before excavation investigations were needed.

Fig. 1. Watered area at the cut slope bottom.

A considerable amount of ice was formed on the west cut slope during excavation in the winter periods 2014-2015 and 2015-2016. Underground water poured out through the strewn roadway in the western ditch and frosts formed in the winter of 2016 - 2017. According to the builders, the flowing water was "warm" (about 8 - 12°C) compared to the ice water that appears when snow and ice melt. Also there are griffins in places of standing of water in a ditch. The water flow along the western cuvette is directed to the south.

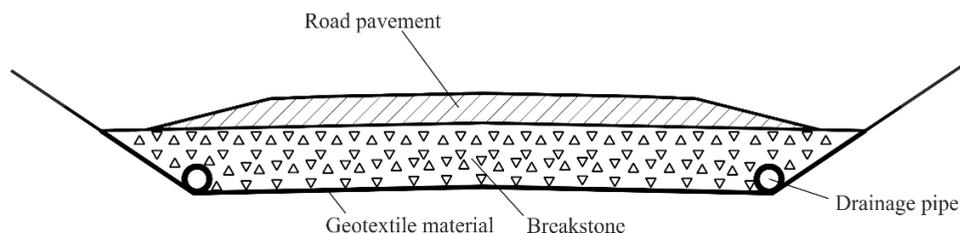
Fig. 2. The construction of drainage.

The revealed features of the engineering-geological structure and hydrogeological conditions of the site and the predicted volume of groundwater discharge determine the ineffectiveness of dewatering by exclusively linear drainage usage, even double-sided. In our opinion, linear drainage should be supplemented with reservoir drainage to intercept groundwater draining under the roadway from the bottom of the cut (Fig. 2).
