# Weld Repair of Steam Turbine Rotor with 12 Cr Weld to Mitigate Corrosion Issues

<sup>1</sup>Sulzer Rotating Equipment Services, La Porte, TX 77571, USA

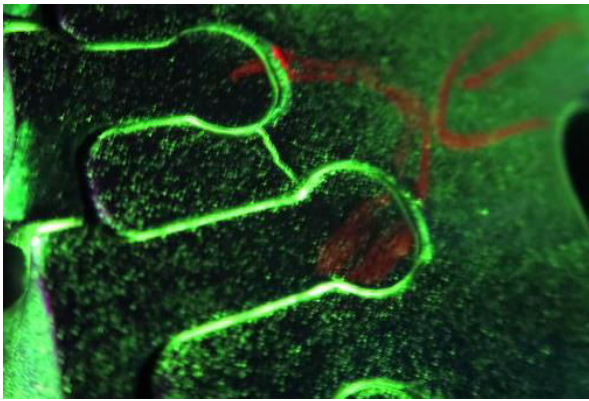
A recent example of stress corrosion cracking in a steam turbine rotor is discussed briefly below. Magnetic particle inspection of the row 6 integral disc of a steam turbine rotor showed cracks in its ball root blade hook

**Fig. 1.** Magnetic particle inspection highlighting a crack in a blade hook fit of a turbine disc.

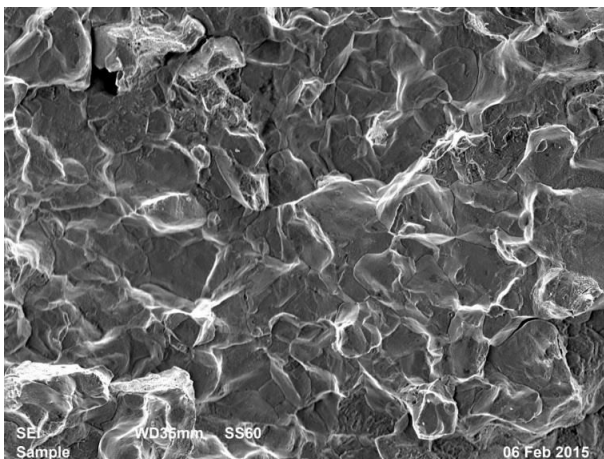
**Fig. 2.** SEM image of the fracture surface showing intergranular cracking which is a characteristic of stress corrosion cracking.

Additional information on this failure can be found in reference [6]. Complete root cause failure analysis (RCFA) was performed and stress corrosion cracking was determined to be the cause of cracking. The original rotor material was a low alloy steel.

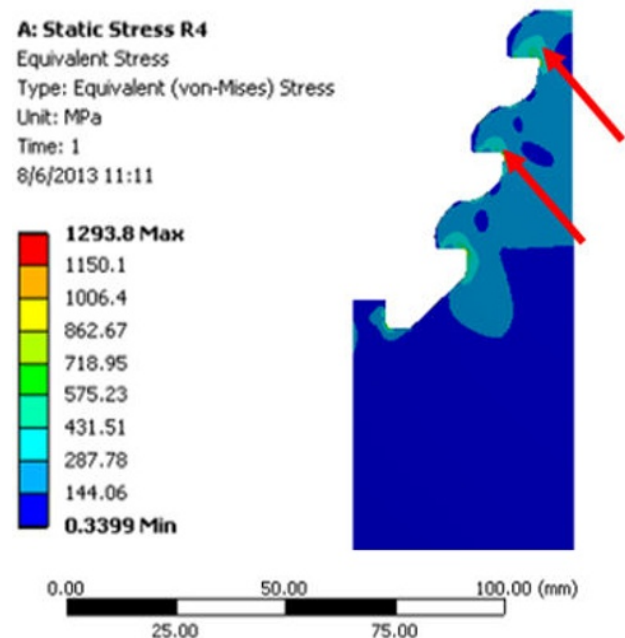
**Fig. 3.** Equivalent (Von Mises) stresses in the disc (half section). The two red arrows point to crack locations. These locations coincide with high stress locations as well.

High stress locations coincided with the crack locations – supporting customer’s conclusion that it was stress corrosion cracking. Therefore it was decided to use the 12 Cr weld (ER410NiMo) for the repair. The six discs were further machined away to strategically locate the weld interface and rewelded with ER 410NiMo as shown in the Figure 4.

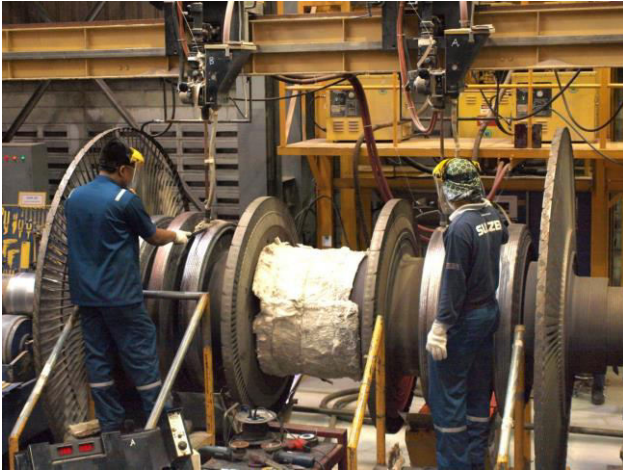
**Fig. 4.** Weld build-up of the discs with submerged arc welding.

After the completion of the welding, the rotor was rough machined, nondestructively tested and then stress relieved. The welded discs passed Sulzer's NDT criteria for welds on rotors. After final machining, the rotor was rechecked non-destructively. After making sure that the rotor passed the NDT criteria, the weld built discs were rebladed with new blades. The rotor was returned to service after the completion of all repairs and no issues had been reported since then.

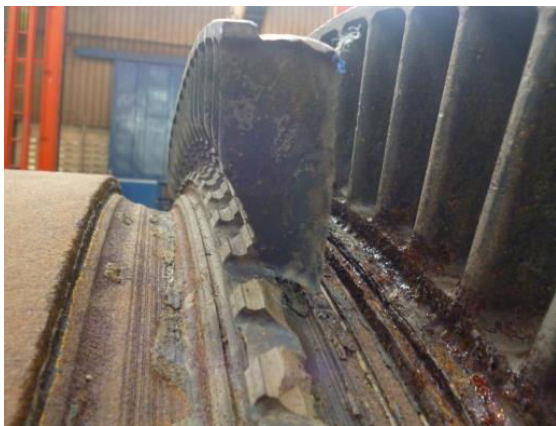
This is also a geothermal steam turbine with a rated output of 20 MW. The rotor alloy was CrMoV. Steam inlet temperature was 165.7 °C and steam inlet pressure was 7.13 Bar. The rated speed was 3,000 rev/min. It has 8 blading stages. By design, all the rows of blades were loaded in the loading slots of the rotor. The loading slots for the first three stages of the blades were heavily corroded as shown in Figure 5.

**Fig. 5.** Heavy corrosion damage in the loading slots of the rotor.

Per the customer, the rotor only ran for 3-4 years. The amount of corrosion seen was too much for a rotor that ran for 3-4 years. To mitigate the corrosion issue, it was decided to machine away existing loading slots that experienced severe corrosion and to use 12 Cr weld (ER 410 NiMo) to build up them. In addition, it was decided to undercut the corroded seal and journal areas and to reweld them with 12 Cr filler wire. Figure 7 shows the rotor being welded after machining away the damaged portions.

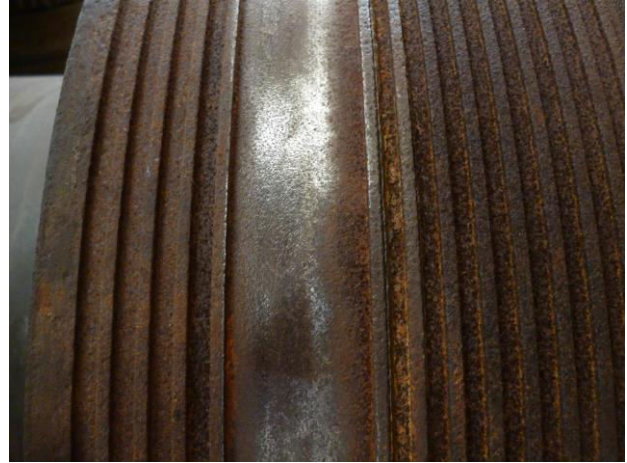
In addition, the seal area sustained heavy corrosion damage as shown in Figure 6.

**Fig. 6.** Corrosion damage in the seal area of the rotor.

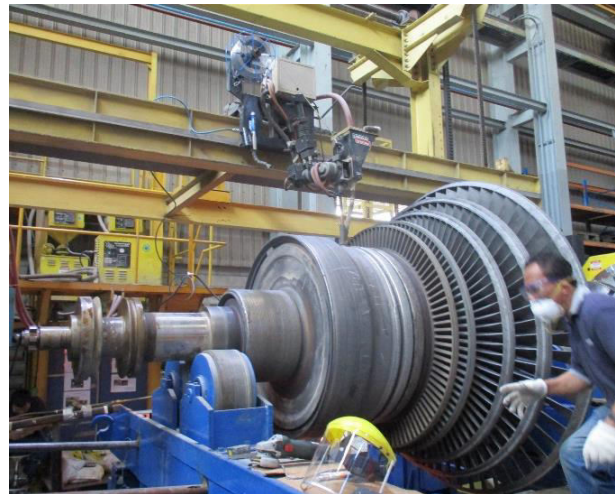
**Fig. 7.** Weld repair of the seal area and blade slots on the rotor.

As the amount of weld to be deposited was high, submerged arc welding process was used. After welding, the welded portions of the rotor were rough machined and inspected non-destructively confirm that it passes Sulzer's internal criteria. Then it was stress relieved per the qualified welding procedure. This was followed by machining the required features such as loading slots etc. Figure 8 shows the weld repaired rotor being rebladed. The weld repaired and machined seal area can also be seen in the figure.

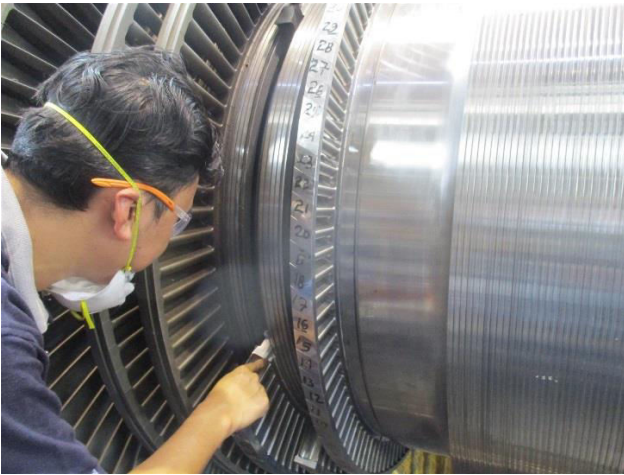
**Fig. 8.** Reblading of welded slots. The weld repaired and machined seal area can also be seen in the photo on the right.

As in the case 1 mentioned earlier, the weld repaired rotor was evaluated non-destructively to make sure that it passed the criteria for rotor repair. After reblading and balancing, the rotor was put back in service.
