# Reconstruction of the terrazzo surface in the exterior

**Abstract.** The article deals with terrazzo surface that is done in the exterior and which shows defects and faults after execution. It was an entry portal of an unnamed institution where the placed surface began to show flaws more or less immediately after laying. The article simply provides a research of the problem, deals with the proposed procedure and presents the results of the technology supervision. Currently, after the second execution, the surface again shows defects and the way of their remedy will be addressed. The article also presents the basic aspects that need to be respected and not neglected when this type of surface is realized. Terrazzo is primarily an interior material (in our conditions), but it is also possible to make it in the exterior – it is a special kind of concrete mixture. The article tries to summarize the issue and provide basic information about the problem and its solutions.

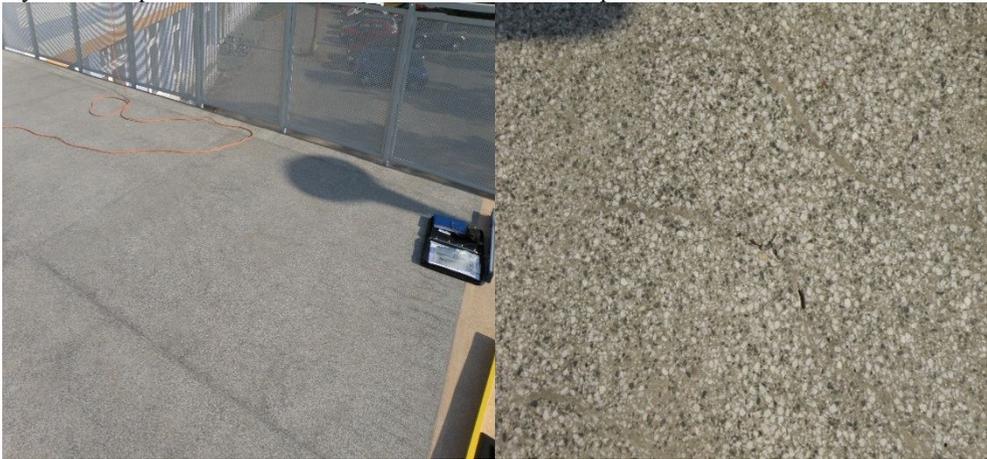
**Fig. 2.** Photo of the damaged original terrazzo layer

Based on the survey of 12 September 2016, when we were at the site with an expert, Mr. Ing. Zdeněk Nevošád, cracks in the surface were found, and it was discovered by tapping that a large part (80%) of the surface was separated from the base. The shape of the cracks indicated an imperfect implementation or large deflections of the base, while pillow effect was not primarily found. Closure of the cracks was not possible, they were larger than hairline ones and the layer had already separated from the base. Another cause could be seen in large expansion units on the surface – 4 fields of approximately 2\*2 m, which, due to the possibilities of deflections of the base, was too much. The identified defects can be described as follows:

- cracks caused by improper execution technology, hardening treatment,
- non-penetrated base without adhesive bridge,
- large expansion fields.

A) In terms of designing:

- Follow possible deflections set by the structural engineer – approx. 10 mm according to available information, [6]

- Adjust the size of contraction/expansion units – recommended approx. 0.9 x 0.9 m. [3,4]

B) In terms of implementation technology:

- Perfectly clean the base from mechanical impurities, the rest of the previous layers, do not allow chemical penetration of the base.

- Start moistening the base with water at least 6 hours before concreting. Second moistening done about 4 hours and another one about 2 hours before concreting. About 30 minutes before concreting, remove excess water from the surface – surface-moistened with water mist. [4]

- Choose a suitable time for concreting with regard to the ambient temperature, limit concreting under high heat – average temperature at the time of execution 25 °C, concrete in checked pattern. [4]

- After concreting, cover the surface with previously well moistened geotextile, which must be suitably anchored against wind blowing, maintain its moisture. [4]

- The remaining field of the checkerboard pattern may be concreted not earlier than 48 hours after the first concreting.

- Prior to the grinding of the surface, the geotextile is pushed away, grinding is performed and the whole surface is refilled (cavity filling). Continue with the moistening until the age of the youngest concrete of about 7 days depending on the weather.

- The final grinding and surface cleaning (slopes, water outflow) will be carried out and a water test will be conducted to remove water from the surface, and any areas with puddles will be eventually grinded again, and a final rehabilitation of any exposed minor defects and cracks is done.

- Before winter, but at least 28 days in the concrete age, impregnation (penetration) is applied to increase the resistance of the concrete surface to the freezing and salt. The most effective products are boiled linseed oil based products.

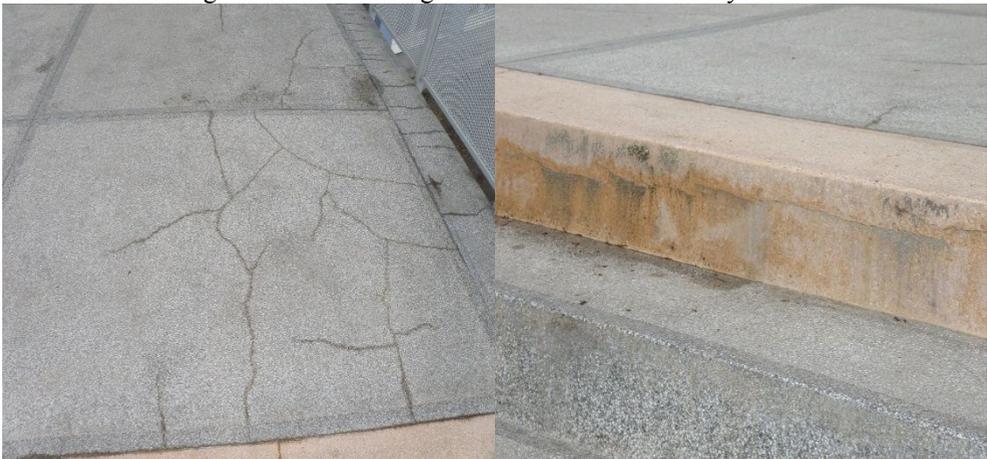
contractor, there was another discrepancy during the new implementation, namely the unification concrete layer, which reduced the thickness of the terrazzo layer. This subsequently had an impact on a new damage in May of the following year, when also imperfections of the surfaces on the stairs, which had appeared to be all right, became evident. The steps recommended to the contractor and the investor for the new layer execution leading to the correct repair were as follows:

These were the basic monitored steps that the company carried out in a quality that complies with the regulations. They used their own initiative only when concreting the unification layer (with specifications unknown to the supervisor), which reduced the thickness of the terrazzo layer to an average of 15 mm, which was not directly inconsistent with the guidelines, but the practice and standards did not recommend a thickness of less than 20 mm for these layers. This step proved, after one year of operation, to be another problem, when the unification layer worked more like an expansion layer.

supervisor considered to be a fault – but this was not in conflict with the standard, because the documentation did not indicate the value of the slopes, while it should have. This repaired layer was in operation for approximately one year before further damage occurred. The causes were more or less the same, moreover the impact of the unification layer and the reduced thickness of the surface had an effect. Damage also occurred on the surface of the stairway, which was sound during the original repairs, and the cause is probably due to the influence of leakage and surface treatment in the winter.

**Fig. 3.** Photo of surface and stairs damage during a new inspection in May 2017

Further talks were convened to make repairs, again with our recommendation not to carry out terrazzo on this structure due to its maximum thickness of 20 mm. As a result of the talks, the investor's decision was only to rehabilitate the surface in cooperation with a new firm for the time being – after the experience, the original one came to an agreement on another form of compensation with the investor. The result of the new company's proposal has not been passed on to us and the current state is unknown, the last known condition is the original one with damage before the summer holidays of 2017.
