# Defects of the building and its remediation – Case study: Elementary school Vodňany

**Abstract.** The aim of the paper is to provide information on the defects in the construction of the elementary school in Vodňany. The building of the elementary school dates back to 1973. It is a reinforced concrete columns skeleton with a filling peripheral and internal dividing brick masonry. The object is used by the primary school and is permanently used and maintained. The extent of structural damage is stabilized in the current state and is not an immediate risk to the user of the object. It concerns only non-load-bearing structures (floor and partitions), the vertical load-bearing structures do not show a decrease and therefore the stability of the whole building is not compromised. However, actual damage complicates operation of elementary school and is very non-aesthetic. Concurrent damage to structures is the result of vertical deformation of the foundation soil. Vertical deformation of the foundation soil - sediment is the result of the building construction on a former creek which was not properly excavated and covered with a suitable backfill. Subsidence further strengthens imperf

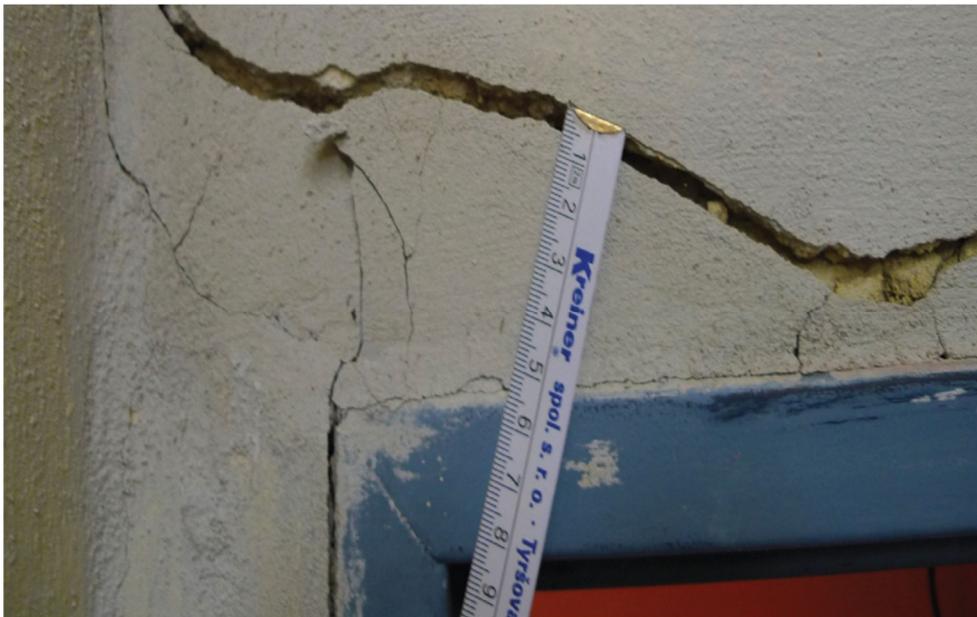
Floor structures have been showing signs of bending and forfeiting locally from the first view. Deflection measured at several points in the building level is 10 to 45 mm. Floating floor layers are ceramic tiles - square and rectangular templates. The strike layer is a sign of long-term use, but it is not damaged by deformations caused by the deflection of the floor. The reason for the deflection of the floor structures is the decrease of the foundation slab due to the vertical deformation of the foundation soil - sitting. Vertical brick construction 125 mm - the partitions are made of brick CDM. The partitions are based on low trapezoidal passports and show a large amount of cracks. These are cracks both vertical and horizontal. Vertical cracks go in some places both perpendicularly to the ground and obliquely and pass through the joints and the brick. Horizontal cracks occur especially in the area of the connection of partitions on the ceiling structure. The crack width ranges from 1 to 10 mm. Because the cracks are located in the masonry walls, they are not statically cracked and do not endanger the safety of the building. The reason for the occurrence of oblique cracks is the decrease of the base passages due to the vertical deformation of the foundation soil - sitting. Horizontal cracks in the partition of partitions on the ceiling structure are the result of the partitioning of the partitions from the ceiling structures due to the fall of the basepasses and the seating of the foundation soil. The cracks in the building show different properties and therefore the research team will not allow to say whether it is a sudden or gradual sit of the foundation soil.

**Fig. 1.** Defects on the vertical structure
