# Analysis of technical condition of footbridges over the railways in danger of collapse

Ryszard Chmielewski<sup>1,\*</sup>, and Aleksandra Bąk<sup>1</sup>

<sup>1</sup>Military University of Technology, Faculty of Civil Engineering and Geodesy, Warszawa, Polska

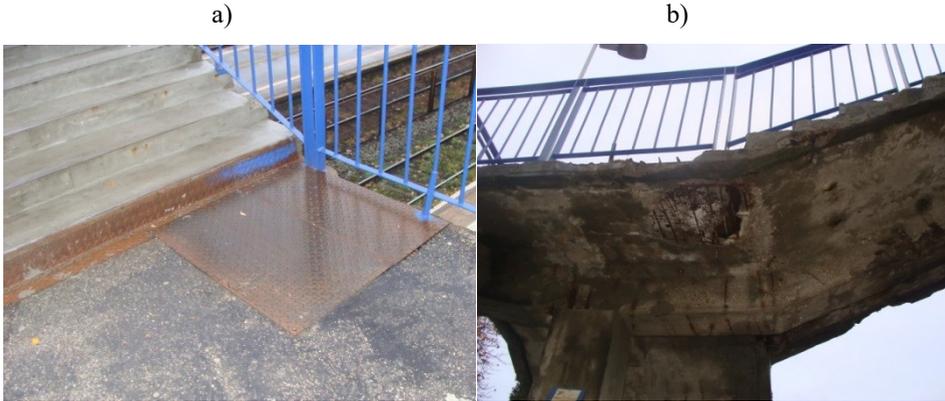
- losses of concrete over the entire thickness of the deck slab and stairs – for example: the opening, in the stoop of the deck above the platform no. 1, that was covered with metal sheet (e.g. figure 16 and 17 [12]) - Figure 2.

**Fig. 2.** The hole in the stoop above platform no. 1 a) covered from the top, b) view from below.

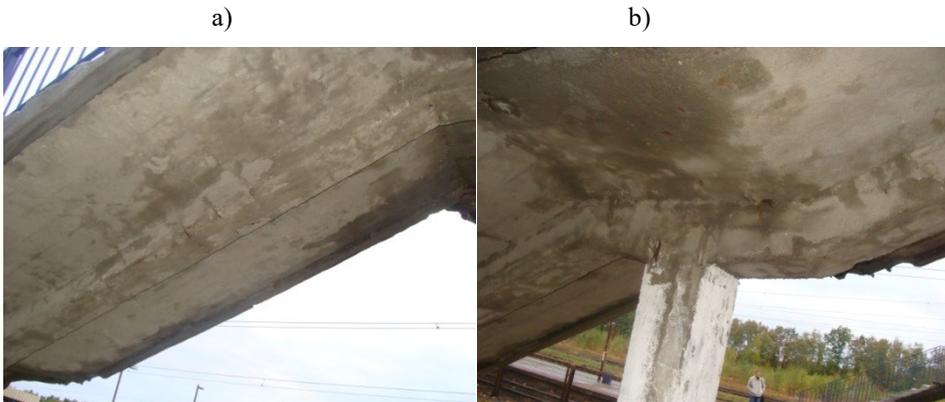
- narrow shrinkage cracks (up to 1 mm in width) occurring on the entire surface of the deck slab and stair slab, that were particularly visible during rainfall (e.g. figures 19 and 20 [12]) - Figure 3.

**Fig. 3.** a, b) Examples of shrinkage cracks.

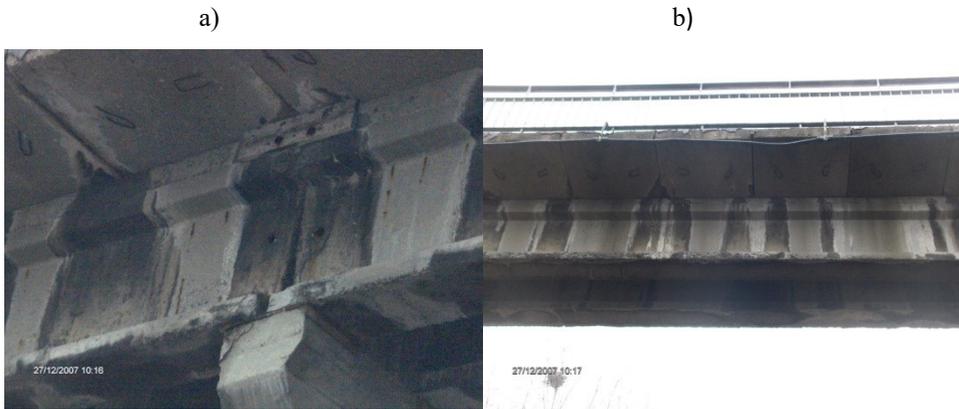
In the case of the second of the assessed facilities, the bad technical condition of the prestressed concrete beams of the piers was the result of numerous rainwater leakage – Figure 5. In the location of the leaks, cement paste was leached, which compounded by the carbonization caused the corrosion the prestressing reinforcement. These processes caused the delamination of the concrete cover, which fell off locally, while in other places during tapping of the construction with hammer, dull noise came out – Figure 6.

**Fig. 5.** a, b) Watermarks on the girders of the footbridge.

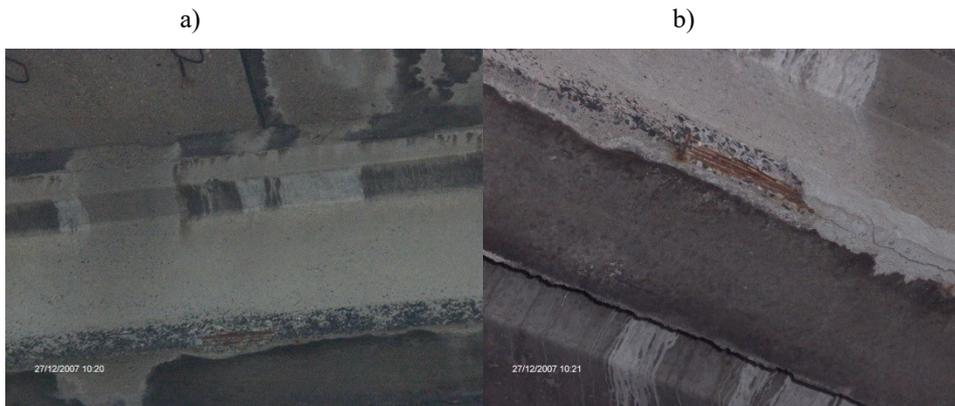
**Fig. 6.** a), b) Local corrosion losses of the reinforced concrete cover.

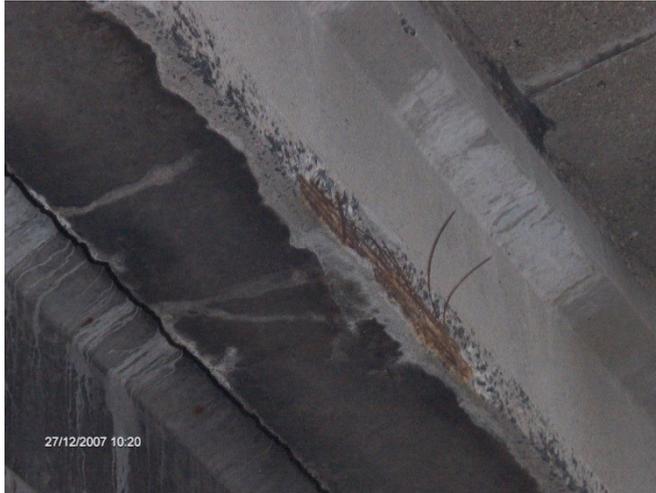
Locally, corrosion of the girder beams contribute to the rupture of some of the prestressing tendons - Figure 7.

**Fig. 7.** Ruptured tendons of prestressed reinforcement caused by corrosion.

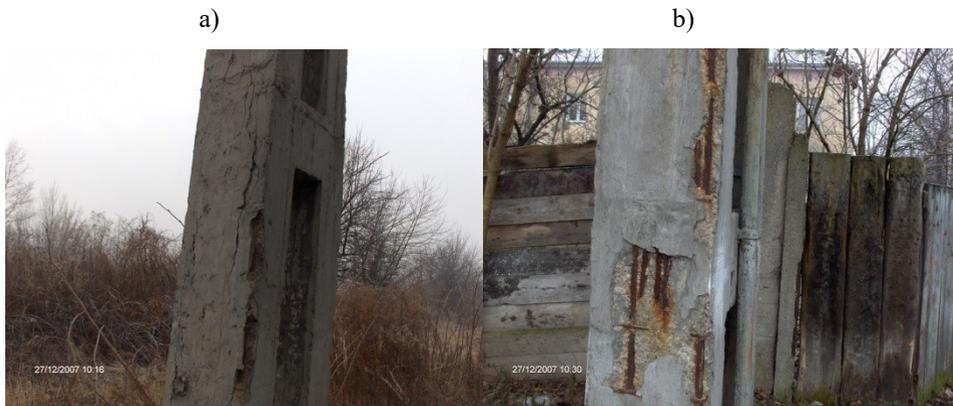
The stairs that descend from the Wola district side was made in the form of a steel structure made of rolled bars. The technical condition of this structural element was evaluated as good, only general corrosion of the surface was observed. The technical condition of the wooden stair steps was determined as bad, due to the cracks and cavities, that were a direct threat to the safety of the building users. On the other hand, the stairs to the Odolany railway station were made as a reinforced concrete structure. The state of this element was also determined as bad. Ineffective insulation have caused large corrosion damage both on the slabs and pillars of the footbridge [12]. The structure of the footbridge deck was based on seventeen reinforced concrete pillars, whose technical condition was evaluated as sufficient [12]. Rainwater runoff and carbonization of concrete have caused corrosion of both concrete and reinforcement. The concrete cover has been delaminated due to the corrosion of reinforcement, that is visible in the form of vertical scratches along reinforcing bars of the pillars. On several pillars, local defects of the concrete cover of the reinforcement were noticed, nevertheless even on unscratched pillars the delamination of concrete cover was observed - Fig. 8.

**Fig. 8.** Examples of cracks in concrete along the reinforcing bars of the pillars.

All pillars were affected by corrosion, therefore, structural reinforcement of all pillars was recommended. Due to the great depth of concrete corrosion and significant general and pitting corrosion of reinforcing bars, all pillars of the footbridge had to be strengthened to achieve the design load – capacity of these elements, while taking into account the current norms. The surface of the footbridge was made of mastic asphalt, no insulation of the deck slabs was noticed [12]. Nawierzchnia kładki wykonana była z asfaltu lanego, nie zauważono jakiegokolwiek izolacji płyt pomostu [12]. Leaky surfaces arising out of the imprecise arrangement of the bituminous mass along the handrail, lead to the leakage of rainwater along the joints of the deck slabs and watermarks on girders. Moreover, leaks were created along unprotected expansion joints.
