# Damage to an overpass bridge from WBS prefab beams

**Abstract.** The article presents a description and analysis of the causes of damage to a road viaduct, made of prefabricated compressed beams of the WBS type in the 1970s. Both the design and damage are typical for objects made in those years. Damage results from the deck slab being too thin, low quality waterproof membrane, easily deformable deck surface, leaking bridge deck expansion joints, linear-contact bearings at excessively long spans, undurable drainage system elements. On the basis of the static and strength analysis, proposals for a way of repairing the viaduct were given, which, taking into account the occurrence of similar structural solutions in existing facilities, can be used as a guide when designing renovation and modernization.

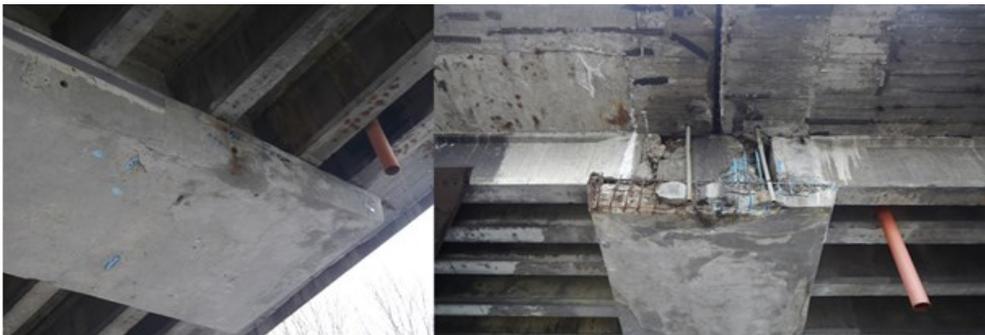
**Fig. 2.** Technical state of some elements of the flyover bridge.

The inspection carried out in June 2018 showed further degradation of the object. New concrete losses and cracking were reported. They are dangerous because they are hazardous to the safe performance of the bridge as they concern prestressed beams and capping beams. While the condition of the beams does not pose a threat of catastrophe, the condition of the cantilevers of some capping beams does pose a threat of catastrophe; especially because the pedestals are partly corroded.

The poor technical state of some elements of the flyover bridge are shown in Fig. 2.

Apart from the presented structural modifications, it is necessary to perform repair of the primary bearing elements. The repair works should include the reconstruction of the deck slab, filling in the concrete losses, injection of cracks and fractures of pier cap beams and WBS beams, anticorrosion coating of concrete surfaces as well as replacement of fittings elements (waterproof membrane, movable joints, cornice boards, kerbs and roadway surface). As the parapets and safety barriers are in good technical state, they can be utilised in the reconstruction of the object.

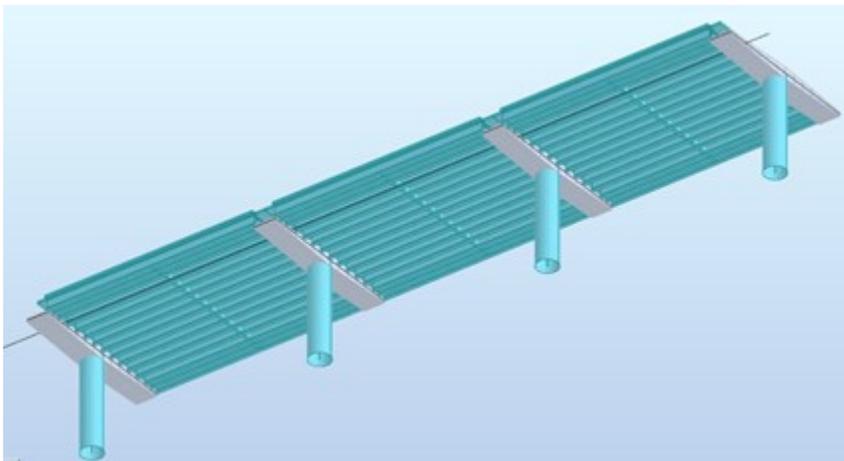
**Fig. 3.** A general view of the model of the current state of the structure.

The existing bearing capacity of the structure was defined by the comparison of the cross-sectional forces obtained from loads after the Standard [1], valid when the flyover bridge was designed, with the forces from loads after the Standard [2]. On this basis it was found that the load bearing of all the elements of the structure, i.e. supports, WBS beams and deck slab corresponds to load class C after [2]. In the numerical model the beams stiffness was not reduced because of their damage (concrete losses and the corrosion of ordinary and prestressing steels). Only in the analysis of the load bearing of the beams prestressing force decrease due to the corrosion of the prestressing cables was taken into account.

A separate analysis was performed on the impact of stiffening the beams at support on relieving the pier cap beams from operational loads. In the existing state, in the support zone the beams are connected on their front with a closing wall, which, since there are no connectors fixed to the beams, does not fulfil its function of a rigid crossbeam. Therefore it was assumed in the model that the crosswise interaction of beams is provided only by the deck slab. For such assumptions, in the place of the cap beam resting on the pier a bending moment from operational loads for class C with a dynamic coefficient was determined. Next, a crossbeam at the bearing place was assumed, 1.20 m high (overall height of the beam

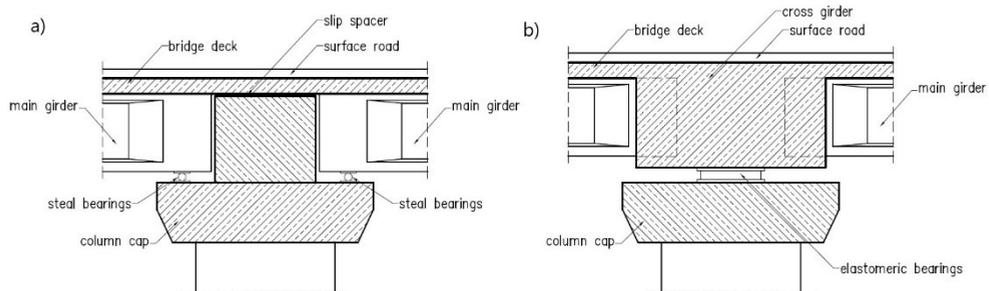
**Fig. 4.** Longitudinal section of the rest position on the pier: a) state at present, b) proposed change.

The main proposed structural modification of the object under consideration is the change of resting the spans on the pier cap beams. The present structural arrangement of the object is proposed to be left unchanged, that is the division into three separate parts (spans 4 + 3 + 4). Another proposal concerns providing the continuity by means of crossbeams bonded with WBS beams on the entire depth. The crossbeams above the piers, where there are expansion joints, should be adopted for beams of each pier separately, at the same time shifting the position of span rest towards the joint centre line (and the centre line of the cap beam). Above the other piers crossbeams common for both spans were proposed as well as a single row of bearings in the centre line of the pier and cap beam. A scheme of the proposed structural modifications together with the existing solution is shown in Fig. 4.

The presented manner of span support on the cap beam will improve its strength performance by reducing the bending moment from operational loads (cf. part 5). Moreover, it will enable the execution of more durable and efficiently operating expansion joints. The latter structural operation will result in elimination of one of the main causes of the poor technical condition of the bridge, its support and beams bearing zone in particular as the beams concrete corrosion was caused by water draining through leaking movable joints.

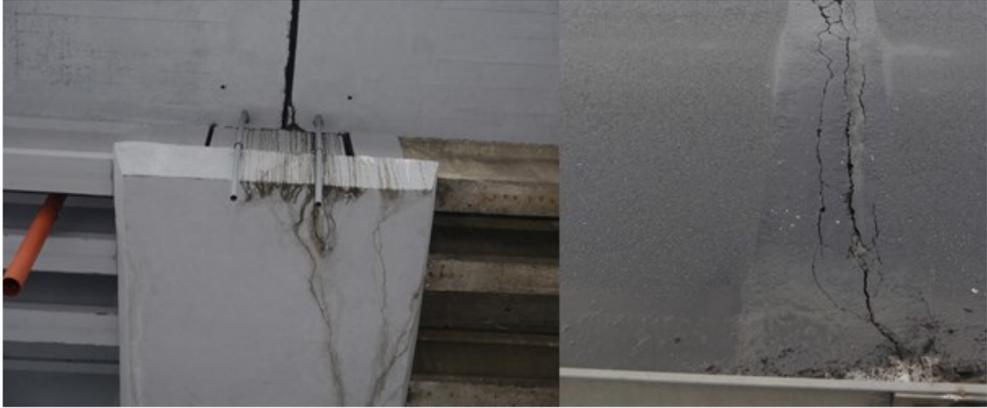
**Fig. 5.** Intermediate expansion joint on the flyover bridge and its damage.

The manner of beams support on the cap beam in the existing structure (and in many similar objects) is very unfavourable. The beams of two adjacent spans are based on the cap beam edge, at a considerable distance from the movable joint centre line (Fig. 5), which necessitates the location of the joint device on the cantilevered deck slab. Since the overhanging slab is not very stiff, the movable joint device is exposed to detrimental dynamic effects caused by the moving vehicles. Moreover, the beam's rotation on the bearing may cause vertical displacements (about 10 mm from operational loads) hazardous to the durability of the movable joint (bituminous especially). Owing to the proposed modifications the support axis can be situated closer to the movable joint centre line, thus eliminating the problem.
