Analysis of the technical condition of a railway bridge at risk of failure

Abstract. The paper presents an analysis of the technical condition of a railway bridge structure with a span structure in the form of welded girders. Static diagram of the structure consists of two simply supported beams. The theoretical span of the spans is 2 x 14.50 m, their overall length is 14.90 m, and the total length of the crossing is 30.6 m. The reasons for the formation and development of bridge degradation were analysed. In addition, the actual load capacity of the structure was determined and the possibility of its further operation was evaluated. Particular attention was given to the quality of workmanship and the degradation progress of welded joints, which led to the exclusion of the object from use. The main purpose of the presented analyses is to formulate general recommendations, whose implementation in a direct or indirect form may contribute to reducing the degradation process of railway steel bridge structures. When inspecting welded railway bridges, particular attention should be paid to the condition of welds and to control and prevent the structure from cracking.

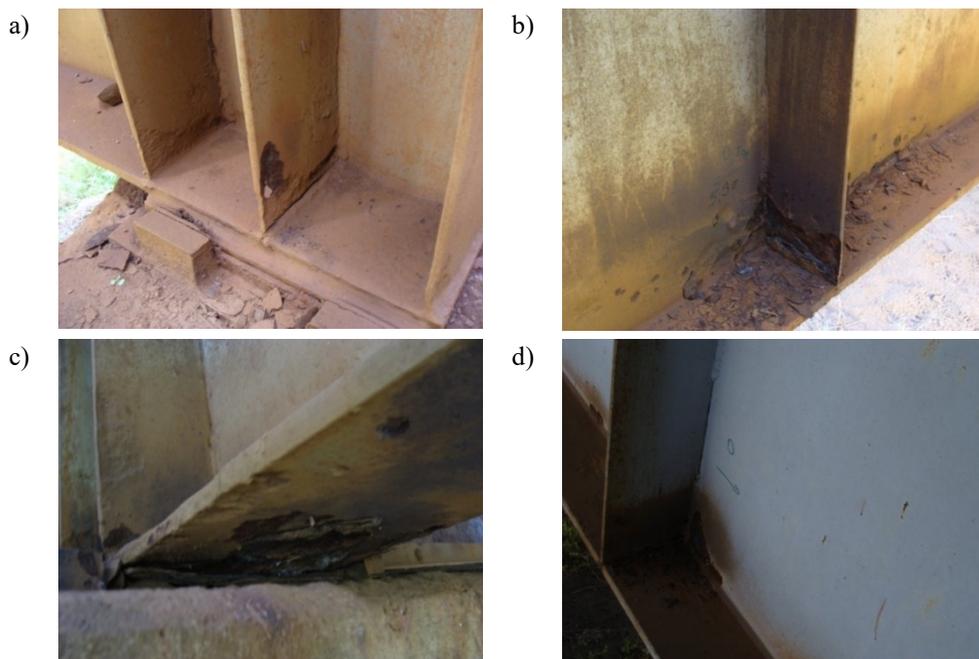
girders' web is stiffened with stiffeners spaced every 1.45 m on the entire length of the bridge. These stiffeners are welded to the girders by means of fillet welds. Transversal braces are made of crossed isosceles angles L 80 x 80 x 9 and attached to vertical stiffeners with rivets. Wind braces are made of L 100 x 100 x 9 N-shaped angles. In general, the condition of the welded structure of the girders has been defined as pre-failure. The corrosion damage of the span structure as well as the cracking of joined girders should be considered as the basis for this assessment. In places where the joints were concentrated, the material was often overheated, causing local intense corrosion, often leading to puncture of elements - Fig. 1 [20].

Fig. 1. Examples of corrosion damage in the place of overheating of elements during the welding of structures a, b) vertical ribs, c) lower flange, d) web.

- replacement of heavily corroded top flanges,
- replacement of the stiffeners and repair of welds connecting the web with the bottom flange in the support zone,
- local replacement of parts of the bottom flange,
- replacement of gusset plates and wind braces,
- replacement of the entire railway track combined with the track alignment.

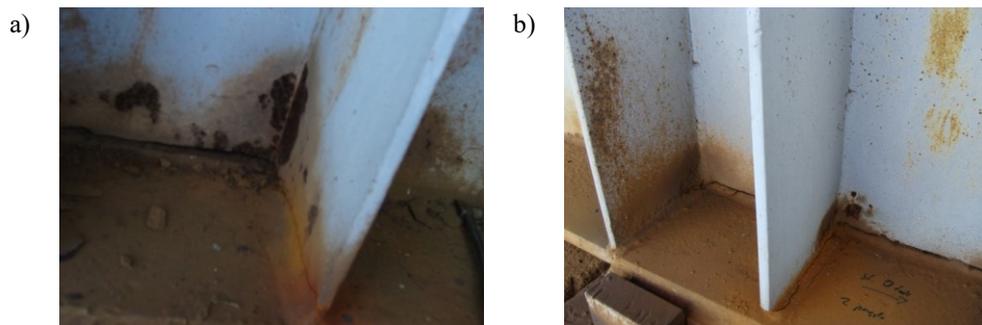
The result of the inaccuracy of the welded joints are cracks, both along the weld as well as the elements next to them. One of the damages observed, often occurred in other welded constructions, are cracks in the weld connecting the bottom flange with the girder's web. This damage is a threat to the operational safety of the bridge. There is a real risk of a construction disaster by the losing of the stability of the main girders in the event of significant horizontal loads (e.g. from braking and acceleration forces). An example of this damage is shown in Fig. 2 a) b) [20].

Fig. 2. Examples of damage to joints connecting the bottom flange with the girder web under track No. 2.

Then the tangential stresses in the support cross-section were analysed. This section originally consisted of six ribs (three symmetrical in the support zone) and the web. As a result of the crack in the area of the weld (with the length of approximately 350 mm) connecting the lower flange of the girder with the web and the ribs in the support zone (see Fig. 2b), the transverse force is being transferred by two 12 mm thick ribs. The total cross-sectional area of the support zone working at shear is 42 cm². Hence the tangential stresses are:

$$\tau_{max} = 137,9 \text{ MPa} > 0,6 \cdot f_{yd} = 114 \text{ MPa}$$

It follows that due to the damage in the support zone, it is impossible to transfer loads from the braking force and acceleration of the rolling stock in accordance with the applicable standards [21, 22].

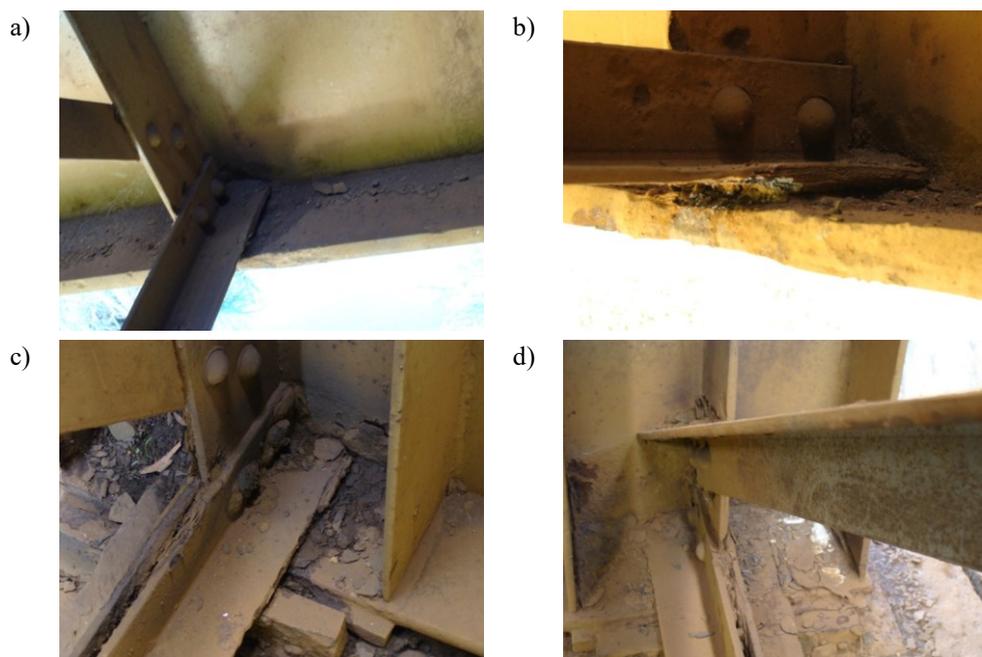
The general corrosion of this bridge is located primarily in joints of girders with bracing - Fig. 3 a) ÷ d) [20]. Due to the lack of maintenance works, corrosion products maintain moisture and cause accelerated technical wear of the structure as well as the development of local corrosion in the form of deep pits and crevice corrosion.

Fig. 3. Examples of corroded joints of girders and braces.

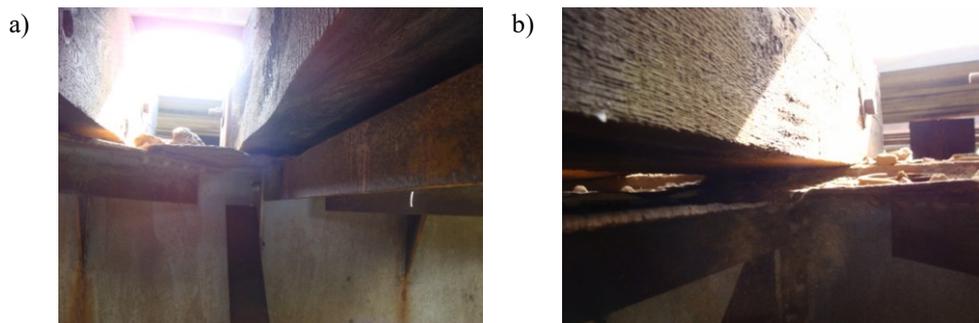
Corrosion damage of the gusset plates of the upper wind braces caused their complete failure. The thickness of the described elements is ~ 3 mm - the corrosion has penetrated them locally - Fig. 4 a), b) [20].

Fig. 4. Examples of damaged gusset plates of the upper span wind braces.

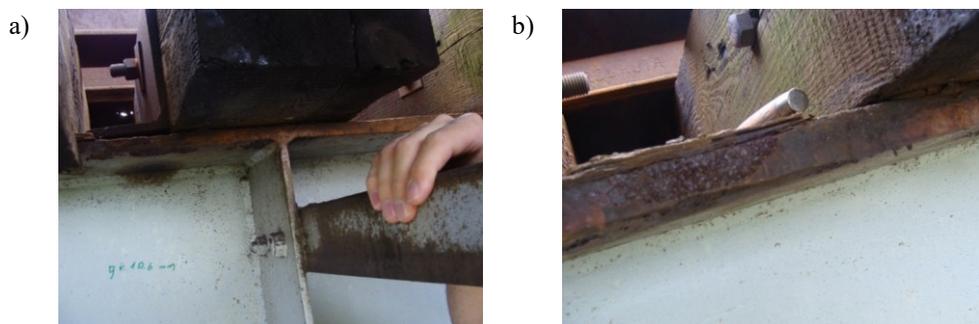
The direct support of wooden bridge sleepers on the top flanges of the spans without adequate protection has caused significant corrosion damage. The minimum measured thickness of the top flange was 10.6 mm, which is approximately 50% of the initial value - Fig. 5 a), b) [20]. These damages are concentrated at the outer edges of the spar flanges. They cause a significant loss of material (up to several dozen percent of the thickness of the top flange), which leads to weakening of the girder, and thus to a decrease in the bearing capacity of the span.

Fig. 5. Corrosion of the top flange causing a decrease in the load bearing capacity of the span.

Assuming the allowable structural design strength for built-in K37 steel (with parameters corresponding to St3M steel) 190 MPa, the determined stresses at the permissible operating speed are not exceeded for the analysed structure only without taking into account corrosion damage. However if we take into account the corrosion damage of the top flange, it will be possible to transfer normative loads only to the class $k = - I$, while maintaining the speed limit to 30 km/h.

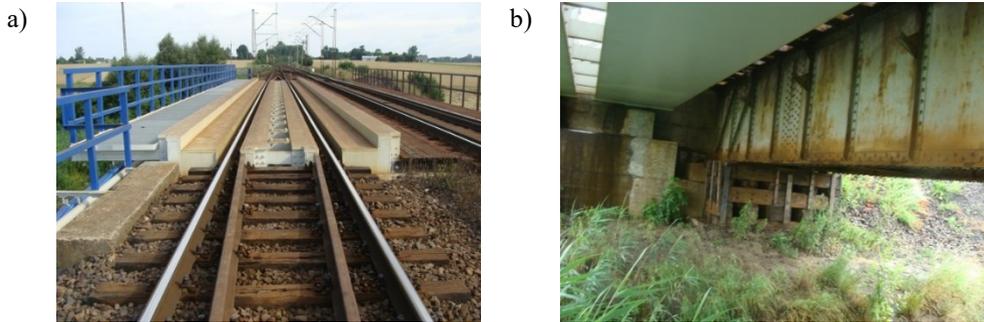
Fig. 6. The bridge after replacement of span structure, a) top view, b) bottom view with modernized support (under the renewed span).

The damage to the assessed railway bridge described above posed a threat to its safety. There was a real threat of a structure failure by losing the stability of the main girders. Therefore, immediate action was taken to exclude this bridge structure from use. As a result, the span structure was changed to the steel box girder and the support system was adopted to the proposed girder solution - Fig. 6 a), b).
