# Analysis of repair works to remove the effects of structural failure after a gas explosion

**Abstract.** The article presents the issues of repair works in a multi-family residential building, whose structural and non – structural elements have been damaged and destroyed by a gas explosion and the fire. Gas explosions in residential buildings constitute a small percentage of the total number of building disasters, however, due to the relatively large number of injured people, these incidents are very dangerous [1]. Moreover, the gas explosion often leads to significant material losses and fatalities. Proper assessment of the load-bearing structure after such incident requires an extensive knowledge of the behaviour of structures. The first authority, that issues a decision regarding further use is Construction Supervision Inspector. Until the demolition of the object is ordered, the next step is to provide expert report made by an authorized construction expert, whose aim is to assess the technical condition of the elements of the structure and to determine the scope of necessary repair works. Construction expert, who give such opinion during the assessment of objects immediatel

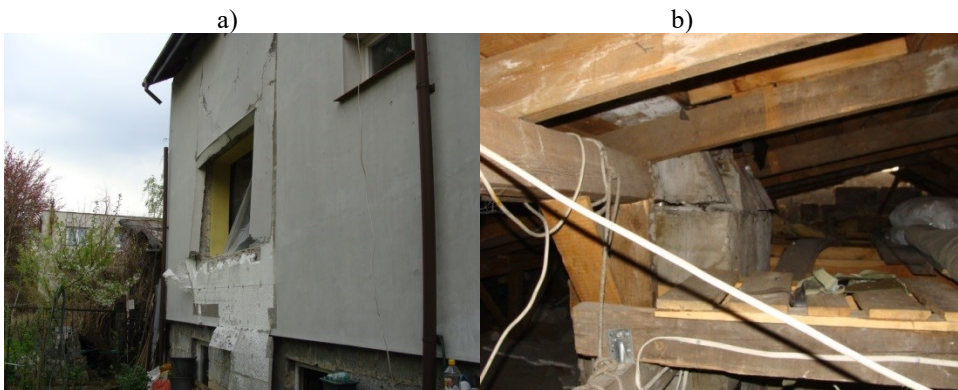
The occurrence of explosion relief openings in the walls of the building and its opening while explosion can reduce the explosion overpressure to a large extent and therefore protect the structure of the building from collapse. In the Figure 2, the building elements that performed the task of explosion openings, were presented [5]. This situation allowed to limit the impact of gas cylinders explosion, that took place in 2015, on the ground floor of a single-family residential building.

**Fig. 2.** Building elements, that acted as explosion relief openings while gas explosion a) window in the kitchen room, b) roof structure.

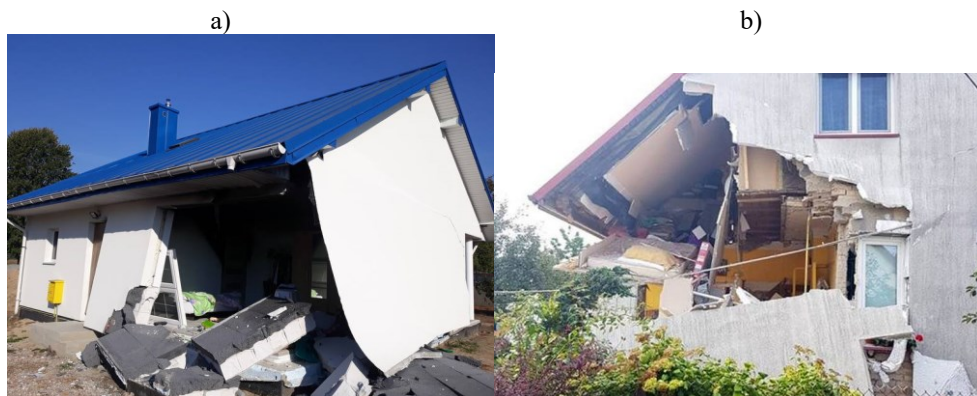
If the door and window joinery is attached to the elements of load-bearing structure in a very durable way, the opening pressure of a relief opening (e.g. broken window) is equal to or greater than overpressure resulting in damage of the load-bearing structure. In this case, the building structure will be destroyed – Fig. 3.

**Fig. 3.** The condition of single- family houses after the non-vented gas explosion a) residential building in Orzechowice [6], b) residential building in Hajnówka [7].

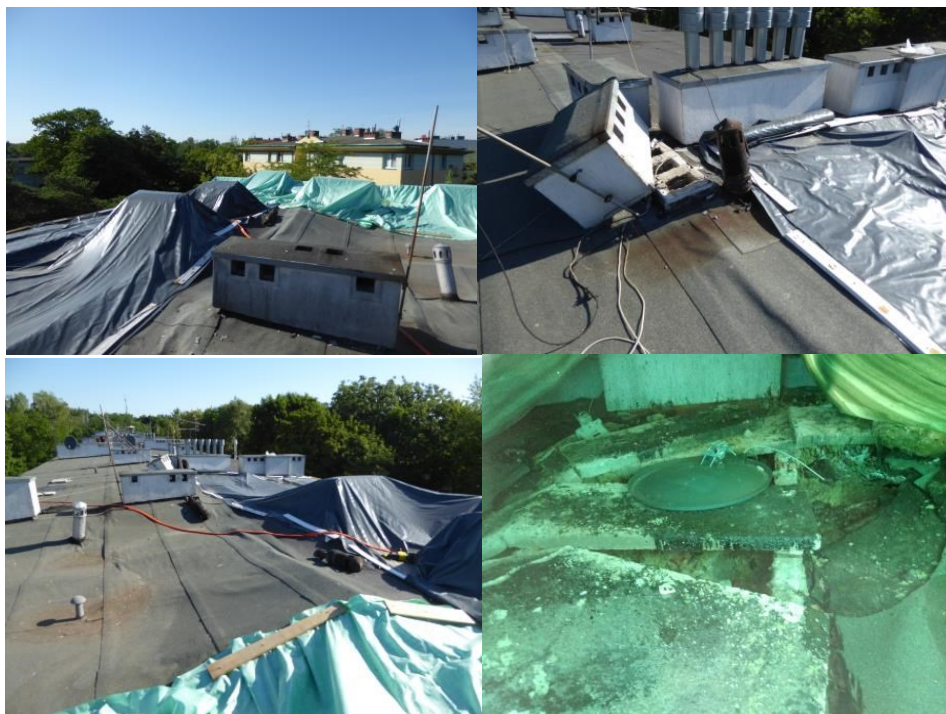
As a result of the gas explosion, both the window and door joinery, as well as the load-bearing structure of the roof and partition walls, have been destroyed. The explosion also caused the damage of construction of the inter-floor ceiling between the apartments no. 106 and 109 [5]. The first of the assessed building elements was the supporting structure of the roof, which was made of channel slabs based on screen walls. These walls have been damaged due to the lifting up the ceiling over the last floor, that also caused the deformation and leakage of the roof - Fig. 4. The free-standing masonry chimneys and ventilation chimneys have also been damaged.

**Fig. 4.** The condition of the roof structure of the building after the explosion.

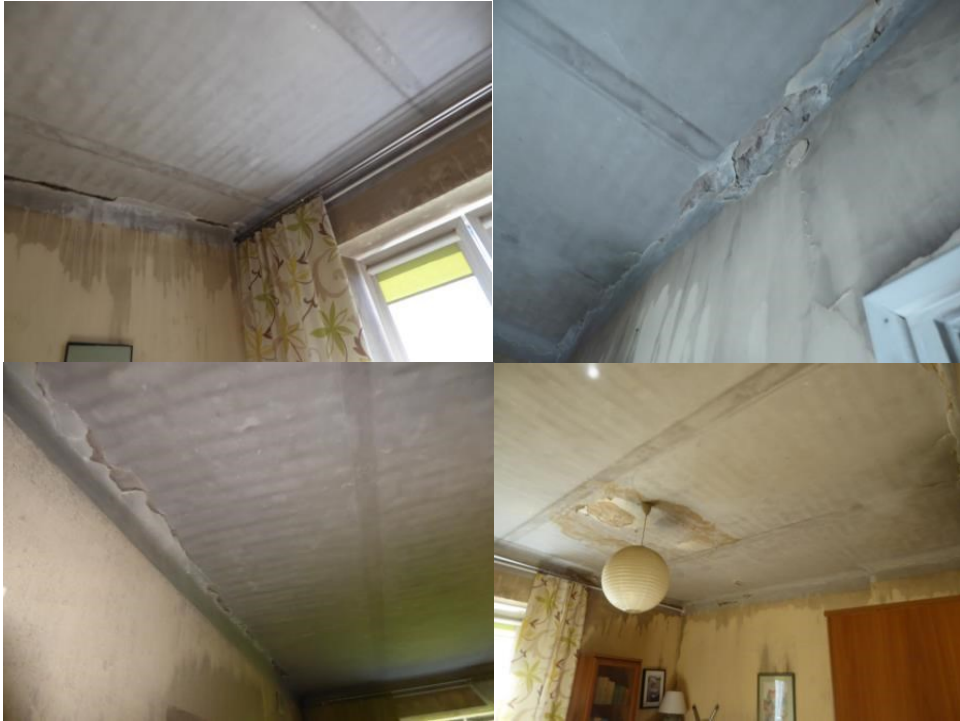
The flat roof of the building was insulated with granulated wool. The explosion, lifted up the roof structure and fell down to its place without any imperfections - Fig. 5.

**Fig. 5.** Examples of damage of joints between walls and ceilings in the housing unit above the last floor.

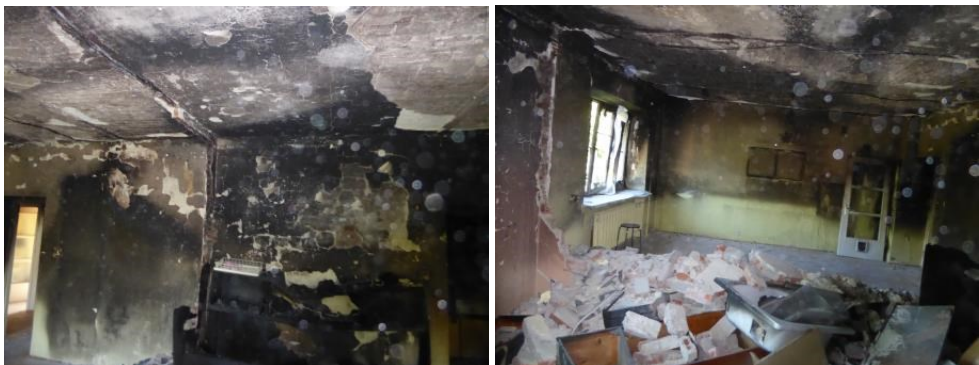
The masonry partition wall between the apartments no. 109 and 110 had been completely destroyed - Fig. 6.

**Fig. 6.** The view of the destroyed partition wall between apartments no. 109 and 110.

The destroyed partition wall between housing units no. 109 and 110 has been dismantled and rebuilt. The hole in the ceiling between apartments no. 106 and 109, created as a result of the explosion of one of the gas cylinders, was filled with cast concrete slab with bottom reinforcement. The explosion of the gas cylinder placed above the kitchen in the apartment no. 106, did not result in damage of the ceiling. After removing the gypsum board cladding, it turned out that the ceiling slab had been broken down on appreciable length. It was recommended to remove ceiling slab along the entire length between the load-bearing walls and filled in the same way as in the case of the hole that was created in the first cylinder explosion - Fig. 12.

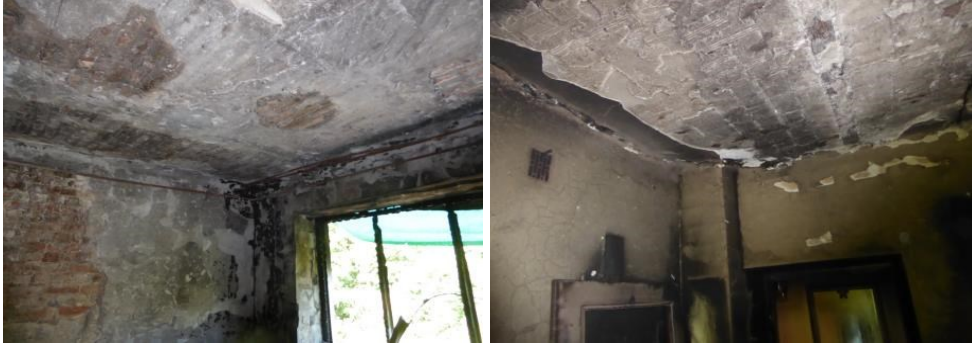
The fire have caused the greatest damage in the apartment no. 109, where all wall, floor and ceiling claddings had to be removed and utilized - Fig. 7.

**Fig. 7.** The interior of the apartment no. 109 after the gas explosion.

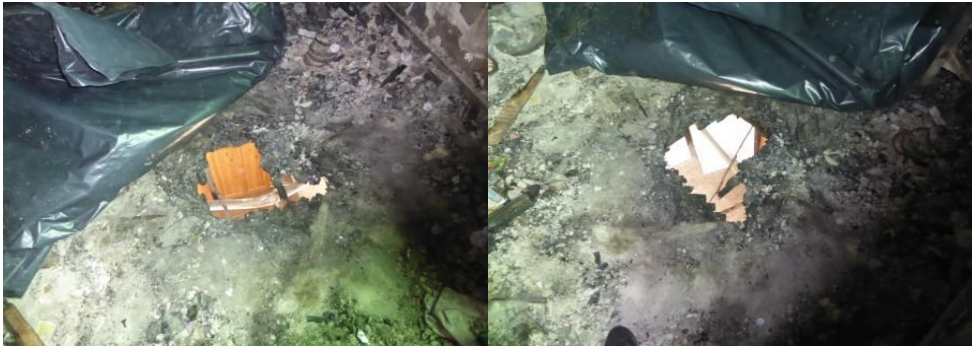
The explosion of one of the gas cylinders caused the penetration of the inter-floor ceiling slab between apartments no. 109 and 106 - Fig. 8.

**Fig. 8.** The damage of the ceiling slab between apartments no. 106 and 109.

It was recommended to repair the damage of the ceiling by filling with a cast reinforced concrete slab, that should be made in combination with an undamaged parts of brick ceiling slab. The ceilings in the apartment no. 106, was constructed as metal framing with gypsum board cladding. According to the expert opinion, it was recommended to remove them and to assess the technical condition of the ceiling slabs. Door and window joinery, which acted as explosion relief openings, have been destroyed in the apartment where the explosion occurred. Additionally, as a result of the fire, one window in the neighbouring apartment (no. 110) has been destroyed - Fig. 9.

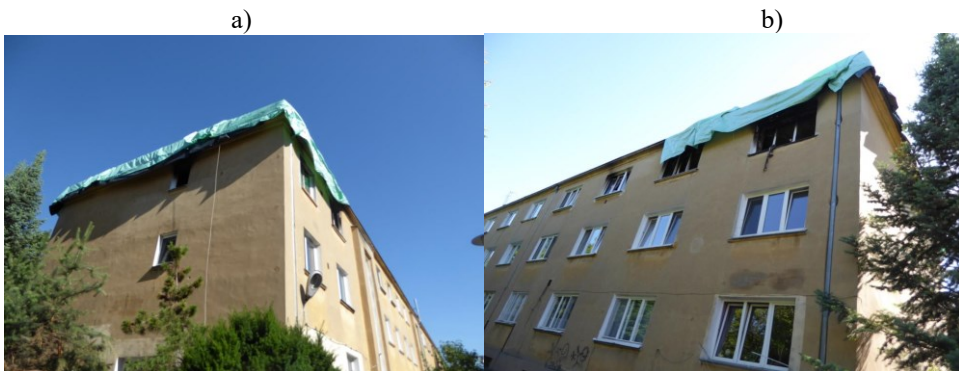
**Fig. 9.** The view of the damaged door and window joinery a) on the front and gable facades, b) on the rear facade.

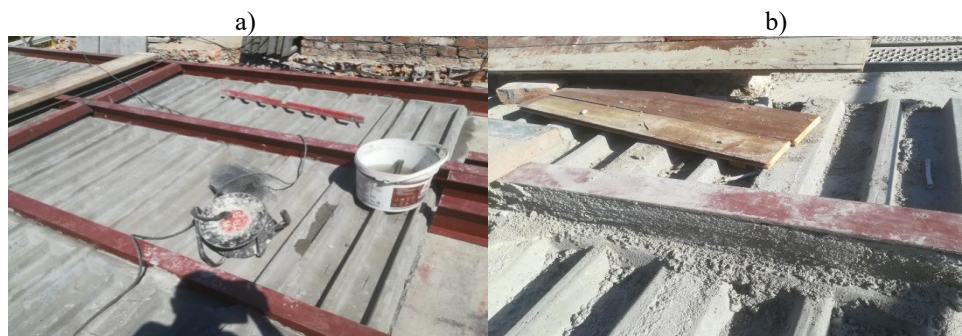
**Fig. 10.** Reconstructed structure of the ceiling over the last floor a) WPS slabs laid on steel beams, b) fillet welding of slabs.

It was also recommended to carry out construction works in accordance with the rules of the building industry, including measures and materials suitable for this type of work. Dismantling works were carried out manually with all necessary precautions, to avoid damage to elements which were to be preserved. Specific safety conditions while carrying out construction works are normalized by the Regulation of the Minister of Infrastructure of February 6, 2003 concerning the occupational health and safety during construction works. This Regulation describes detailed conditions of the safe carrying out of demolition works as well. During the renovation works, involving replacement of the roof, the contractor provided protection against an atmospheric precipitation. When the demolition works were completed, the ceiling was rebuilt. To this aim, a ceiling with steel beams and WPS slabs was constructed - Fig. 10.

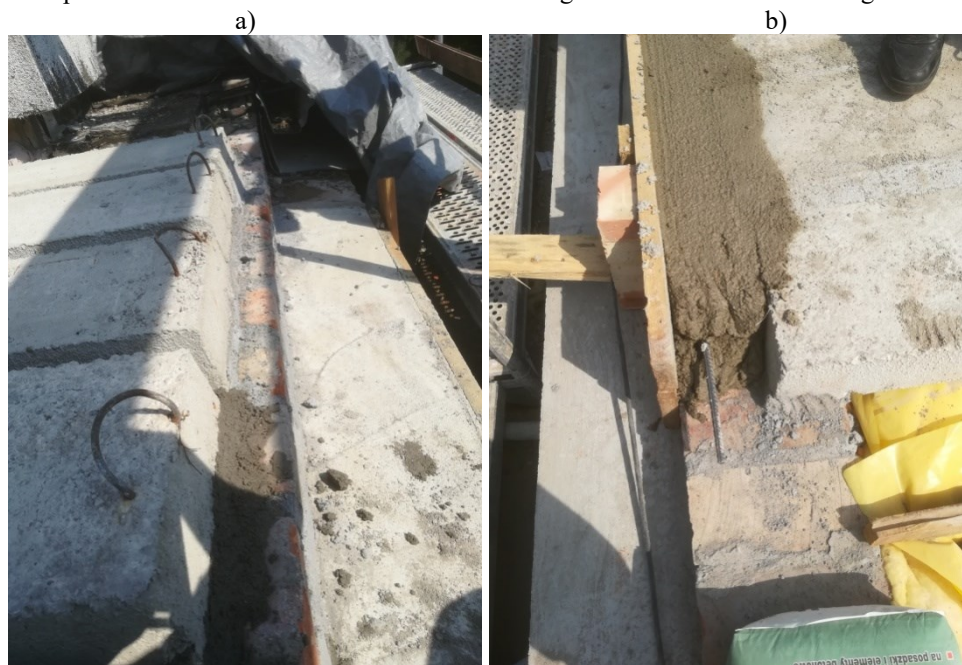
**Fig. 11.** The structure of the roof a) channel roof slabs, b) the ring beam around the slabs.

The reconstructed ceiling structure was covered with a new reinforced concrete ring beam and on the steel beams of the ceiling, the walls supporting the roof slabs were made. Precast reinforced concrete channel slabs of 0.30 m width were used, that in comparison with other solutions, provided the smallest structural weight. When the roof slabs have been laid, on their perimeter an additional reinforced concrete ring beam was constructed - Fig. 11.

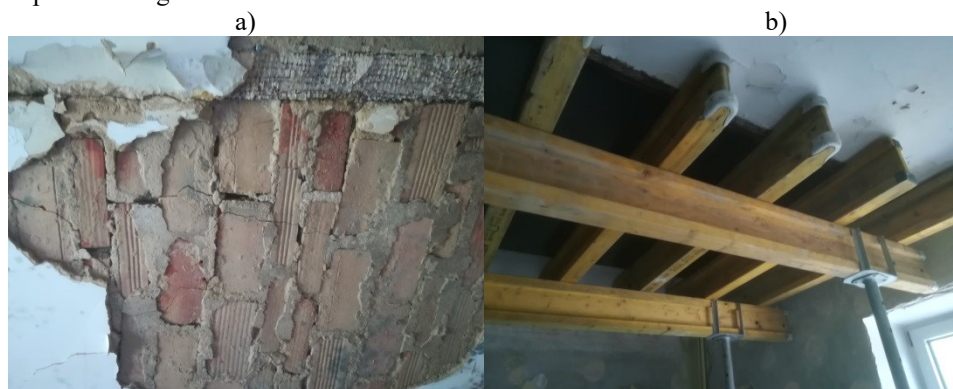
**Fig. 12.** The ceiling above the kitchen room in the apartment no. 106 a) the broken ceiling slab, b) formwork under the reinforced concrete slab.
