Impact of improper storage and installation of glazed fire rated walls on their performance

Jacek Kinowski¹, Paweł Sulik^{1,}, and Bartłomiej Sędlak¹*

¹Institut Techniki Budowlanej, Zakład Badań Ogniwych, 00-611 Warszawa, ul. Filtrowa 1, Polska

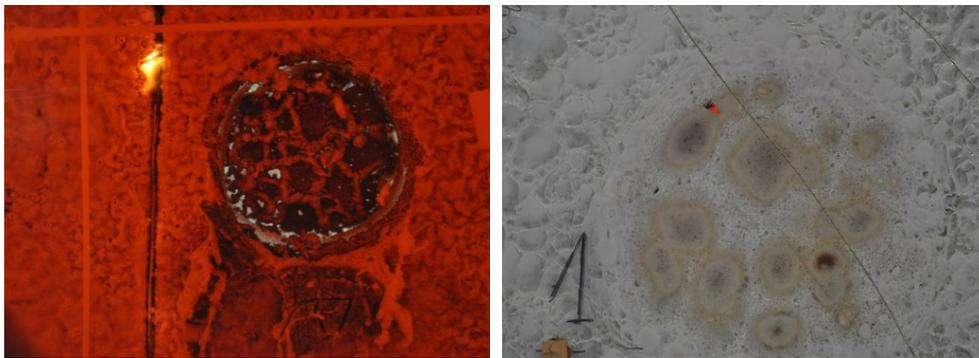
A scenario where glazing is stored incorrectly is particularly dangerous, as the chemical changes which occur when glass intended to be used indoors is exposed to sunlight (and temperature) are frequently impossible to see with the naked eye. Fig. 5 shows photographs taken during a fire resistance test of a mullion-free glazed partition wall and progressing loss of insulation on the element’s surface. The same test specimen before the test is shown in Fig. 4. Incorrect behaviour of the gel in this area, according to a later “investigation” was most likely caused by the glazing being stored for (only) 5 days without cover outside the test building in sunny, warm July weather.

Fig. 5. Photographs of fragments of exposed and unexposed surfaces of the glass at 26 minutes of a fire resistance test carried out on a mullion-free glazed wall. Building Research Institute's archive.

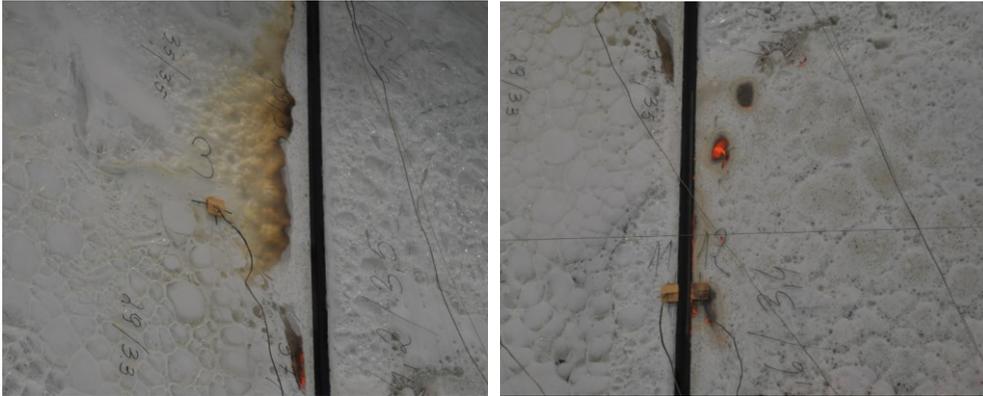
Fig. 6. Photographs of fragments of unexposed surfaces of the glass at 31 minutes of a fire resistance test carried out on a mullion-free glazed wall. Building Research Institute's archive.

The graph in Fig. 8 confirms the possibility of exceeding limit temperature at points where the gel inside the fire glazing was scorched. Increase recorded on thermocouples 11 and 12 located near each other (photograph on the right in Fig. 6) show differences in temperature increase at the point where the gel performs correctly and where it was scorched.

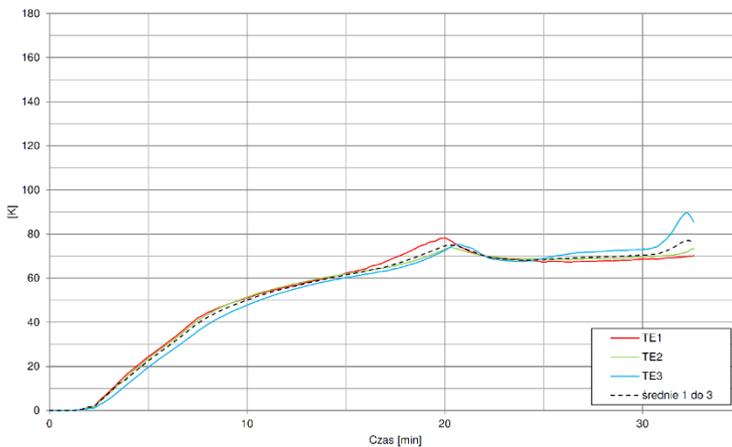
Fig. 7. Graph of temperature increase on the unexposed side of the test specimen – readings from thermocouples measuring maximum and average temperature on the glass pane shown in photographs in Fig. 5. Building Research Institute's archive.

As can be seen on the graph in Fig. 7, the increase in temperature recorded by thermocouples 1–3 for measuring average temperature is moderate in value – far below maximum accepted by standards as safe. This does not change the fact that due to local scorches on the glass, at which the temperature increase, measured with a special mobile thermocouple, exceeded 180 K, the specimen failed the insulation criterion before assumed time.

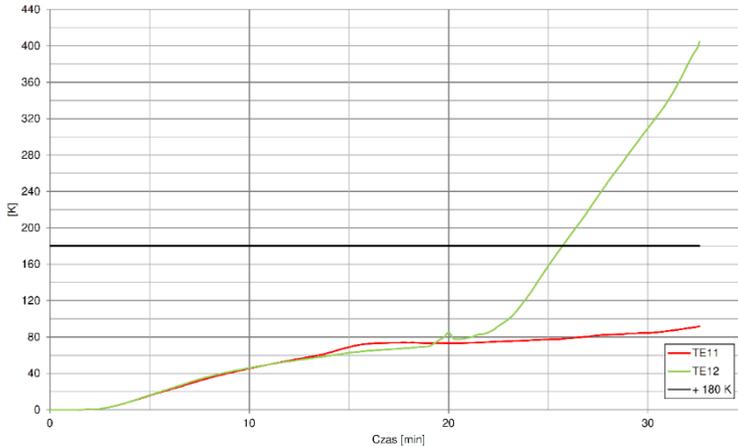
Fig. 8. Graph of temperature increase on the unexposed side of the test specimen – readings from thermocouples measuring maximum temperature at faults shown in photographs in Fig. 6. Building Research Institute’s archive.

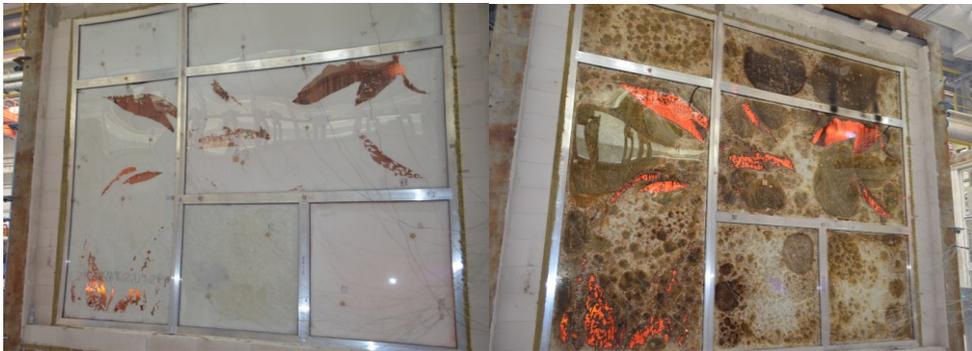
Fig. 9. Photographs of unexposed surfaces of a partition wall at 6 minutes (left) and 16 minutes of a fire resistance test. Building Research Institute’s archive.

Similarly to the scenario described in the previous item, occasionally the fire test exposes manufacturing defects of the glazing, which a consumer, or even a qualified employee of an accredited laboratory, is unable to spot. According to a declaration from the manufacturer, an entire batch of faulty glazing is then recalled from the market as it may pose fire safety hazard in a building; additionally, measures are taken to improve the consistency of characteristics of components. The process with highest difficulty is undoubtedly application of the gel, which requires specialised equipment to be distributed evenly between glass panes.

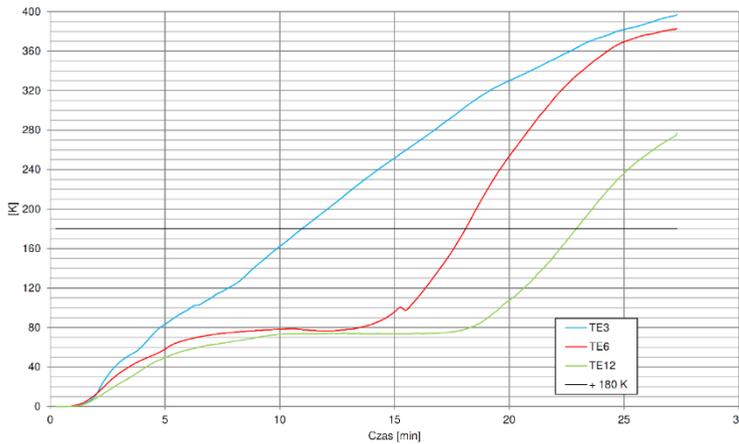
In contrast to graphs presented in Fig. 7 and 8 above, we can see a rapid increase of temperature in the first minutes of the test, indicating a technological problem of transparent filling.

Fig. 10. Graph of temperature increase on the unexposed side of the test specimen – readings from thermocouples measuring maximum and average temperature on the glass pane shown in Fig. 9.

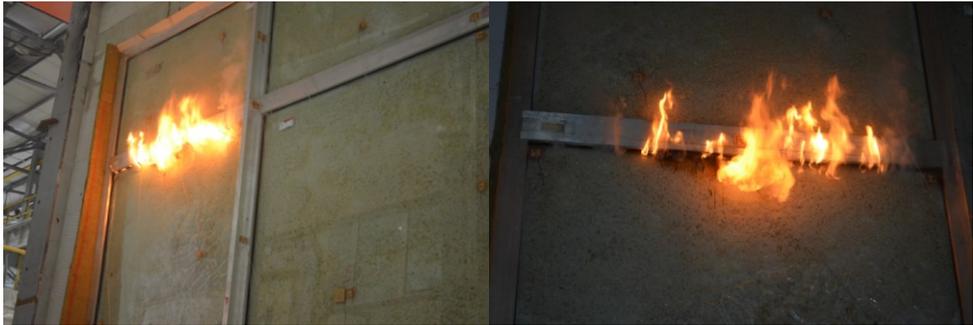
The graph above presents a very similar situation to that shown for a test on a mullion-free wall – regular increase and moderate values. However, due to problems with improper mounting of the glazing the test failed. Details of the test specimen – non-load-bearing glazed wall with profiles – aluminum; the analysed area is shown in Fig. 14.

Fig. 12. Photographs of fragments of unexposed surface of the glass at 14 minutes (left) and 18 minutes of a fire resistance test carried out the test specimen presented in Fig. 11. Building Research Institute's archive.

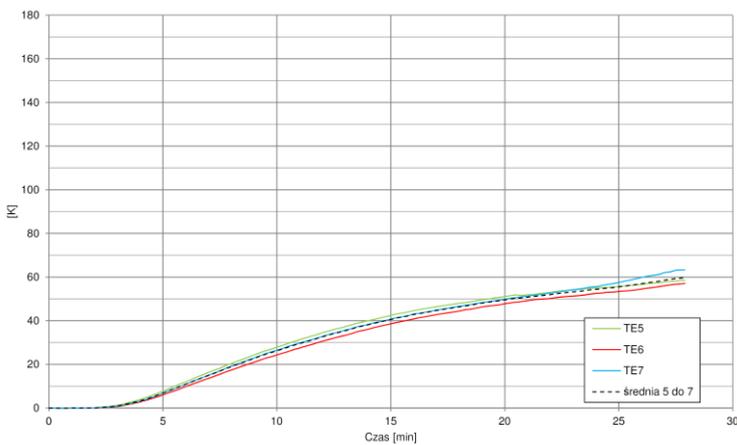
Fig. 13. Graph of temperature increase on the unexposed side of the test specimen – readings from thermocouples measuring maximum and average temperature on the glass pane shown in photographs in Fig. 11. and 12 (glass under the beam).

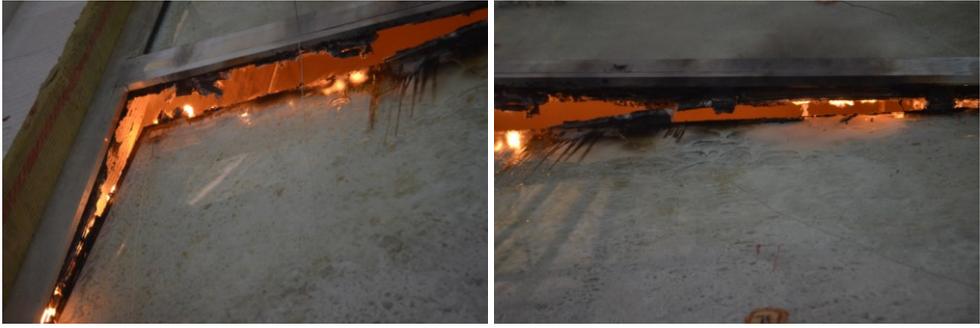
Fig. 14 Photographs of fragments of the test specimen after tests are shown in Fig. 11 and 12. Building Research Institute's archive.

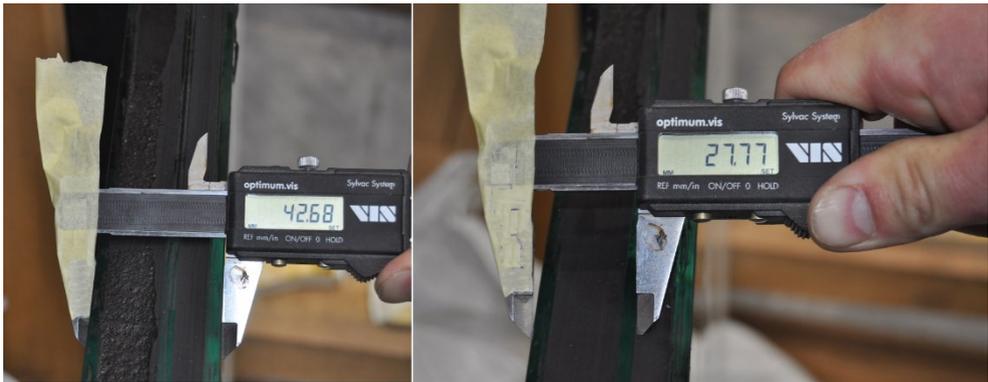
Fig. 15. Photographs of measurements of a fire resistant glass unit and glass pane. The measured difference from the nominal value was 2.77 mm. Building Research Institute's archive.

A defect that is equally difficult to identify before installation of a piece of glazing is an uneven or insufficient thickness of the fire resistant glazing. In the case of multiple-pane glass units there is basically no more possibility to check the thickness of the glazing responsible for fire resistant characteristics of the assembly. Test experience with single layered glazing suggests that differences in thickness of up to 3 mm are possible between panes which are theoretically identical (same type and manufacturer). Coupled with the fact that 5–7 mm of gel is often the only difference between glazing used for structures with declared fire resistance class EI 30 and EI 60, this shows the extent of the issue.

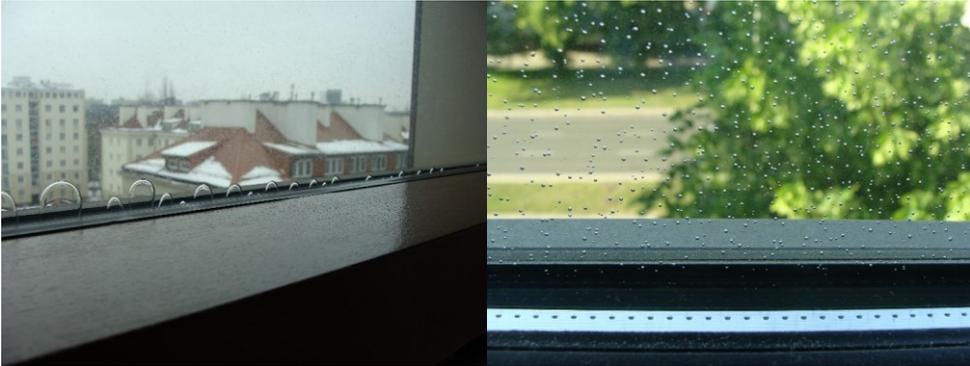
Fig. 16. Photographs of fire resistant glazing with visible defects. Building Research Institute's archive.

In the case of fire resistant glazed elements there are two possible scenarios. The first concerns elements in which damage is visible and repairable, usually through replacement of the glazing (Fig. 16) and the second when there is no visible damage but a significant risk exists that a given barrier will not provide the expected safety parameters. In the latter case non-compliance with the requirements can only be determined through tests, using destructive test methods. The test results presented above prove that many factors have significant impact on performance of glazed fire resistant structures; they include correct transport, properly selected storage place and meticulous installation, as even slight imperfections may pose a serious risk in an emergency situation such as fire [17, 18], which may result in a catastrophe and criminal charges for responsible persons.
