# Diagnostics of the structural failure of sports hall external wall layers

**Abstract.** The paper presents the diagnostics of the technical condition of the external layers of the sports hall walls. Structural failures related to construction defects themselves constitute a relatively small percentage (4.1% in 2017, 5.05% in 2014-2017 [1]), although the main reason for them is the lack of maintaining technological rigors (76.9% in 2017, 68.4% in 2014-2017 [1]). The presented and described case study of the technical condition of the newly built sports hall does not refer to structural failure, but to the reduction of the risk of that failure as a result of non-compliance with construction technology, in particular, in relation to the external walls. Contrary to the design, the walls of the sports hall were made of aerated concrete. According to the declaration of a designer, the contractor neither consulted the changes with the designer nor gain the acceptance of the designer for using aerated concrete instead of the primary proposed and designed brick structure. In addition, aerated concrete curtain walls with a height of about 4.5 m were made without any wall connectors. This

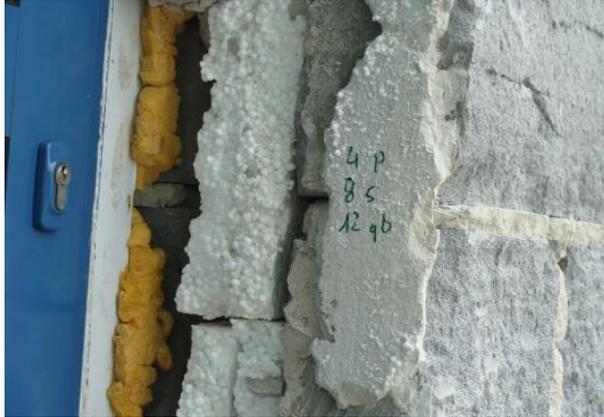
The main reason for the risk of a structural failure was the incorrect execution of self-supporting walls on two façades, i.e. from the west and south sides of this sports hall building [2]. The south wall of the sports hall was built as a sandwich structure. It was constructed contradictory to the rules of the civil engineering practise and the technical conditions for this type of building structures. The structural inner layer of this wall was 2.4 cm thick and it was made of the autoclaved aerated concrete blocks (according to the registry of embedded materials). It had welds of too great thickness - the maximum thickness of the weld in the made outcrop was 24 mm, which should not exceed 15 mm (Fig. 2). In

turn, the wall covering layer was made of 12 cm thick cellular concrete blocks. It should be emphasized that the use of such material for the covering layer is not recommended. The insulation layer was made of two Styrofoam boards with a thickness of 4 cm each. Unfortunately, they were not fixed to the structural layer, but loosely inserted into the air gap of 12 cm. The loose arrangement of Styrofoam panels indicated that there were too few (or none at all) steel connectors that would have enabled a proper interconnection between these two layers of the wall.

**Fig. 2.** Layer system of the outer multi-layer and self-supporting wall - description in the text.

The lack of anchoring between the covering layer and the construction layer on the lower part of the building is a great hazard for a structural failure. It is absolutely necessary to tie these layers with special connectors. These connectors should be anchored mechanically or chemically in the structural wall to a minimum depth of 12 cm (half the thickness of the structural wall). This depth and the number of connectors (at least 4 pcs/m<sup>2</sup>) should be precisely determined after choosing the anchoring system. The use of the special Helifix DryFix universal connectors was proposed as a solution. Made of stainless steel self-screwing connector does not require the use of resin or other mortars. It is installed by screwing it, using a special, patented adapter, into a previously prepared pilot hole (it is proposed to create a pilot hole only through the protective layer). This method does not cause additional stress

to the masonry structure. Due to the large slenderness combined with the low strength of the cover layer, it is proposed to use 50 cm long connectors, screwed in at an angle of  $30^\circ$  alternately at 20 cm spacing with a horizontal offset of 6 cm + weld thickness of  $\sim 7.5$  cm. The proposed mechanical pinning and anchoring solution of the curtain wall is shown in Fig. 14. The proposed spacing of connectors is 90 cm horizontally and 37.5 cm vertically, which gives an average of three connectors per square meter, or 6 pieces of connectors per  $m^2$ . The use of Helifix DryFix solution in the form of intersecting DryFix tie will additionally ensure fastening of the existing insulation layer.

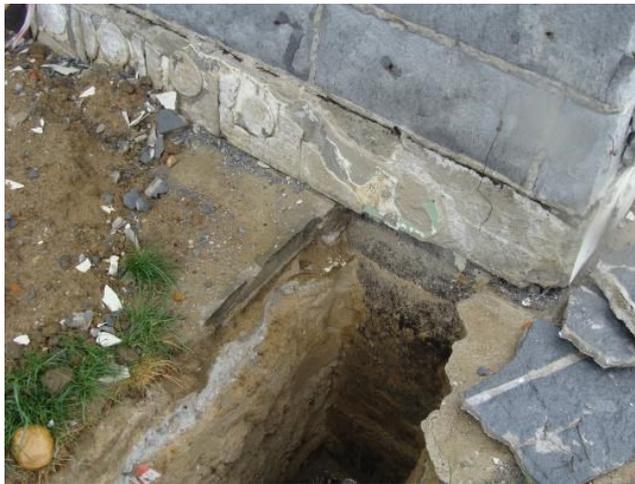
The lower edge of the aerated concrete wall was at a height of about 25 cm above ground level. This is too low because the technical construction requirements of the wall made of cellular concrete blocks provide that this height should be at least 50 cm. At the bottom of this wall, no drainage slots were found - Fig. 3.

**Fig. 3.** A detailed view of the foundation of the wall covering layer.

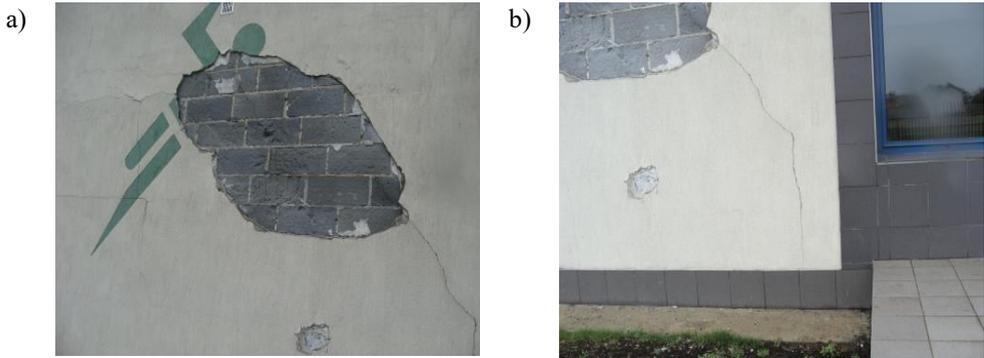
The abovementioned defects of this masonry structure caused by undue performance of the builder resulted in the formation of distinct sloping cracks in the outer casing layer. This proves improper behaviour of this wall layer system - Fig. 4.

**Fig. 4.** Examples of visible cracks in the cover layer on the southern façade.

In the first stage, the entire plaster coating should be removed from the whole facade of the southern and western building. Damaged - cracked walls of the building should be strengthened by surface reinforcement.

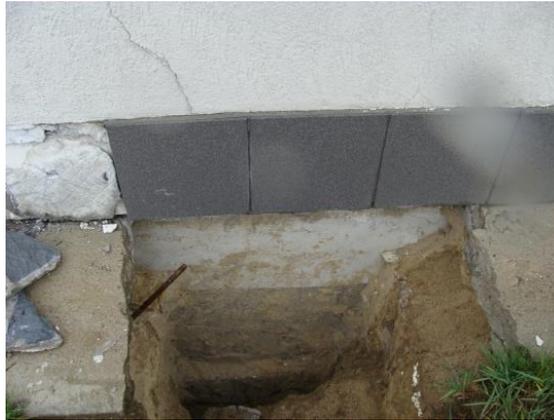
Based on a test pit of the foundations of the building, it was found that the above cracks did not result from the process of uneven settlement of the foundations, because the foundation walls were not damaged - Fig. 5.

**Fig. 5.** Test pit of the building foundations.

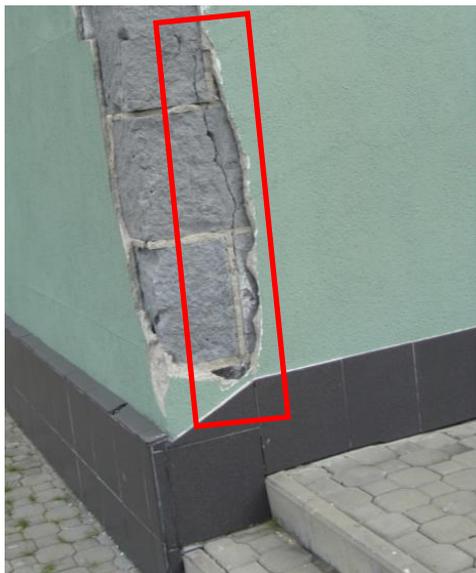
An analogous situation occurred on the west façade - in the lower part no signs of wall connectors were observed (Fig. 6). Based on this site uncover it was established that the wall was made as a layered wall in the form of two layers of cellular concrete units with a thickness of 24 cm each, with a thermal polystyrene insulation layer of 4 cm thick placed in between them. Carrying out the aerated concrete curtain walls with a height of about 4.5 m, without the wall ties, caused a risk of a structural failure involving the possibility of its collapse. The structure of this wall was not considered as self-supporting because the number of applied wall connectors were insufficient [8-11]. The observed damages were the result of the mistakes of the contractor. The wall layer system was incompatible with the design and as-built documentation. According to the statement of the designer, the contractor neither consulted nor obtained the consent of the designer to the use of the cellular concrete instead of the building ceramics.

**Fig. 6.** Damage to the lower part of the western façade wall.

With regard to the western wall of the hall (west elevation), visible damage in the lower part results also from the lack of connectors between the layers of the wall. Therefore, it is

necessary to tie the masonry layers by making mechanical connectors - at least 4 pcs/m<sup>2</sup>. Also in this case, it is proposed to use DryFix ties from the Helifix system in the number and spacing as shown in Fig. 19.

Then, the wall should be made in the same way as for the part of the low base using a 4 cm layer of polystyrene and an external façade mass in the form of mineral plaster painted with facade silicone paint on a fiberglass mesh.

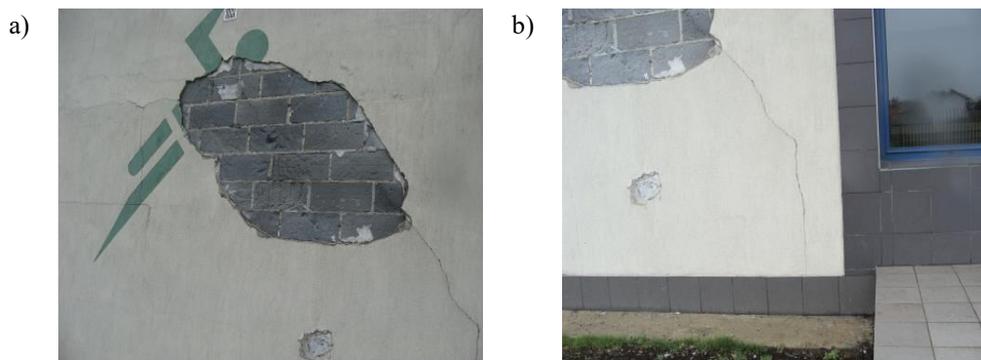
Another significant diagnosed damage (removable damage) was the spalling of the plaster coats - Fig. 7. These damages occurred both on the south and on the west façades of this building. The spalling of the plasters on the façades was the result of their improper execution. No application of any joint layer was found. In addition, the applied plastering was very absorbent, which in combination with the execution of the outer layer of walls with air concrete resulted in their so-called "spalling" due to weather conditions.

**Fig. 7.** Examples of the spalled plasters: a) on the south façade, b) on the west façade.

The extent of damage to plastering on the southern and western elevation disqualifies them from further operation. The plaster should be removed from the entire surface of the façade and the wall should be cleaned. Then it should be levelled and the additional protective layer placed in the form of insulating with foamed polystyrene should be placed. Finally, new thin-layer elevation plaster coatings should be made. Flashings should be made in accordance with the relevant construction standard. The sheet should not be placed directly on the concrete or the plaster nor on the materials containing sulphur. A new layer of building paper should be placed under the flashing to ensure the proper insulation. As part of the above repair works, new ventilation grilles should be also installed on the façade.

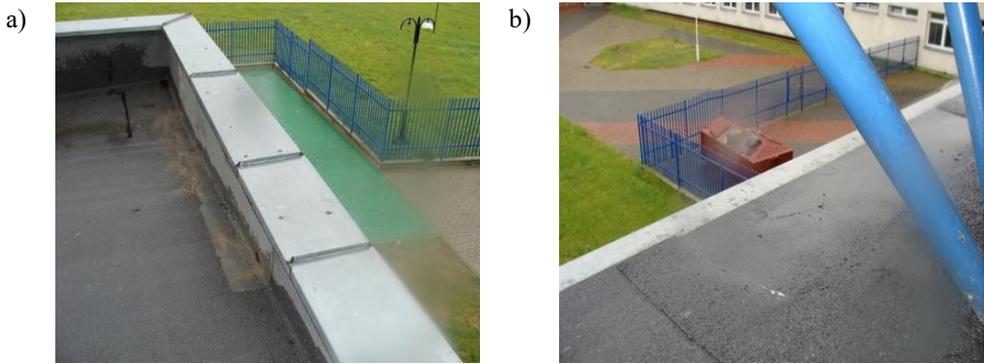
An additional factor causing soaking of the façade walls and their plastering was improper preparation of flashings (leaks due to the use of plastic plugs) and the unsuitable slope in the top parts of these walls - Fig. 8. The described damage to the façade sandwich walls was significant and constitutes of removable physical defects. They not only significantly worsened the aesthetic state of the building but also significantly reduced the utility value of this part of the building. Furthermore, they were a direct hazard to the safety of the use of the hall. The area next to the building was excluded from use due to the danger of falling of large fragments of plaster or walls [12, 13].

**Fig. 8.** Improper ending of façade walls: a) use of plastic dowels for fixing flashings, b) retention of rainwater due to improper slopes.

Due to the increase in the thickness of the outer walls of the west and south facades, all the flashings of these walls must be replaced with new ones. When replacing the flashing on the western wall of the hall, attention should be paid to the formation of appropriate declines (from the building). After removing existing plasters, making a 4 cm layer of insulation and mineral plaster on the mesh, the thickness of this wall will have increased by about 3.5 cm.

The new roofing works should protrude beyond the face of the wall by at least 40 mm and should be made in such a way as to protect the façade against rainwater run-off. External window flashings and window sills should be carefully attached.

Flashings should be made in accordance with the relevant construction standard. The sheet should not be placed directly on the concrete or the plaster nor on the materials containing sulphur. A new layer of building paper should be placed under the flashing to ensure the proper insulation. As part of the above repair works, new ventilation grilles should be also installed on the façade.

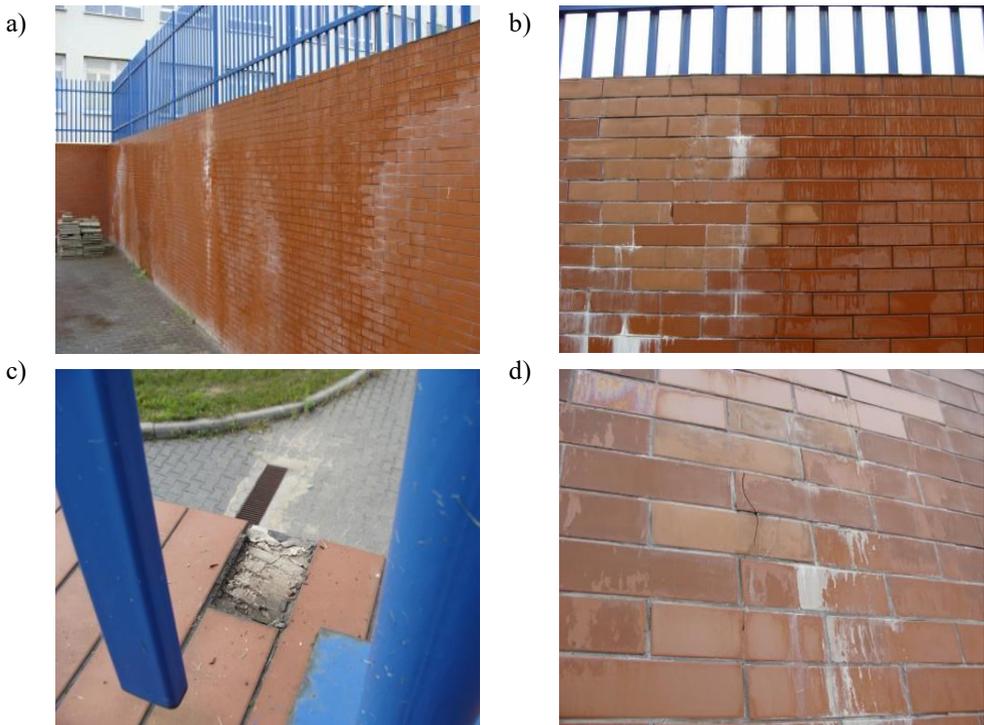
The retaining wall and the basement wall at the exit from the building, marked in yellow with yellow arrows (Fig. 1), were covered with clinker tiles with joint sealing compound. The adoption of such a solution in connection with the careless execution of the barriers, the lack of expansion joints, the improper arrangement of the tiles on the mortar as well as leaving free spaces beneath them, caused both weeping and loosening of these tiles due to rainwater - Fig. 9. It should be emphasized that the phenomenon of cyclic freezing and thawing in the winter period played particularly significant role in this issue.

**Fig. 9.** Damage to the cladding of the retaining wall made of clinker tiles: a) general view of the cladding with visible wet weeping and traces of washed calcium, b) clear runoffs of the rainwater on the clinker tiles of the cladding, c) inspection of the cladding of the upper part of the retaining wall - visible spaces in the adhesive mortar, d) weaning and cracking of the clinker tile cladding.

The described damages of the clinker cladding of the analysed retaining wall constituted of significant removable physical defects because they not only significantly worsen the aesthetic condition of the building but also significantly reduced the operational value of this structural element.

Cracked façade cladding in the form of clinker tiles poses a direct hazard to the users of the sports hall. The impact zone around the facility should be marked and excluded from use until the repair is implemented. The repair plan should consist in dismantling the damaged claddings and making new ones. Moreover, due to the significant moisture in the walls observed, it is highly recommended to remove the moisture in a natural way and to perform new flashings on the upper, horizontal surface of the masonry. It is proposed to make new flashings from titanium-zinc sheets of 0.8 mm thick.

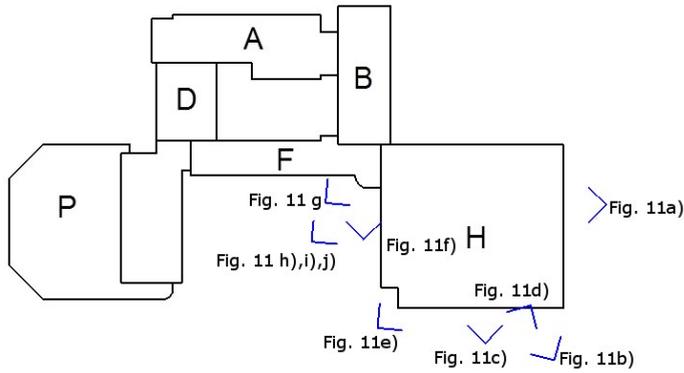
Another group of defects are damages to ceramic claddings on the external walls, the stairs and terraces next to the building. Figure 10 shows the scheme of the site with the location of individual damages. Figure 11 presents examples of these damages that essentially consist of cracking and detaching of ceramic tiles.

**Fig. 10.** Location of ceramic damage to façade claddings.

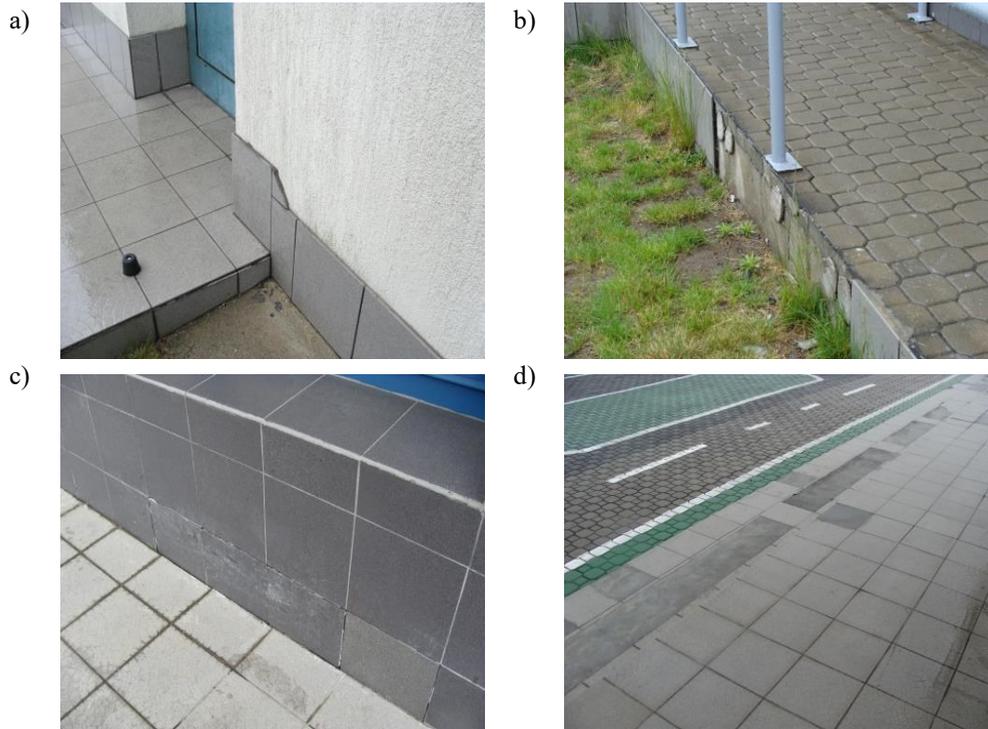
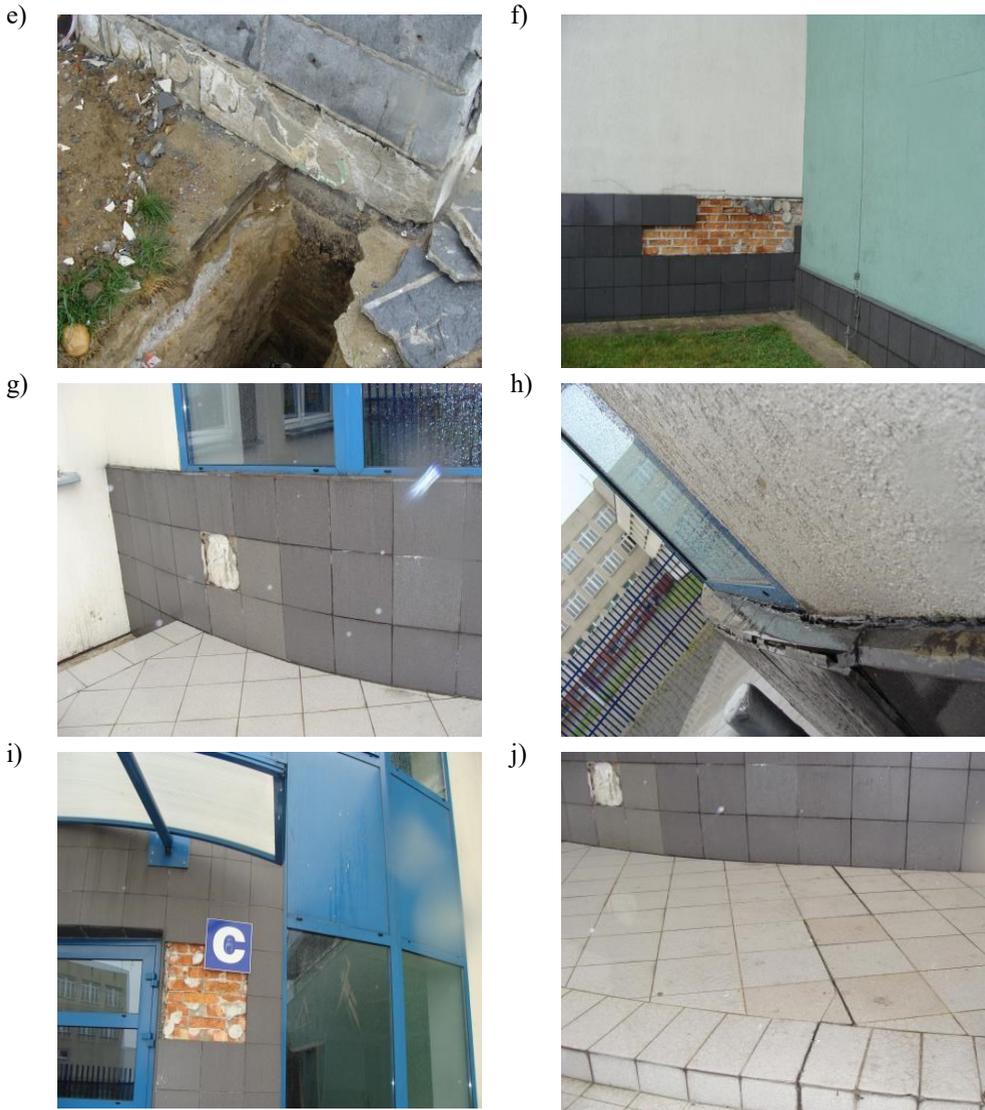
**Fig. 11.** a) ÷ j) Examples of the ceramic damage to the cladding of the façades and the entrance stairs.

Damage to ceramic claddings was the result of careless arrangement of them with the method of so-called "pancakes" which resulted in free fall of water under the tiles. This implied especially the damage to the mortar and the lower layers of the claddings in winter conditions. In addition, the facings made did not possess appropriate flashings that would have protected façade elements against rainwater (Fig. 11 c, f, g, h, i). Therefore, the protection of the lower part of the façade, as well as the cladding at the entrances to the building against rainwater drainage, had to be reconsidered through the use of flashings. In addition, the layout of the tiles in the dilation area is incorrect (Fig. 11 j). This shows that the works have been carried out without care and accuracy.

Due to the considerable extent of damage to the entire surface of ceramic claddings and the way they are made, it is necessary to remove these claddings from the entire surface with the mortar on which the cladding was laid. Then the preparation of the surface for renovation is recommended. The surface of exposed walls, both masonry and concrete, should be cleaned. They should not be wet, dirty, greasy or dusty.

In the case of elements of bricks poorly tied with the wall, as well as the presence of highly corroded bricks, they should be removed and the resulting cavities should be refilled. Then, the new ceramic cladding should be laid on the entire surface. Building materials should be intended for outdoor use (frost-proof).

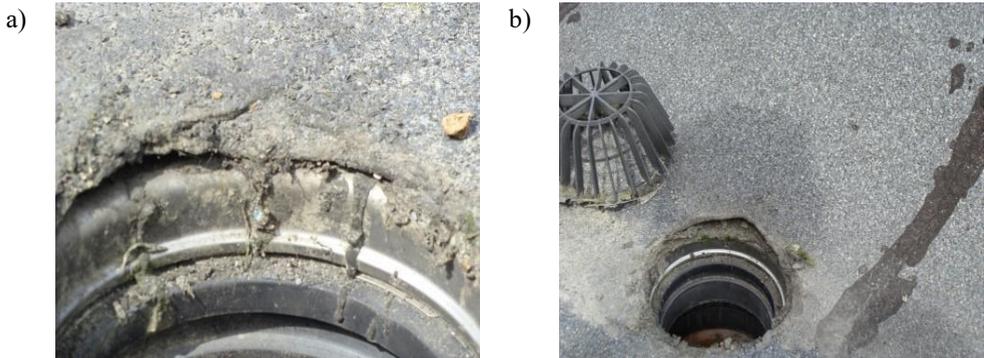
Leaks in the roof slope result primarily from improper fitting of inlets of rainwater drainage system - Fig. 12. Local damage to flashings of cornices was also observed.

**Fig. 12.** Examples of improper installation of rainwater drainage system with roofing paper.

Damage to the installation of rainwater inlets constituted removable however significant defects because it allowed rain water to enter the building. This resulted in accelerated technical wear of internal elements of the structure. Leaks in the chimney seats and local damage to flashings caused local water marks on the ceilings - Fig. 13. These physical defects had to be removed after repairing the entire roofing and painting the ceiling.

Leaks in the roof slope are the result of the improper fitting of inlets of rainwater drainage system - see Fig. 12 a), b). These places should be sealed using appropriate sealing materials based on bituminous masses. After making repairs to all roofing elements, it is necessary to remove the existing stains on the ceilings and to paint all the rooms in which stains occur.

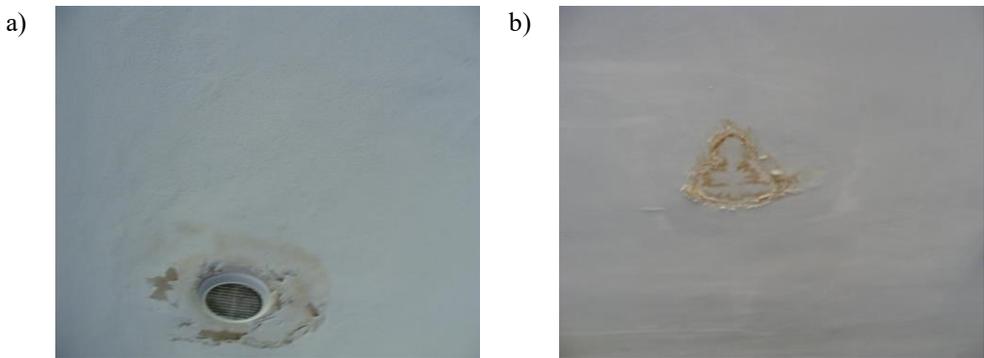
**Fig. 13.** Examples of water marks on ceilings.
