Design errors of the external lift shaft and their negative impact on the operation of the clinic building

Maciej Niedostatkiewicz^{1,*}, Tomasz Majewski², and Patryk Ziółkowski¹

¹Gdansk University of Technology, Faculty of Civil and Environmental Engineering, Department of Concrete Structures, G. Narutowicza 11/12, 80-233 Gdansk, Poland

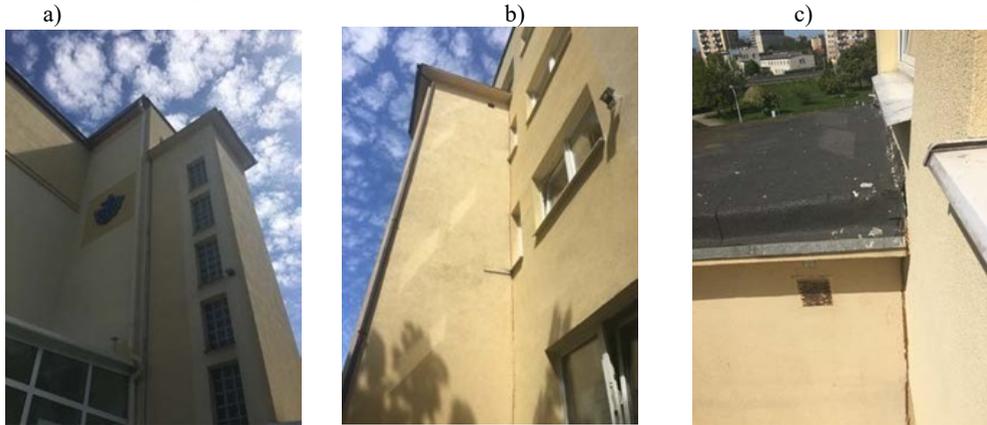
masonry structure, made of hollow clay bricks, with horizontal battens in the form of reinforced concrete, monolithic wreaths made in the level of ceilings above the ground floor and over the first floor of the clinic. The clear internal dimensions of the shaft are 158×190 cm, while the clear external dimensions are as follow 196×228 cm. The shaft is placed on a reinforced concrete foundation slab with a thickness of 25 cm and external dimensions the same as of the elevator shaft. The underground part of the shaft is made from reinforced concrete with dimensions 19×120 cm up to ground level. The cover of the shaft is non-ventilated flat roofs, whose load-bearing structure is a reinforced concrete monolithic slab with a thickness of 8 cm, insulated and secured with a roofing membrane [Fig.3 and Fig.4]. Three years after completion first defects occurred. We observed with the naked eye the detachment of the shaft structure from the building's gable wall which ranged from around 2 mm at the ground floor to about 8 mm on the second floor. We were notified that during the use of the lift there were cyclical stops of the moving elevator, which caused significant difficulties in the functioning of the clinic. As part of ongoing renovation works, the rifts were filled with a rigid sealing material. In the period of further exploitation at the level of the shaft along the wall contact (passenger lift and building top wall), hairline cracks were still formed which widened to a width of 1 mm over time. The user successively masks visible scratches covering them with filler methods.

Fig. 1. External lift shaft located next to the clinic: a) front-view, b) courtyard-view, c) rooftop view.

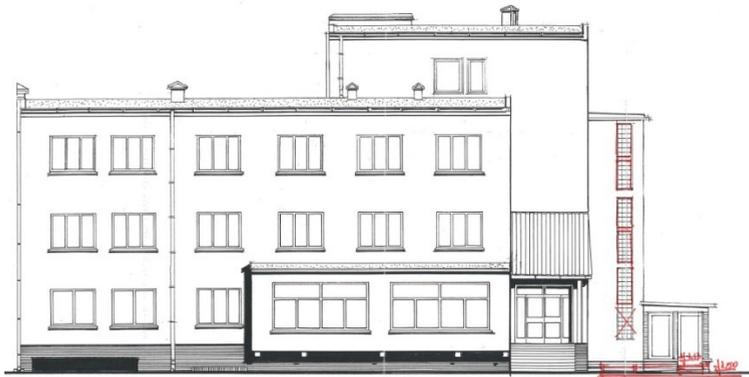
Fig. 2. Front facade of the clinic. External lift shaft is visible on the right-hand side of the image.

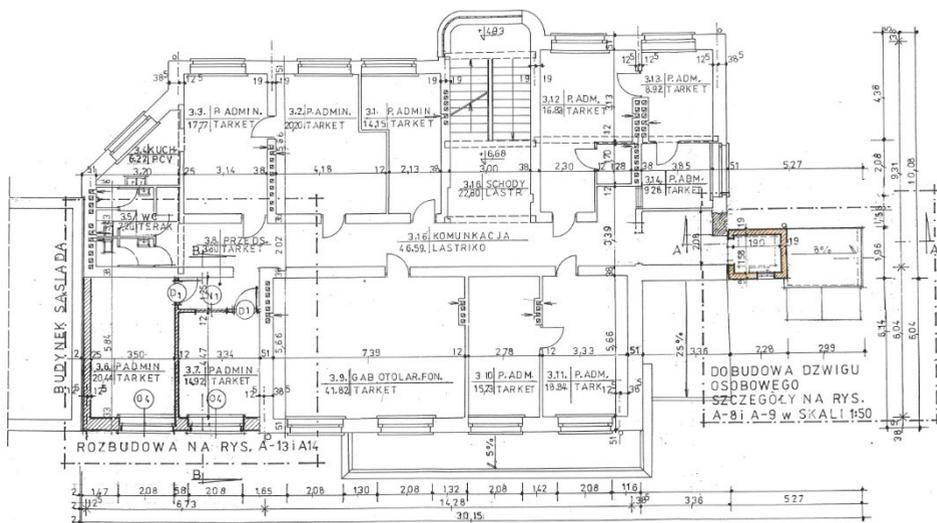
Fig. 4. External lift shaft located next to the clinic: a) second-floor plan, b) shaft detail.
