# Emergency overflows – consequences of non-compliance with the construction law

**Abstract.** The article is based on a technical opinion that specifies the causes of a construction disaster within an industrial hall that occurred after torrential rain. This article describes the condition before the disaster, provides an analysis of legislation along with a commentary on the analysis of provided materials, in particular - stormwater drainage installation projects from before and after the modernization of the roof - as well as a summary and conclusions.

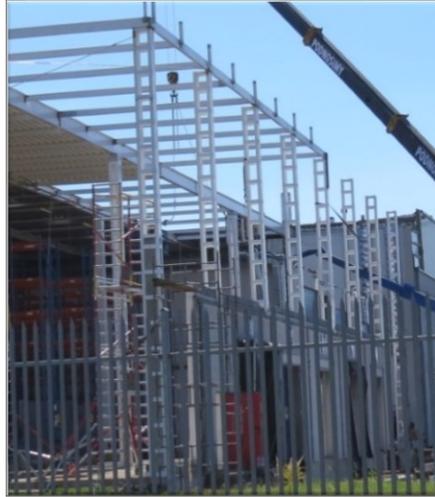
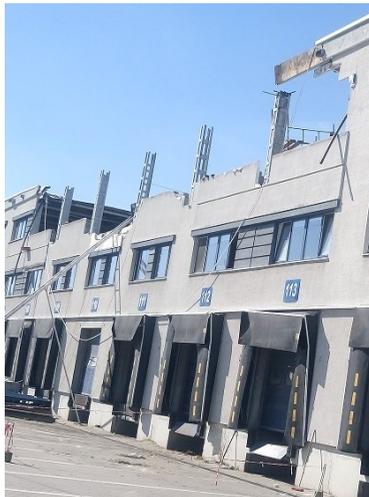
In June 2016, heavy rainfall resulted in the destruction of the structural components of the roof covering the high-storage warehouse hall and part of the wall frame construction [Fig. 1 and Fig. 2]. The Institute of Meteorology and Water Management (IMiGW) classified this rain as torrential rain [1]. The decision of the State Construction Inspection identifies sudden downpour and overload due to the weight of residual water as the initial causes of the

disaster. Furthermore, besides structural elements, parts of the electrical system as well as drainage and hydrant systems were destroyed as well [2].

**Fig. 1.** North-western elevation [4].

**Fig. 2.** Front elevation [4].

The damages occurred in the north-west corner in the three 3x18 m aisles at the width of two 2x6 m space at an area of approx. 650 m<sup>2</sup>. The steel structure of the roof, including beams, purlins, bracings, internal and external support columns as well as outer walls, and part of electrical and hydrant installations, were all damaged. Roof damage also included the central portion of the hall’s front elevation at an area of approx. 180 m<sup>2</sup>.

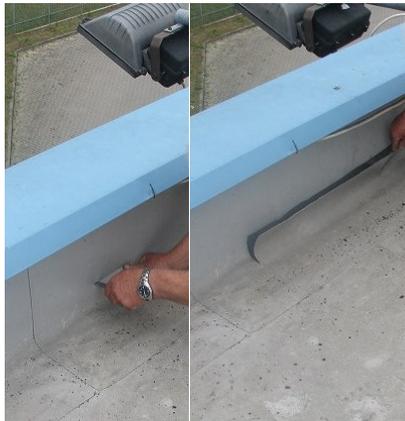
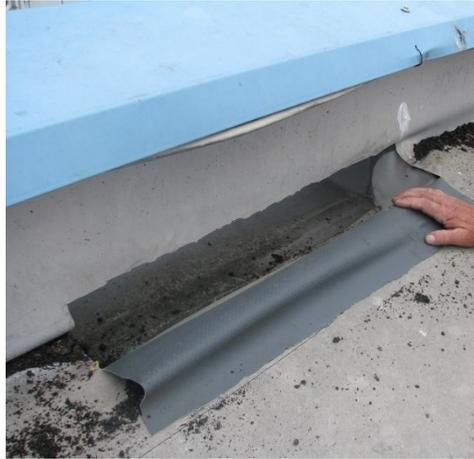
- directly, by completely covering and sealing some of the openings [Fig. 4 and 5],
- directly, by reducing the area of the overflow openings, by inserting wires with a smaller section - approx. 12 x 29 cm - in the existing troughs with dimensions of approx. 15 x 30 cm [Fig. 6].

**Fig. 4.** Closed emergency opening [4].

**Fig. 5.** Closed emergency opening [4].

The disaster was also prompted by the reduction, made during the roof renovation in 2011, of the number and size of safety overflows - by 75% in the warehouse area and by 45% in the office part, as well as increase of the overflow edge with respect to the lowest point of the roof plane by approx. 12-14 cm . This was incompatible with the project from 2005 and contributed to the excessive accumulation of water on the roof, which thus exceeded the load capacity of the structure.

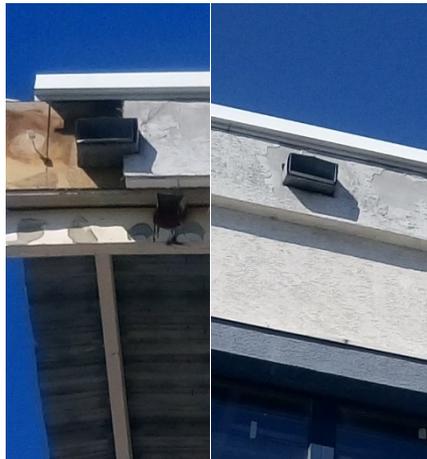
**Fig. 6.** Reduction of the size of emergency openings [4].

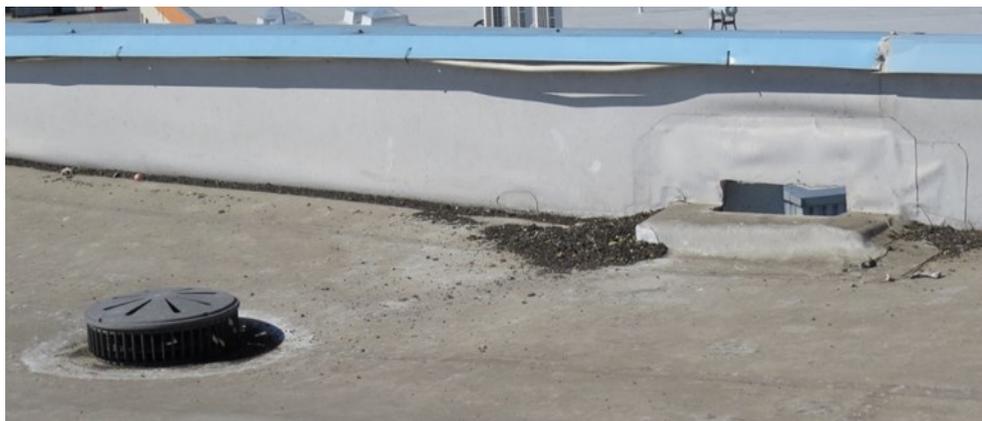
- indirectly, by changing the height of the location of emergency overflows from the lower edge of the overflow to the lowest surface of the roof, which led to the accumulation of more rainwater in this part than originally provided for the project. Water access threshold increased significantly to approx. 12 - 14 cm. In places where the overflow was located in the recesses between the polystyrene uplift, the bottom edge was raised deliberately [Fig. 7]. As a result, the emergency overflows either failed to work at all or were not functioning properly at an appropriate time. Increasing the level of the roof and performing overflow thresholds resulted in significant accumulation of water in a part of the roof different than designed, thus the emergency openings ceased to fulfill their functions.

**Fig. 7.** Increase of the bottom edge of the emergency opening [4].
