Defects of sandwich walls

Bohdan Stawiski^{1,*}

Abstract. Thermal protection of spaces contributes to the fact that sandwich walls dominate in heated buildings. Their design requires knowledge regarding the operating principles of sandwich systems. Without knowledge of these principles, numerous mistakes are made. The study describes mistakes encountered made during erection of triple-layer and double-layer walls. The effects of a shortage and excess of connecting pieces in triple-layer walls are presented. For double-layer walls, the necessity of insulation expansion joints is shown using an example. Using the tests, it is proven that the strength of the adhesive layer created during the autumn/winter transitional period is very heavily decreased, even more than 50%, which in connection with over-stiffened anchors leads to very numerous cracks, to the destruction of the external layer of insulation. High diffusion resistance of the external layer of insulation with low diffusion resistance (mineral wool) also leads to the destruction of the adhesive & plaster layer. Furthermore, the considerable significance of the use of good quality reinforcing, anchoring, gluing and painting

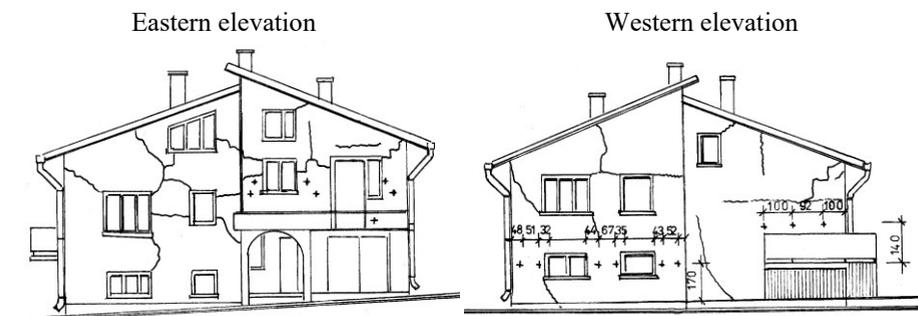
Fig. 1. Cracked triple-layer walls in a single-family house. No crevices were found on the north elevation. Locations of detected steel anchors are marked with crosses.

The first suggestions concerning mistakes in settlement were precluded because the observed cracks did not have the characteristic trajectory typical of unevenly settling walls. The walls did not have any cracks on the internal side either. Therefore, the trajectory of the crevices was recorded and their span was measured. The larger crevices had the span from 0.25 to 1.6 mm. The trajectories of the crevices were random which might indicate a human factor that is errors in workmanship. Preliminarily it was assumed that the errors may concern improper connection of the protective layer with the load bearing layer.

Due to accessibility, only the following were examined: on the eastern elevation the area accessible from the balcony, on the western elevation the area accessible from the ground level and from the balcony, the southern and northern elevations were examined in a similar way. It was determined that the location of anchors is completely random and the number per 1m² is grossly lower than the requirements (Fig. 1), one anchor per m² or less. No connecting anchors were placed at all on the circumferences of window or door openings [3-5]. Such a gross deviation from good construction principles explains the cracks appearing in the elevation [6-8].

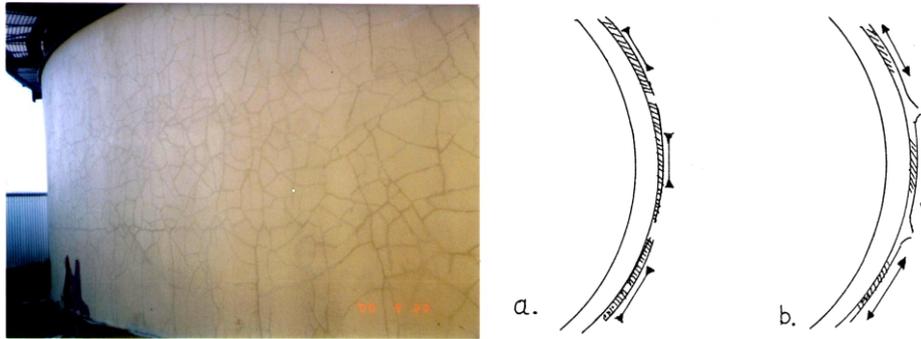
Fig. 2. Heavily cracked layer of skim coat plaster. Defects appearing as a result of thermal deformations: a) at low temperatures, b) at high temperatures.

The elevation from the north cracked most intensively. It can be concluded from the analyses performed that the heated adhesive and plaster layer expanded under the influence of temperature. The displacements ran in the direction of walls less heated and they accumulated on the northern wall. Buckling occurring locally between anchors prevented the wall from falling apart. Buckled sections of plaster cracked in various directions. The cracking mechanism during heating and cooling is presented in Fig. 2a and 2b.

In this case, the basic mistake was negligence in design and execution of the expansion joints at a distance of approx. 7 m (tank circumference 28 m). On non-curved walls, these distances may be bigger up to approx. 10 m. As can be easily calculated, with a change in temperature of 30°C, elongation of the circumferential adhesive & plaster layer will be 8.4 mm.

In the adhesive & plaster layer, 4 expansion joints should have been made, each at least 3 mm wide.

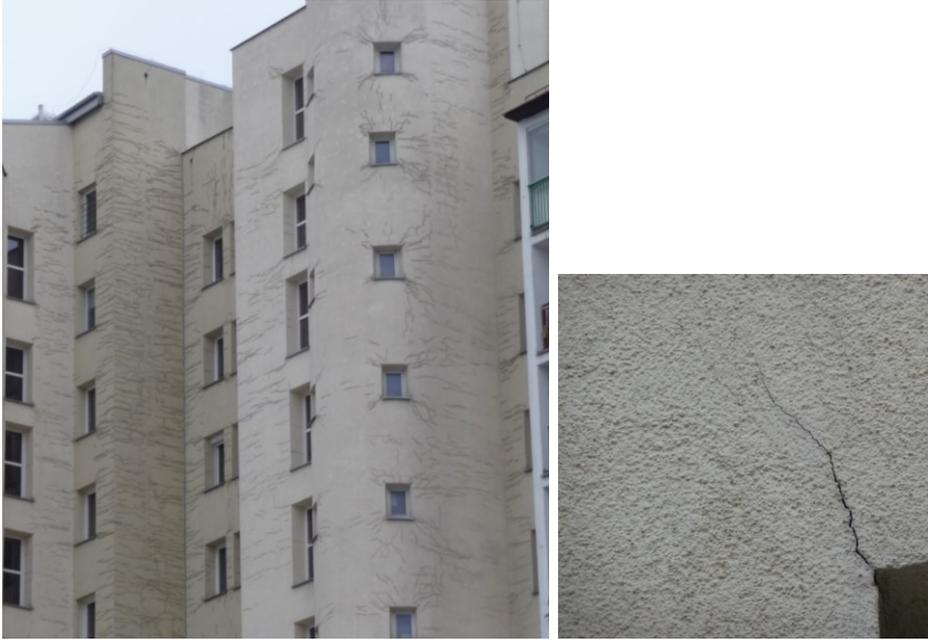
Fig. 3. Cracked adhesive & plaster layer. Mainly horizontal crevices and skew crevices from window corners. Good visibility of crevices is caused by an attempt at superficial sealing. The attempt was ineffective because the thin layer dried up quickly.

In spite of undoubted mistakes in anchoring, the intensity of cracking was not the same on all walls and it was not the direction of exposure but the time of execution and the durability of the adhesive and plaster layer which were clearly marked.

In the described case, the failure condition was the effect of too rigid connecting pieces and the reduced strength of the adhesive which underwent the process of freezing and thawing during the initial hardening phase.

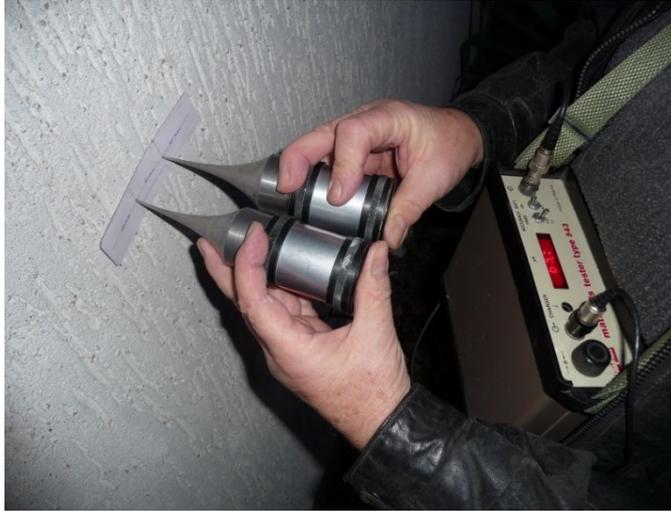
The strength of the adhesive & plaster layer made in winter was much lower than that of the one made in summer, on the average it reached 59% of the strength value for the summer period, however some areas were detected where mean compression strength was only 32%.

Fig. 4. Ultrasonic tests of the strength of the adhesive & plaster layer on the building.

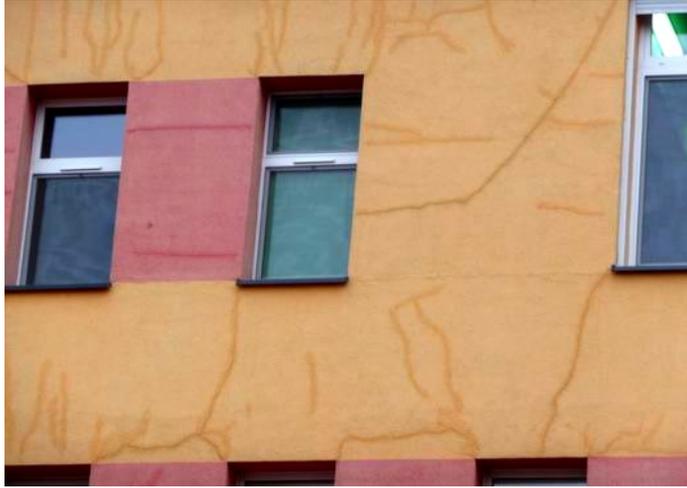
Another example indicating improper reinforcement of the glued layer using mesh is shown in (Fig. 5).

Fig. 5. Irregular cracks in the adhesive & plaster layer.

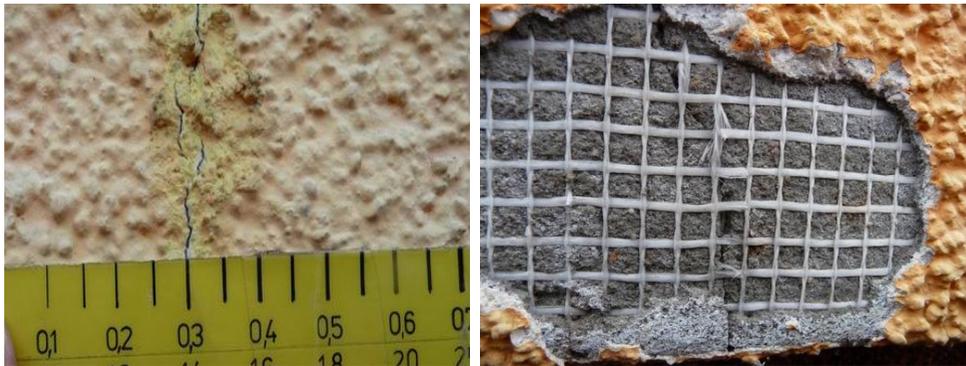
While examining the causes of cracks in one of the structures in the location of cracking with significant span of 0.3 mm (Fig. 6), it was found that the adhesive under the mesh was also cracked and the mesh was not interrupted.

Fig. 6. Cracks in the adhesive & plaster layer with the span of 0.3 mm.

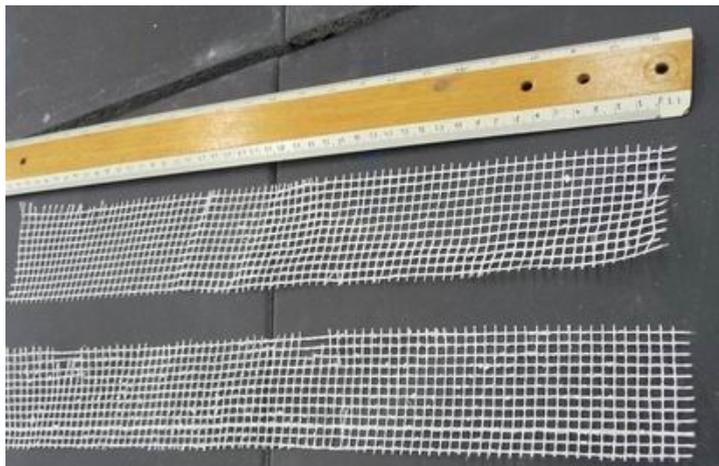
Fig. 7. Straps of reinforcement mesh samples for testing.

With destructive load, elongation of the mesh was 9.4% and for one strap as much as 22.9%, while acceptable elongation is 5%. So strongly deforming mesh made of fibreglass did not transfer stresses from thermal deformations and resulted in tearing of the adhesive and plaster layer in all places where the tensile strength of the adhesive layer was exceeded.

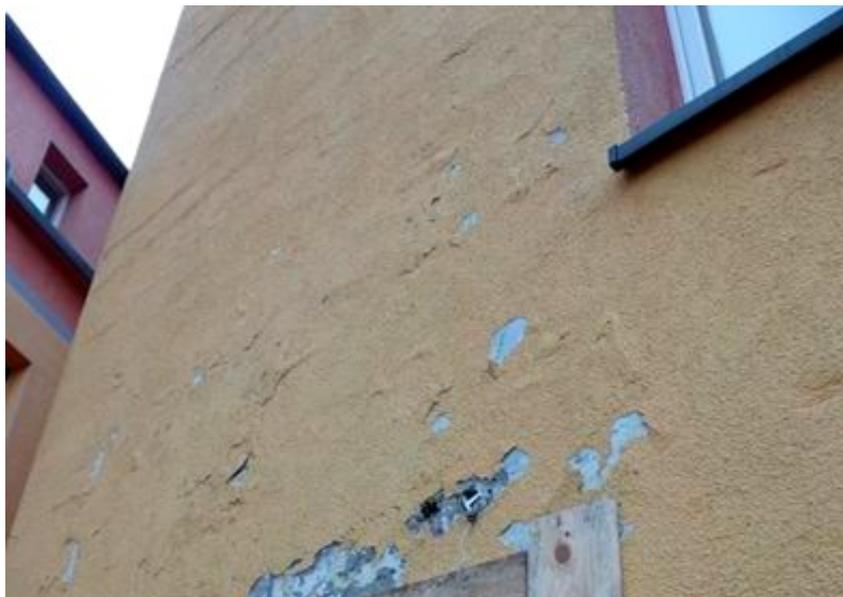
A hospital building was examined which had been insulated using mineral wool on which an adhesive layer and silicate plaster had been designed. However, acrylic plaster had been made. Considerable diffusion of water vapour occurred through the external walls of wet spaces. The process of vapour condensation in the partition was analysed by means of calculations for silicate plaster and acrylic plaster. Under normal conditions, at external temperature of $t_e = -18^\circ\text{C}$, internal temperature of $t_i = 20^\circ\text{C}$ and air humidity of $\varphi_i = 55\%$, in the partition coated with silicate plaster $19\text{g}/\text{m}^2/\text{year}$ are condensed and with acrylic plaster $121\text{g}/\text{m}^2/\text{year}$. In the cases of slightly increased humidity of $\varphi = 65\%$, $322\text{g}/\text{m}^2/\text{year}$ are condensed under acrylic plaster. The mineral wool under the adhesive mass was wet. The test was performed in the exposed pit. As a result of freezing and thawing, the damp plaster and adhesive mass began to crumble and flake off (Fig. 8).

Fig. 8. Damaged surface adhesive and plaster layer on the walls of wet spaces. Dampening of wool and adhesive layer caused by diffusion of water vapour and freezing process.
