The analysis of the causes of the collapse of two timber sheds during the construction

Abstract. The paper describes collapses of two timber sheds located in Cieszyn and Zebrzydowice, Poland. The collapses took place during the construction process. The structures of the sheds are described, the construction works are analysed, the causes of the collapses are determined and the recommendations and technical solutions regarding their repair are presented.

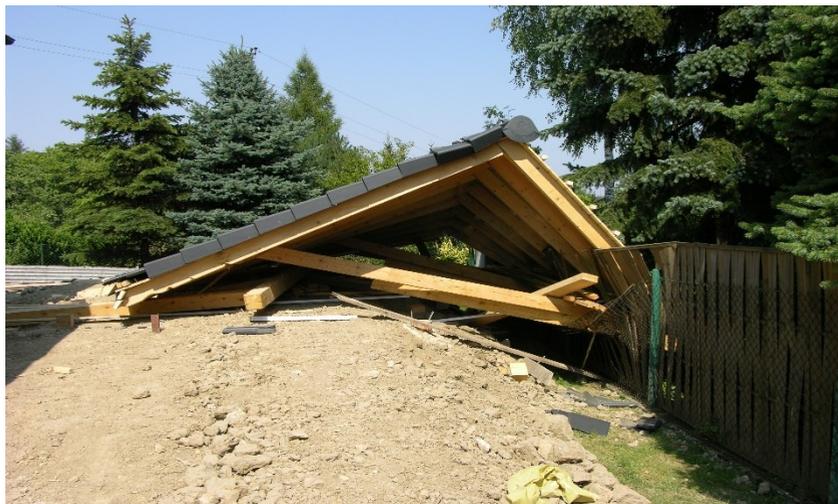
The shed in Cieszyn collapsed on 4th August 2015 in the afternoon. The whole structure leaned in transversal direction which was caused by the loss of balance of the posts. The fence of the plot 19/8 and a few trees were also damaged by the falling shed (Fig. 2).

Fig. 2. The shed in Cieszyn after the collapse.

The collapse took place during the construction works and caused injuries of three workers who were working on the roof. Two of them fell off the roof from the height of 4 m.

The direct cause of the collapse was the cumulation of the abovementioned factors which resulted in creating torsional stress in the posts and in the end the loss of balance of the shed (Fig. 2).

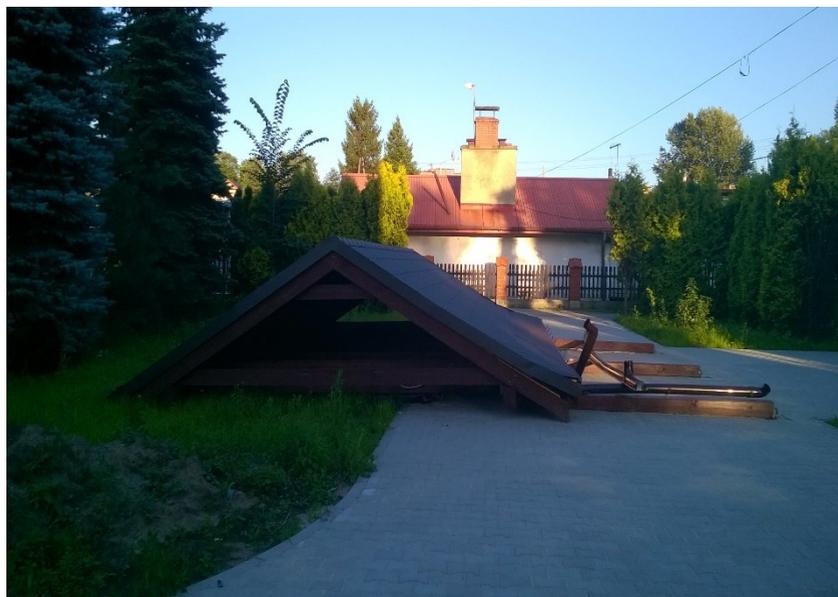
The other shed in Zebrzydowice near Cieszyn collapsed on 5th August 2016. The whole structure leaned in transversal direction which was caused by the loss of balance of the posts. The collapsed shed is shown in Fig. 3.

Fig. 3. The shed in Zebrzydowice after the collapse.

During the construction process the contractor used temporary transversal stiffening by struts which were taken off after finishing the construction and that was the moment the collapse took place. None of the workers was injured but because the shed was built in a busy town centre, the collapse caused disturbance in the traffic.

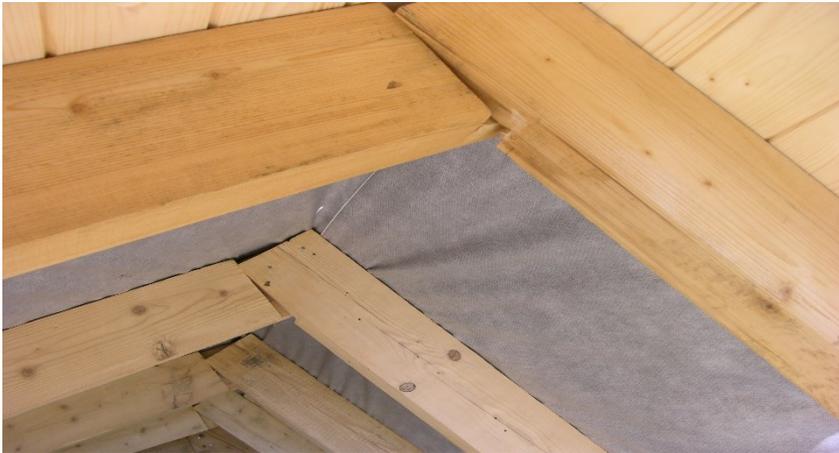
During the construction works there was no temporary protection in the form of struts. Another cause of the collapse was the lack of transversal stiffening and bad quality of joining the construction parts such as short nail connections between the rafters and the wall plate (Fig. 5) or too small nails between the rafters ends or even their absence (Fig. 4).

Fig. 4. The rafter – to – rafter connection – not enough or no nails.

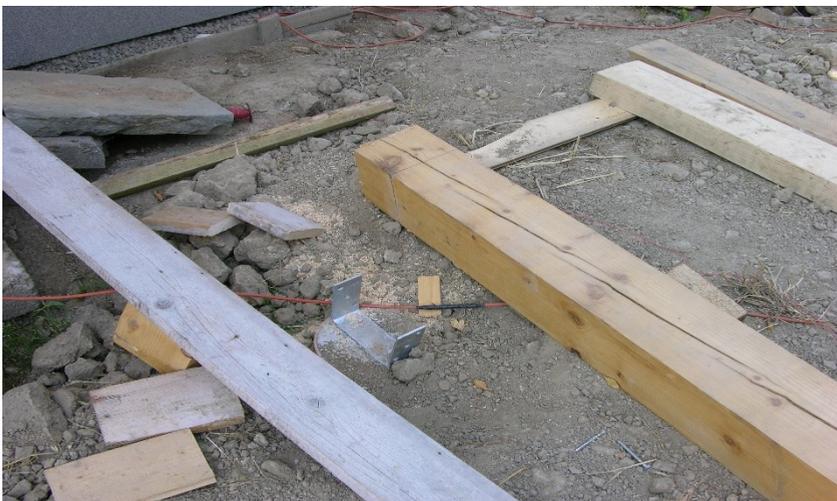
There were numerous causes of the collapse of the shed in Cieszyn. During the construction process the correct sequence of the works was not observed. The construction of the cement-tile roofing had commenced before finishing the structural works and resulted in errors such as the lack of connectors between the posts and foundation anchors (Fig. 4) and the lack of connectors of the collar beams.

Fig. 5. The post – foundation block connection – no screws in the connection.

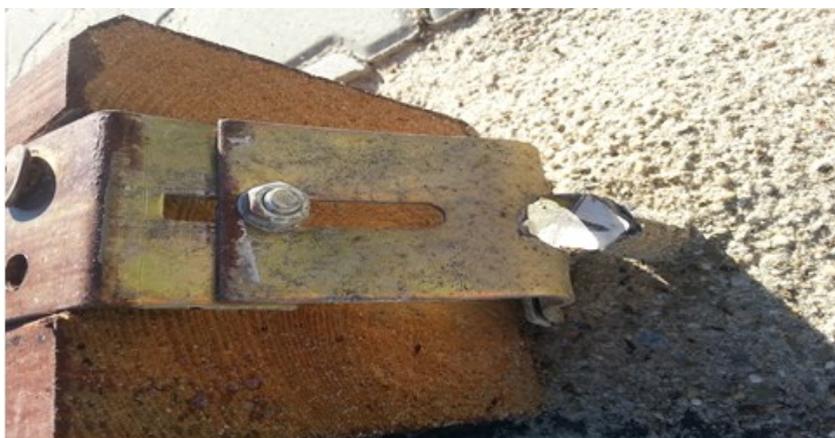
Fig. 7. The post – strut – wall plate connection.

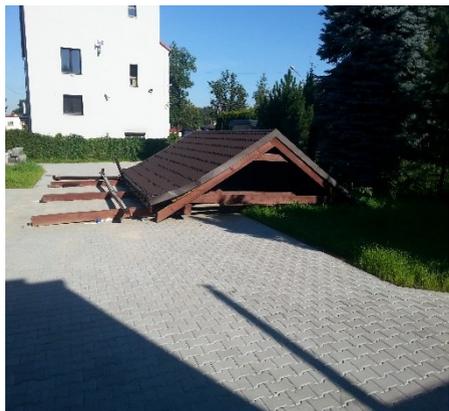
Fig. 8. The shed in Zebrzydowice after the collapse.

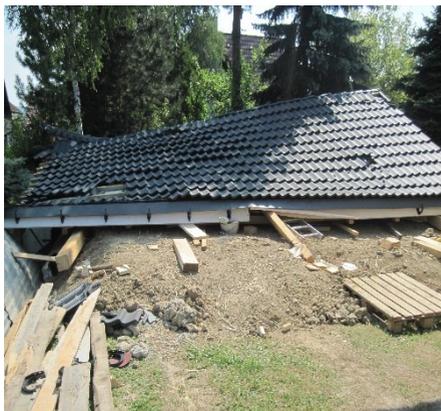
Fig. 9. The shed in Cieszyn after the collapse.

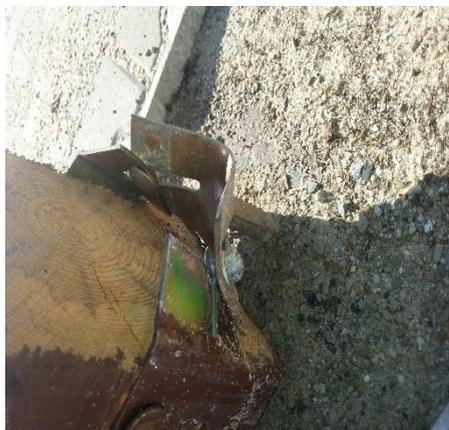
Fig. 10. The column – foundation block connection in Zebrzydowice.

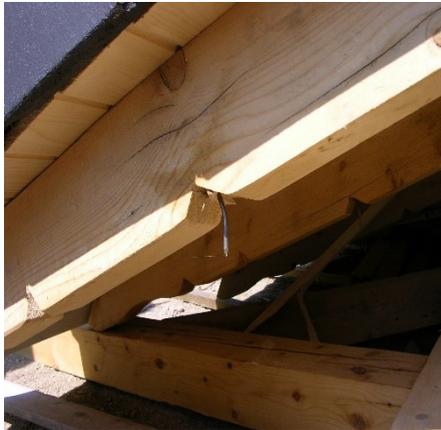
Fig. 11. The rafter – wall plate connection in Cieszyn.

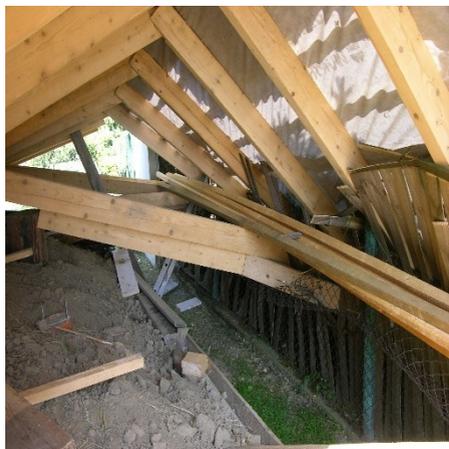
Fig. 12. The shed in Cieszyn after the collapse.

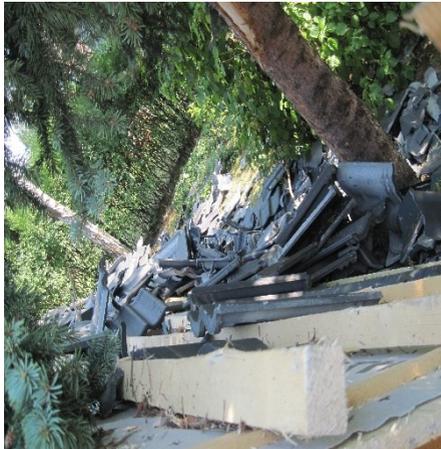
Fig. 13. The damage after the collapse in Cieszyn.
