Change in groundwater conditions as a cause of structural failure – selected case studies

Tomasz Godlewski^{1,*}, *Witold Bogusz*¹ and *Lukasz Kaczyński*¹

¹Institut Techniki Budowlanej, ul. Ksawerów 21, 02-775 Warszawa, Polska

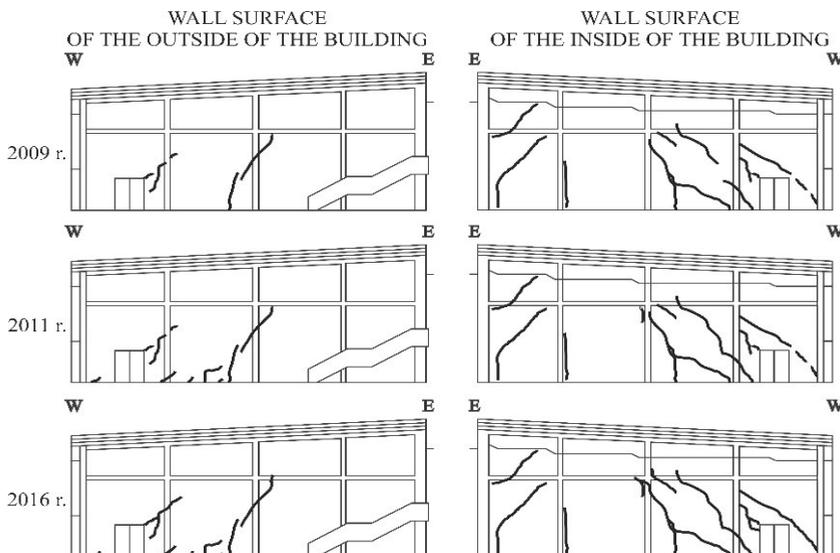
First damage to the structure was recorded after 7 years of use of the building. After next 4 years, new cracks and propagation of existing ones had been noticed. Main cracks were vertical and diagonal, inclined in the eastern direction, ending at half of the height of the southern wall, extending through its entire thickness (Fig. 2).

Fig. 2. Evolution of cracks at the southern wall of the building.

The distribution of the cracks and their propagation indicate an ongoing process of degradation. The maximum crack width at the lower part of the wall reached up to 1 cm. Due to this and the general state of the wall, it was considered as a state preceding the failure. The levelling pins were installed on the southern wall to measure its settlement and crack-meters were installed to monitor the progress of cracks.

Recent observations and geotechnical site investigation confirmed earlier conclusions regarding the cause of the damage to the external walls, namely, differential settlements. Conducted analysis showed that foundation on sand layer would result in settlements not exceeding 4 mm. However, on soft soil, the final settlement was predicted at 31 mm. Interestingly, the observed displacement was not characterised by a constant rate of settlement usually observed in such conditions up to stabilisation (typically 1-2 mm/year). More dynamic process has been observed (Fig. 3).

Finally, identification of the underlying causes and conducted observations allowed to implement proper remediation measures. Steel micropiles have been installed to support the wall on the bearing stratum. The detailed description of the implemented technology can be found in the earlier publication [3].

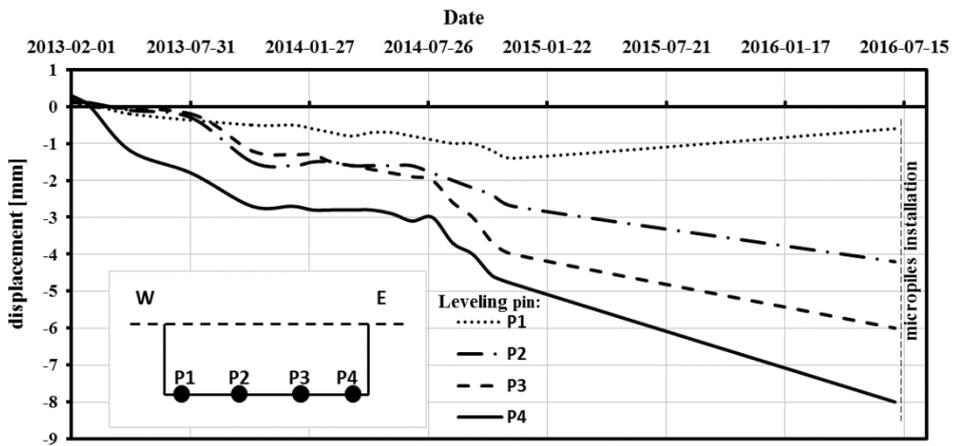
Fig. 3. Vertical displacements of the wall.

Although the data from the time of construction were not available, a clear stabilisation period can be noticed. However, in mid-2014, in relatively short time, a rapid increase in displacements had occurred, by approx. 50% of the already reached values. The lowering of water table, observed in a relatively large area of Warsaw, was identified as the underlying cause of this behaviour. Those changes were not season-related, but they were probably connected to the changes in hydrological circulation (e.g. decrease of infiltration due to paved areas) rather than associated only with climate change.

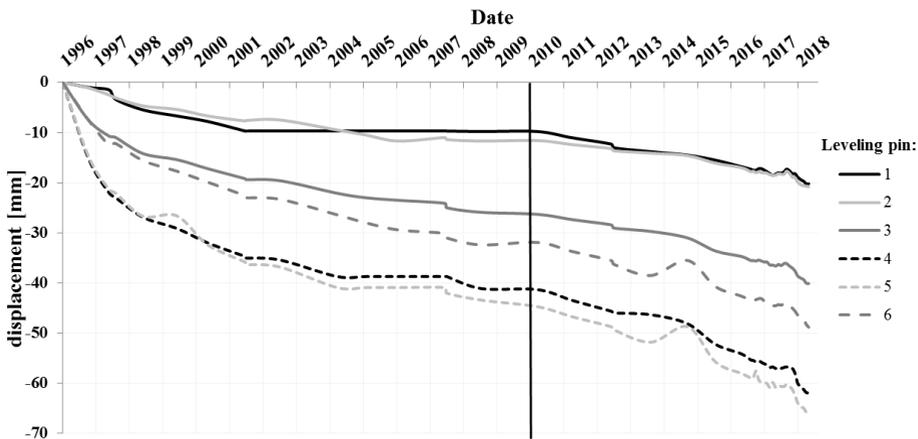
Fig. 4. Displacements of the one of the buildings (after underpinning).

Measured settlements were noticeably stabilizing from the execution of underpinning and displacements after further consolidation reached approx. 5-10 mm. However, from 2010, the displacements increased and the rate of settlement practically doubled. The analysis of groundwater levels, based on piezometer measurements, with additional analysis of regional settlement data obtained from satellite interferometry, lead to the conclusion that reactivation of consolidation processes influenced the behaviour of the buildings. Lowering or even disappearance of the first water table resulted in further consolidation of the peat layer. Although the buildings do not show any signs of reaching ultimate limit state and loss of bearing capacity, excessive tilt may limit serviceability of the structure (e.g. use of elevators).

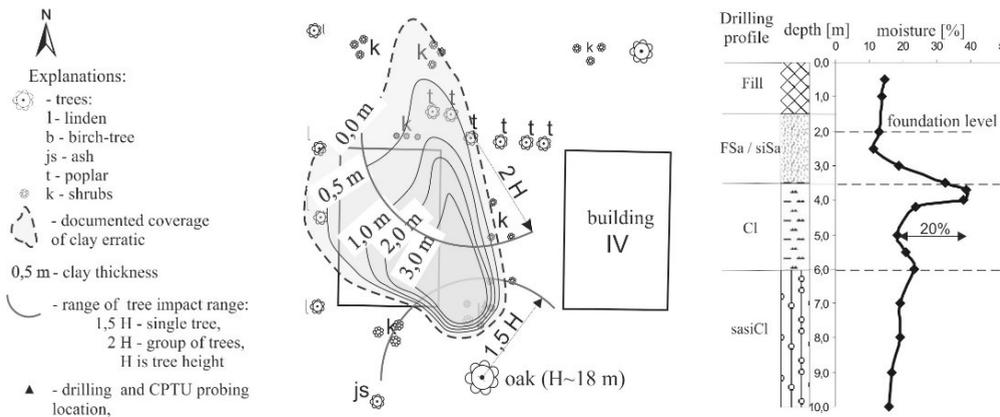
Fig. 5. Situation plan with the extent and thickness of clay erratic, with the range of influence of adjacent trees, as well as measured change of water content in soils samples from various depths.

In addition, the water level originally occurring approx. 2.5 m bgl was not encountered. However, variations in moisture content of about 20% were documented in the clay. During investigation, in clay samples, parts of tree roots were noticed, which pointed to the cause of moisture change. The influence of trees, established according to ITB recommendations [4], extended below the building where clay erratic was documented. With limited infiltration due to pavement of the area and drainage, the cause of building settlement was identified as shrinkage of expansive soils. Unfortunately, displacement monitoring was not conducted for this building, but based on available materials, it was estimated that significant damage occurred in the period from 1990 to 2004. The original 3 mm cracks increased to 8-12 mm.

Beside the repair of damage to the walls, the proposed solution was to underpin the building with micropiles extending below the clay erratic. Additionally, changes in upkeep of the trees were proposed, by installation of an irrigation system or removal of the existing trees and their replacement with less invasive species at a safe distance from the building. More details on this case study can be found in [5].

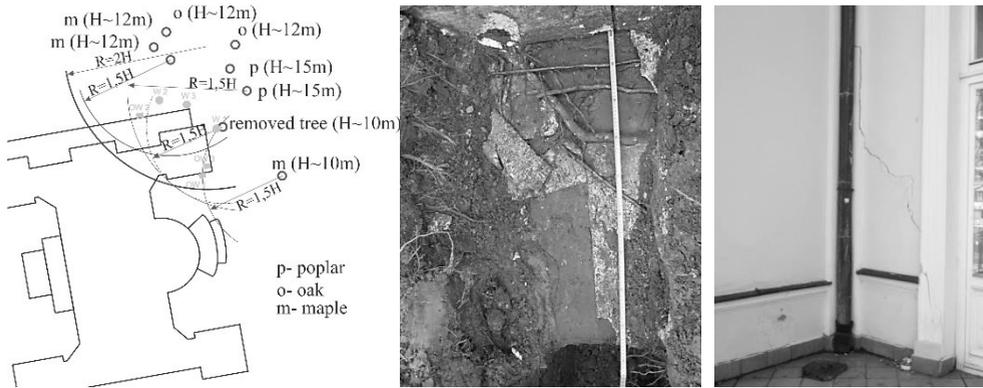
The existing cracks and their progression suggested that they were caused by local differential settlement due to the change in moisture content in clays. This hypothesis was further supported by the presence of clays under the foundations of considered part of the building as well as the close proximity of trees. The zone of influence (Fig. 6) of trees was estimated based on [4], in relation to their height.

The estimated zones were noticeably extending under the part of the building. In trial pits near the foundations, tree roots were encountered (Fig. 6), which spread even under the foundation itself. At the same time, no damage has been observed in other parts of the building, even in close proximity to trees but with clay layer at larger depth. Finally, it was judged that cyclic movements (heave and settlement) lead to the occurrence of damage, due to ineffective water management, existing trees, and presence of expansive soils.

Fig. 6. The extent of influence of trees on the building, the view on tree roots in the trial pit at the north-east side of the building, and the crack at the wall due to resulting differential settlements.

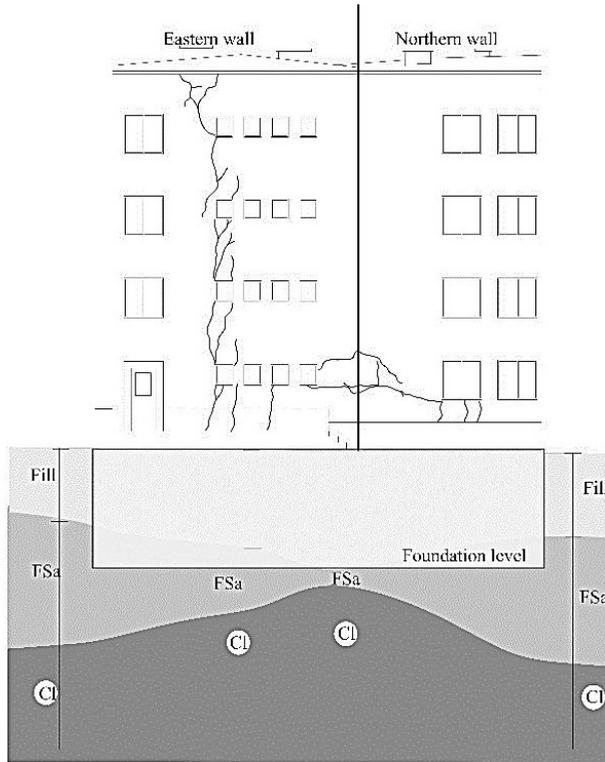
First damage to the building was recorded in 1970s, with the intensification in 2005-2006. Conducted technical assessment proved the existence of cracks on external walls, mostly in north-eastern corner, reaching through the entire thickness of the walls and with width of up to 5 mm. The cause was identified as shallow occurrence of expansive soils. In 2007, partial underpinning of this part of the building was executed with the use of 11 driven micropiles (140 mm in diameter, 6.5 – 7.5 m in length). Measurements taken later showed that the settlement process stabilised (Fig. 7).

Strip foundations are not sufficient for limiting the impact of differential settlement on the structure due to the presence of expansive clays. Spread foundations with possible seasonal water table variations lead to further differential displacements. Lack of comprehensive approach to repairs since 1972 resulted in widening of existing cracks and occurrence of new ones.

Fig. 7. Damage to north-east corner of the building in the light of geotechnical conditions.
