# An Example of Failure of an Office Building in Upper Silesia

**Abstract.** The paper describes an example of a failure of an office building in Upper Silesia, Poland. Following a technical description of the building, the authors describe the damage to the building structure and damage development. The causes of damage of the building structure are assessed and discussed. The main cause is a long-term failure of the water supply system that resulted in deterioration in the foundation subsoil. The investigations also showed previously unidentified subsoil deformation left after old mining exploitation. The paper concludes with the discussion of the ongoing restoration of the technical efficiency of the building.

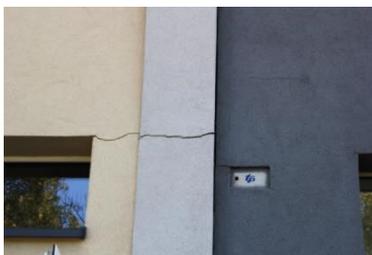
- cracking of the western external wall with an aperture of up to ca. 1.0 cm, visible outside and inside office rooms,

**Fig. 6.** Cracking of the thermal insulation layer of the external wall in the zone near the movement joint between the northern and central segments.

Lastly, it was recommended to replace / restore the damaged fragments of the thermal insulation of external walls along with the unification of the painting of the walls of the extreme northern segment and the central segment (the eastern façade).

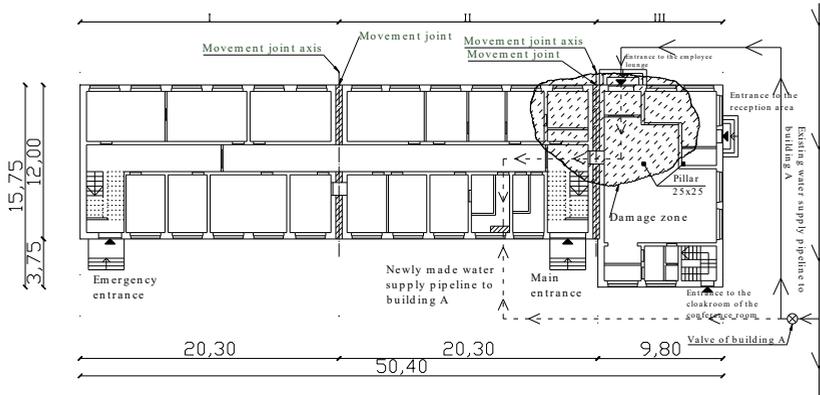
During the first days of August 2018, in some of rooms on the ground floor in the middle and the extreme north segment (Fig. 1), damage to the structure of the walls, window and door lintels and concrete floors was observed. The damage consisted of:

- heavy cracking of internal longitudinal load-bearing walls, walls near movement joints and partition walls; the aperture of these cracks was up to ca. 15 mm (on the ground floor of the building) and ca. 5 mm in part of the first floor rooms.

**Fig. 7.** Location of damage in the office building.

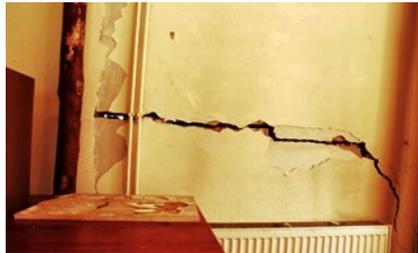
During the initial 1.5-month period, increase in the crack apertures and cracking of the walls were observed, the increased tilting of the floors on the ground floor of the building was noticed along with the appearance of new damage. The biggest increase in the crack aperture of the ground floor walls in this period amounted to 24 mm. In one of the walls located near the movement joints on the ground floor, a sectional, horizontal deformation was also determined (to the inside of the room – Fig. 8).

**Fig. 8.** Cracking of the wall located near the movement joints of the ground floor of the building with horizontal displacements of its parts.

Restoration of the technical efficiency of the structure of the cracked fragments of the load-bearing walls with an aperture of over 5 mm will be based on partial replacement (areas with horizontal deformation) and their re-walling. The purpose of this work is to reconstruct the original rigid system of the structure.

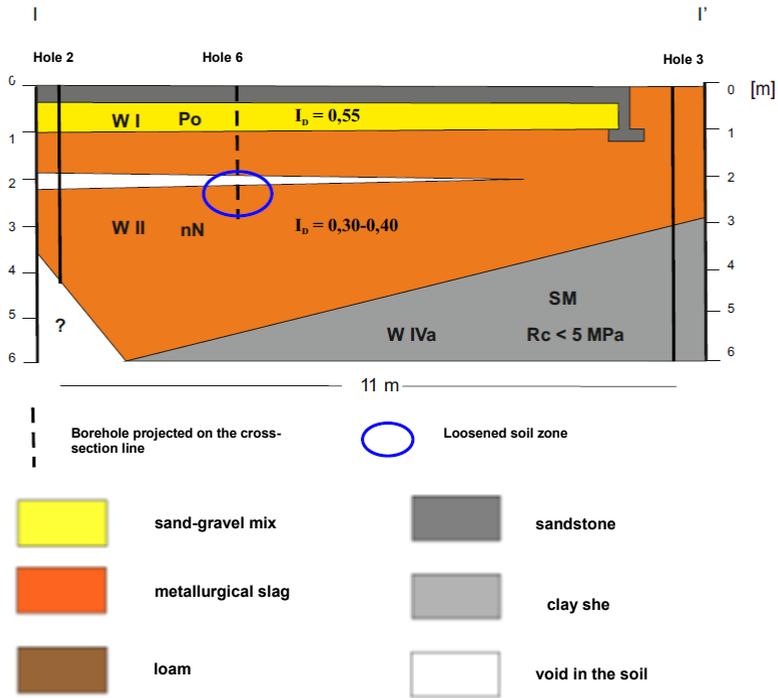
**Fig. 9.** Geotechnical cross-section I-I.

The building is constructed on a layer of metallurgical slag of the varied thickness (between 2.8 m and 5.0 m). Currently, the slag is in the medium dense state and parts of it are in the loose state.

The occurrence of two void types in the soil was determined during drilling. These are the voids formed at the boundary between the concrete flooring and its underpin (with a height between 2 cm and 5 cm) and intra-layer voids within layer II – metallurgical slag. The second type are soil voids occurring at various depths: in bore hole No. 1 at a depth between 4.8 m below flooring level (b.f.l.) and 5.7 m b.f.l. and in borehole No. 2 at a depth between 1.9 m b.f.l. and 2.1 m b.f.l. During the investigations, varied degree of the moisture content of the slag was observed: from moist up to wet and soft.

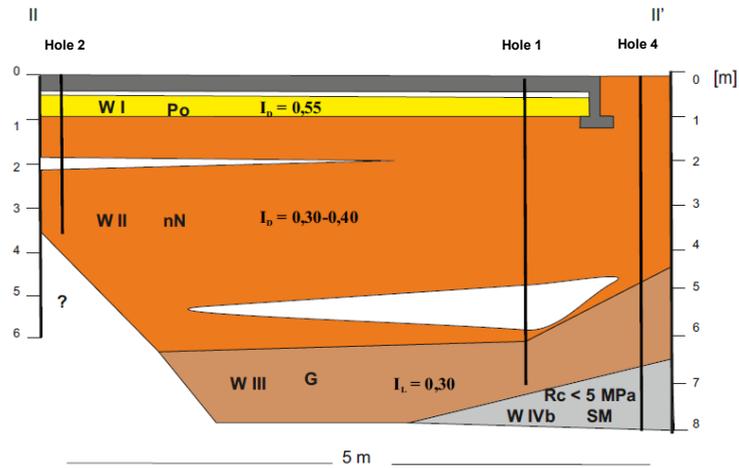
**Fig. 10.** Geotechnical cross-section II-II.

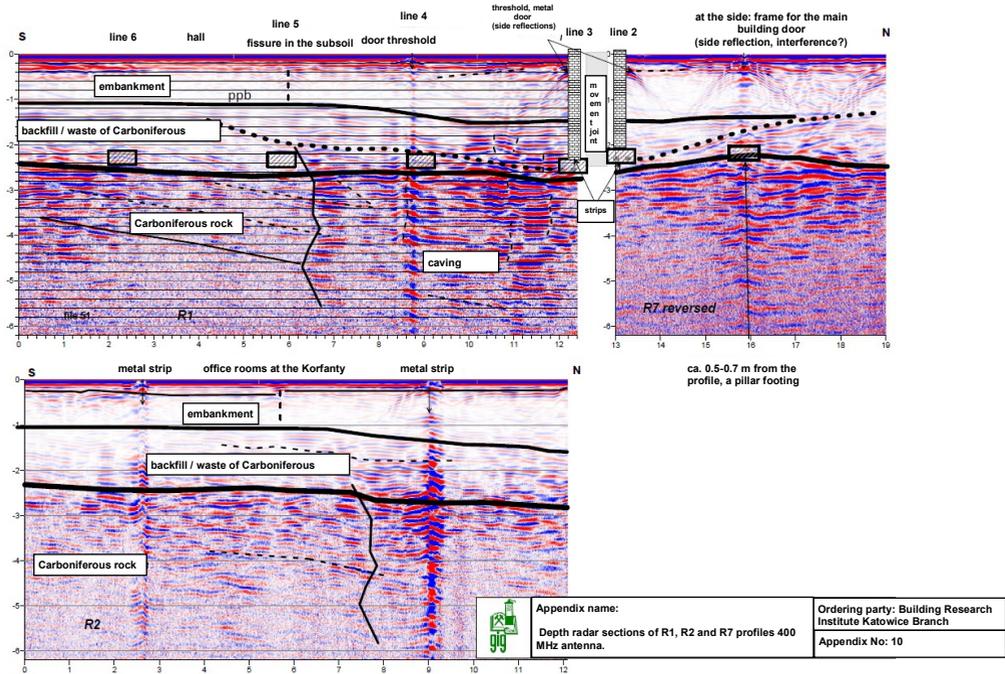
- I) A surface layer with a thickness of ca. 1-1.2 m. Foundations of floors of office rooms are in this layer. In the area of damage to structural elements (walls, concrete flooring of the ground floor), the thickness of this layer is clearly increased by ca. 0.1-0.3 m.

**Fig. 12.** Example of depth radar sections R1, R2 and R7.

II / Layer present below layer I, within a depth interval between ca. 1.0 and ca. 2.8 m. The average depth of occurrence of the layer roof is around 1.2 m. It lowers distinctly in the area of damage to the building structure. This layer is built of the soil formed as a result of weathering of the Carboniferous rock (loamy and sandy rubble).

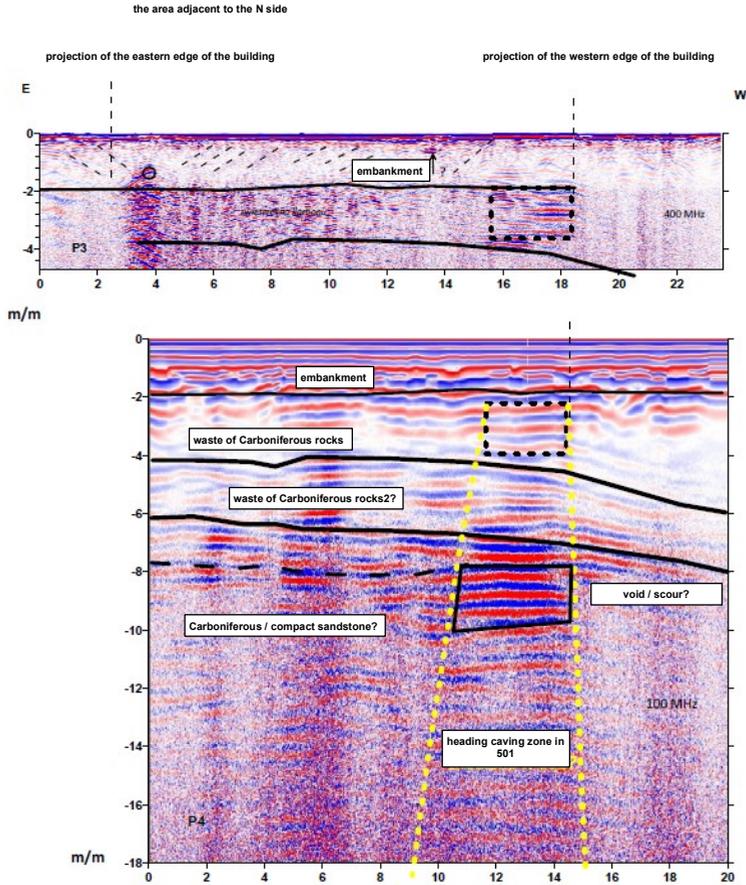
On one of the profiles (Fig. 13) at a depth of 7 to 10 m (i.e. in the layer that most likely is already a compact Carboniferous rock) a group of reflections with a relatively large amplitude was revealed. At this point, a mine heading is visible on the mining seam map. It is therefore plausible that the registered wave anomaly was caused by the presence in the Carboniferous subsoil of secondary mining voids created as a result of the heading collapse.

**Fig. 13.** Depth radar sections of P3 and P4 profiles.

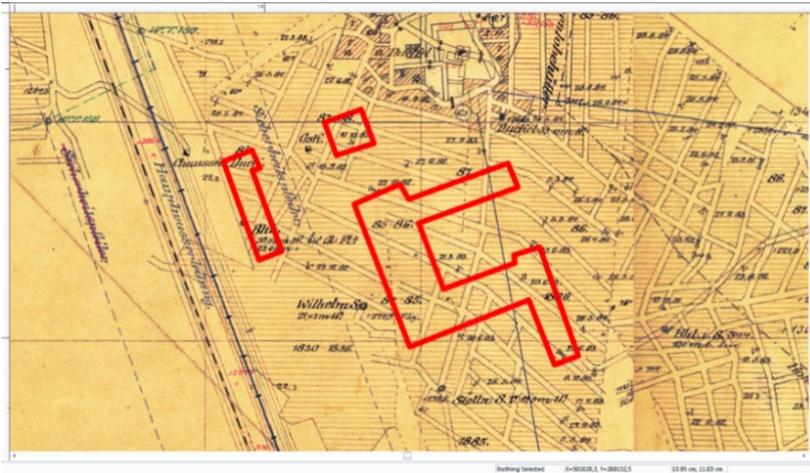
Analysis of mining data implies that the entire office building is located in the post-mining area (Fig. 14), where in the period from about 1885 until the end of the 1920s, a 6- to 7-meter-thick seam was exploited using the roof caving method. The base of this seam occurred at a depth of ca. 23 m. The exploitation was carried out using the roof and pillar system and resulted in alteration of the structure of the overburden layers. Because a thick bed of sandstone occurs between the coal seam and the original land surface, mining exploitation caused only localized cracking of it.

**Fig. 14.** Location of the building in the area of old mining exploitation.

Based on a mining map analysis it can be assumed that there were 6 or 7 mining plots in the area of the land strip covering the building plan. The plots were divided by mine headings. These headings indicate the most probable places where the continuity of the overburden layers could have been interrupted. Three of such headings are located in the area of damages in the building structure.

On the basis of the analysis of the results of geophysical surveys, it can be assumed with high probability that these headings collapsed creating primary and secondary voids at depths of around 8-10 m. The presence of voids may be connected both with the underground exploitation of the coal seam directly under the building at a depth of 15 meters or with the opencast extraction carried out in the area of outcrop of this seam (voids in the backfilling material of the open pit). Rainwater and water from the inefficient supply pipe may enter these voids and fissures causing leaching of loose soils from the subsurface layer on which the foundation strips of the building are located.

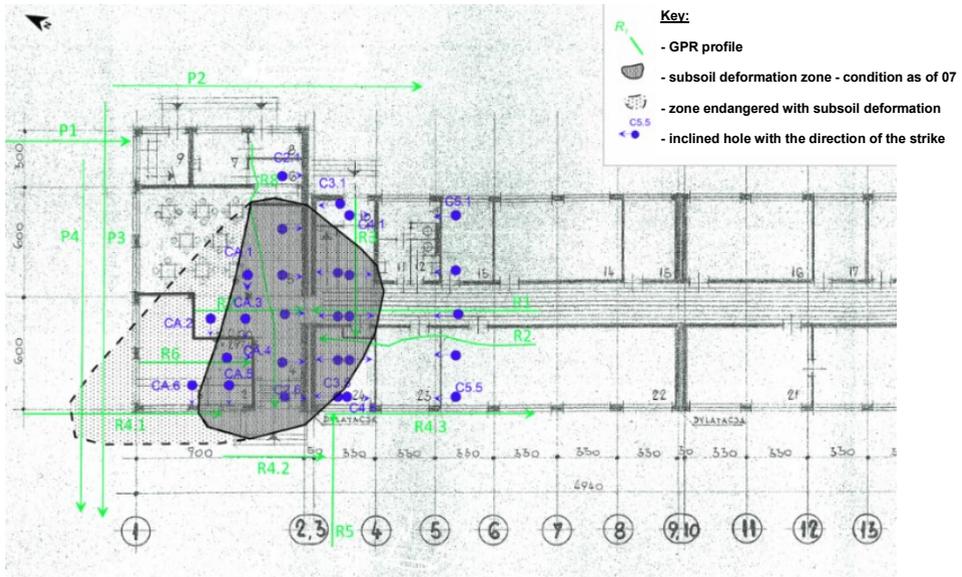
**Fig. 15.** Concept of location of injection holes to strengthen the subsoil under an existing building.

**Phase II** - will cover drilling and backfilling work in the area from the roof of Carboniferous deposits to the floor of the coal seam. As a result of this work, voids and cracks should be filled within the Carboniferous rock massif. For this purpose, it was recommended to drill 4 boreholes 25-28 m deep, whose location is shown in Fig. 15. These holes will be used to carry out filling of the voids and cracks in the Carboniferous rock massif initially with the gravity method and next using a pressure not exceeding 0.3 MPa. The injection material will be hydraulic cements made of fly ash, water and cement. These works will be carried out outside the building.
