Geotechnical failure of a slope featuring site development with industrial facilities caused by irresponsible leveling in the neighboring area

Maciej Kordian Kumor^{1,*}, and Lukasz Aleksander Kumor¹

¹University of Technology and Life Sciences, 7 Kaliskiego Street, PL 85-386 Bydgoszcz, Poland

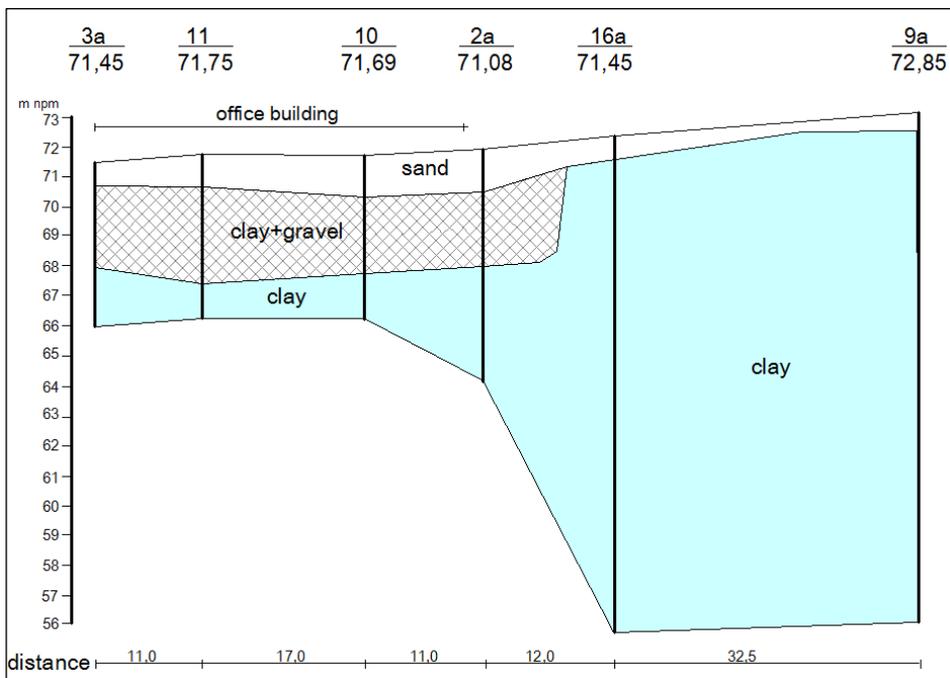
Fig. 4. Archival geological-engineering cross section according to [3].

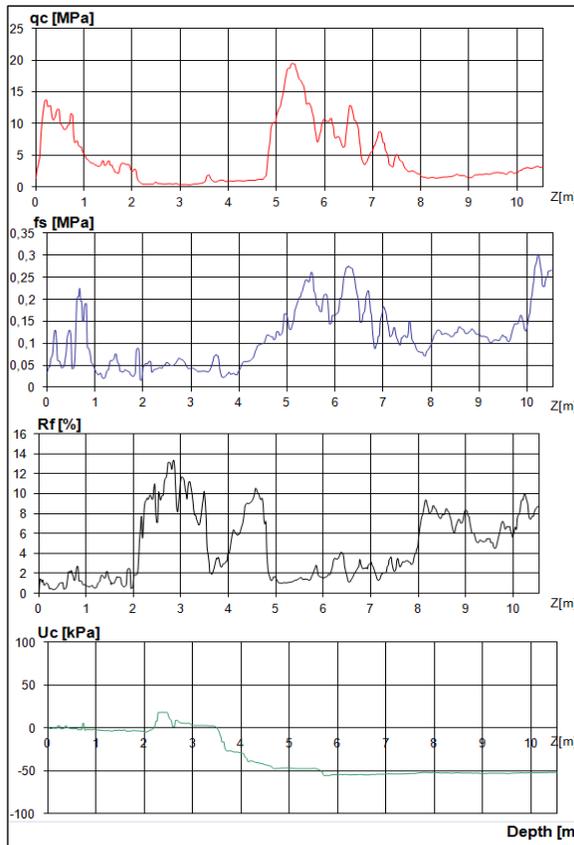
Fig. 5. Sample CPTU 1 probe testing on the slope.

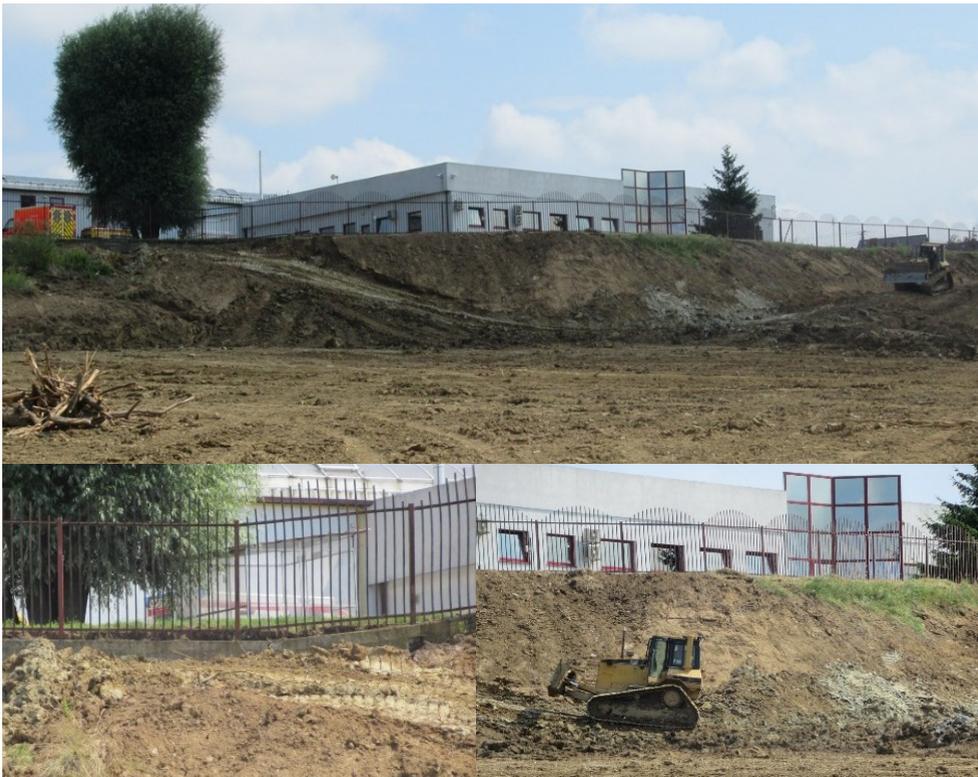
In June 2017, the owner of the neighboring western building lot, i.e. lot no. xx/11, started – without any arrangements [6] - earthworks, preparing the land for its own investment project. Cleaning works included initially tree clearing, Fig. 2, expanded successively by extensive levelling of terrain, including entries and operation of heavy equipment on the lot no. 15/10, increasing the angle of inclination of the slope and undercutting the base of the slopes, Fig. 6 and 7.

Fig. 6. Sample CPTU 1 probe testing on the slope.

Fig. 7. Beginning of landslide – caused by undercutting of the slope. Visible collapse of the fence.

It was determined that from the lot no. 15/10 and the slope running alongside the boundary with the lot no. xx/11, over 2500 cubic meters of soil were removed during leveling, which is illustrated by the panoramic view, Fig. 6.

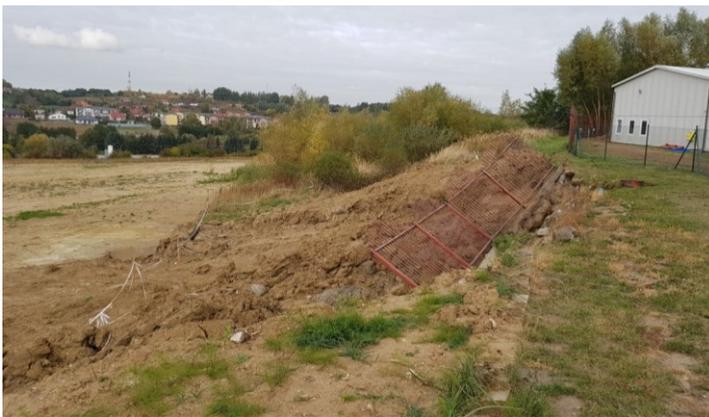
On July 30, due to continuing earthworks and dangerous disturbance of the slope stability by workers performing leveling of the construction lot no. xx/11, during leveling works, the County Inspectorate for Building Supervision was notified about a threat of construction disaster. During that time, there was a landslide along with shifting of the fence and discharge of waters from mains, threatening directly the foundation of the existing office building and production facility on the lot no. 15/10, Fig. 8.

Fig. 8. Landslide triggering – after undercutting the slope. Visible collapse of the top backfill, development of a niche and destruction of the fence.

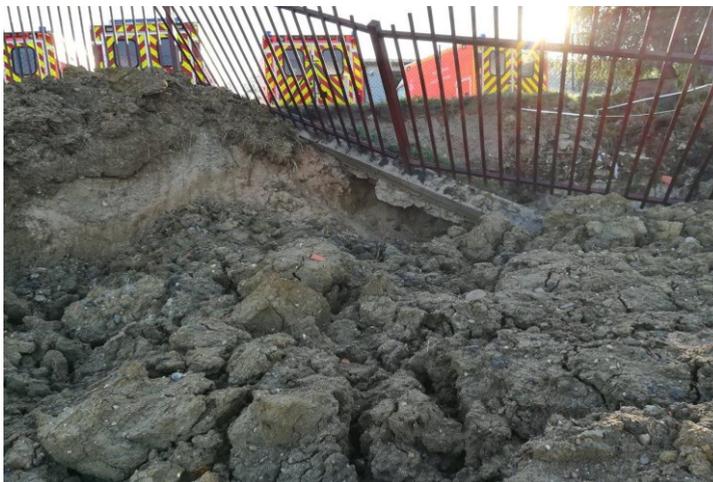
Fig. 9. Results of destruction of the top backfill of the slope as a result of undercutting the slope on the neighboring lot.

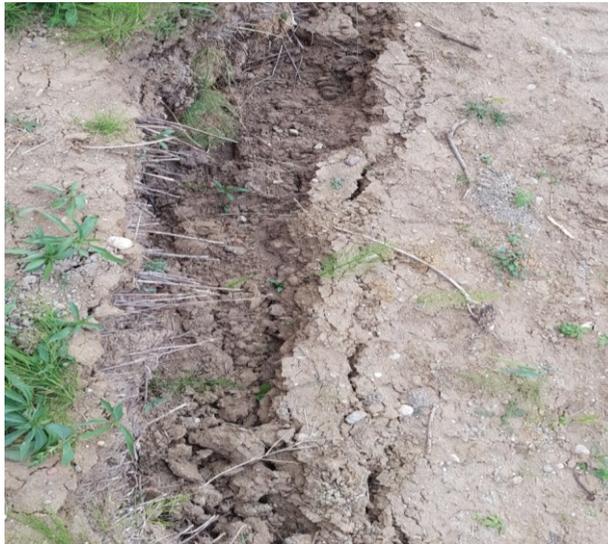
Development of surface movements of the ground massif and a down-slide movement of the slope led to destruction of the fence, interruption of continuity of the drainage system, and formation of new zones in tension, run-off and landslides of colluvial masses, Fig. 10.

Fig. 10. View of surface cracks confirming the progressing instability of the slope outside the existing wedge.

Based on results of analyses and stability calculations of the slope, as well as direct monitoring in the area (September 2018), it was stated that without design and performance of proper securing works, the local landslide that occurred on the site is in the limit state of increasing trend of random activity, Fig. 10.

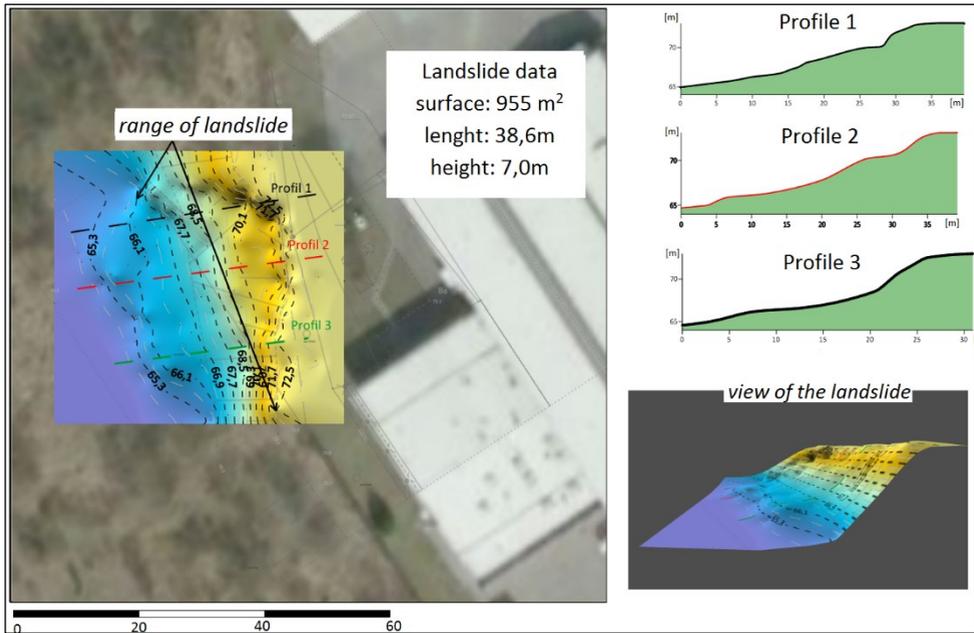
Immediately after the geotechnical failure, in September 2018, verifying geotechnical testing of the subsoil was conducted. One of the tests was statistical CPTU method at the top edge and the foot of the bottom edge, and in the area of the undisturbed slope. Stability analysis was carried out in three distinct, active cross sections outlined in the area, Fig. 11 and 12, [4, 5]. Figure 11 shows general data, extent and geometry of the landslide in relation to the office building and industrial facility.

Fig. 11. Extent and profiles of the landslide formed on the lot no. 15/10 in the proximity of buildings.

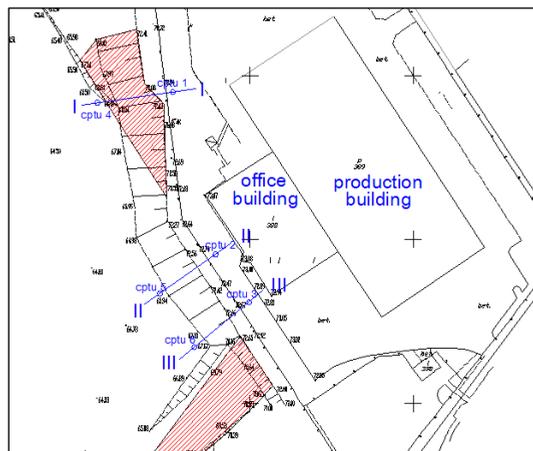
Sites of CPTU tests for statistical analysis were located in the zone of slope undercutting and disturbance of stability of the slope as well as the initial, stable area. In addition, the extent of active, newly formed colluviums was inventoried, Fig. 12.

Fig. 12. Extent of newly formed colluviums and testing sections of the landslide on the lot no. 15/10 in the proximity of buildings

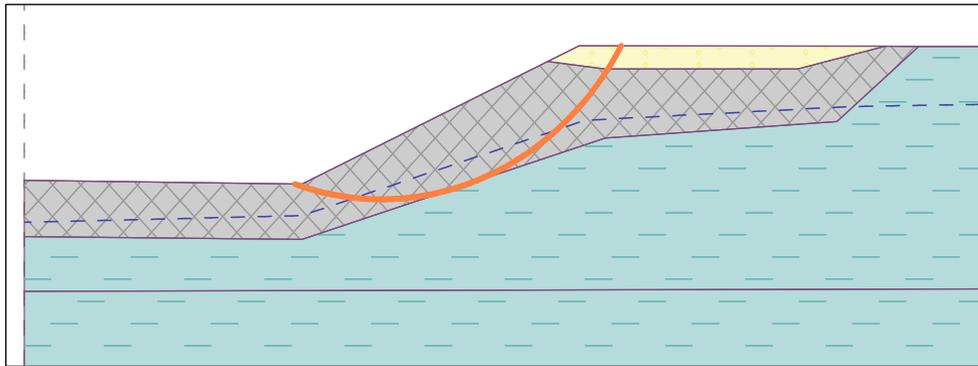
Bishop :	Used range = 81,2 %	Requirement met
Fellenius / Petterson :	Used range = 87,2 %	Requirement met
Spencer :	Used range = 81,4 %	Requirement met
Janbu :	Used range = 81,4 %	Requirement met

Fig. 13. Cross section of the slope I-I on the site of landslide. The original condition. Simulation with additional water flow pressure – stable slope.

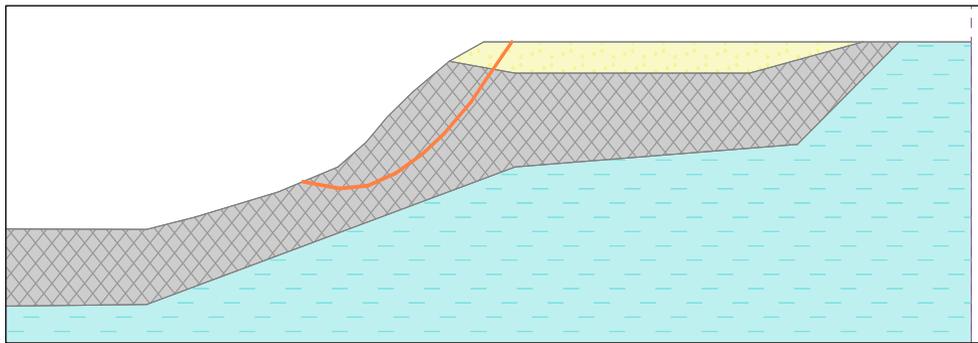
Sarma :	Used range = 101,1 %	Requirement not met
Spencer :	Used range = 104,6 %	Requirement not met
Janbu :	Used range = 105,4 %	Requirement not met
Morgenstern-Price :	Used range = 105,4 %	Requirement not met

Fig. 14. Results of slope stability analysis I-I on the site of landslide occurrence, Fig. 8, 9, without taking into account flow pressure of groundwater. Unstable slope.

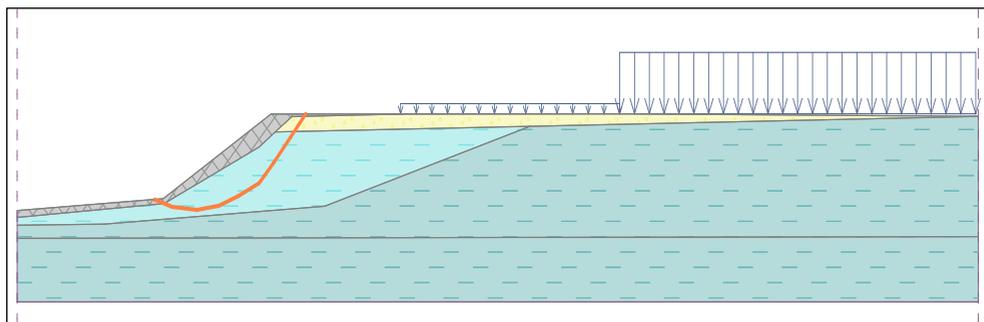
Sarma :	Used range = 74,2 %	Requirement met
Spencer :	Used range = 74,9 %	Requirement met
Janbu :	Used range = 75,2 %	Requirement met
Morgenstern-Price :	Used range = 75,2 %	Requirement met

Fig. 15. Cross section II-II in the proximity of the existing office buildings. Despite undercutting of the slope, the massive is stable. There is no threat to the office building, Fig. 12, 8.

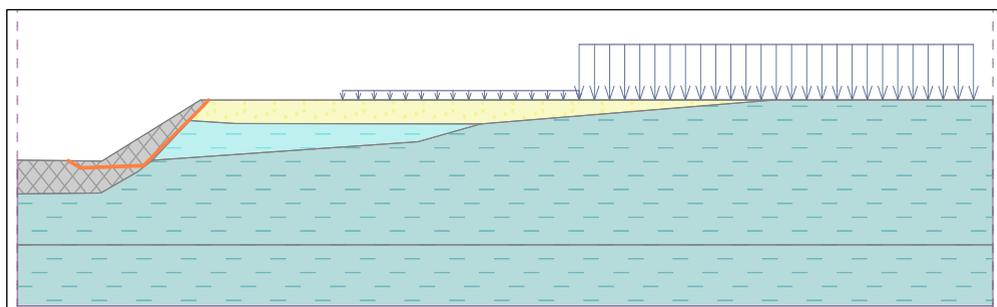
Sarma :	Used range = 61,2 %	Requirement met
Spencer :	Used range = 59,0 %	Requirement met
Janbu :	Used range = 59,5 %	Requirement met
Morgenstern-Price :	Used range = 59,5 %	Requirement met

Fig. 16. Cross section of the slope III-III alongside the existing buildings. Despite undercutting of the slope on the neighboring lot, the landslide is stable, Fig. 9, 12. There is no threat to the office building.
