Rectification and stabilization of the foundation as an opportunity in reference to preventing construction failures as regards transformer station facilities located on a wind farm

Abstract. In the paper, the results of inclination measurements of 9 transformostation objects are presented. The inclination was caused by uneven settlement of the ground below the foundation level. The causes of uneven settlements are described and the method of performed rectification works is presented.

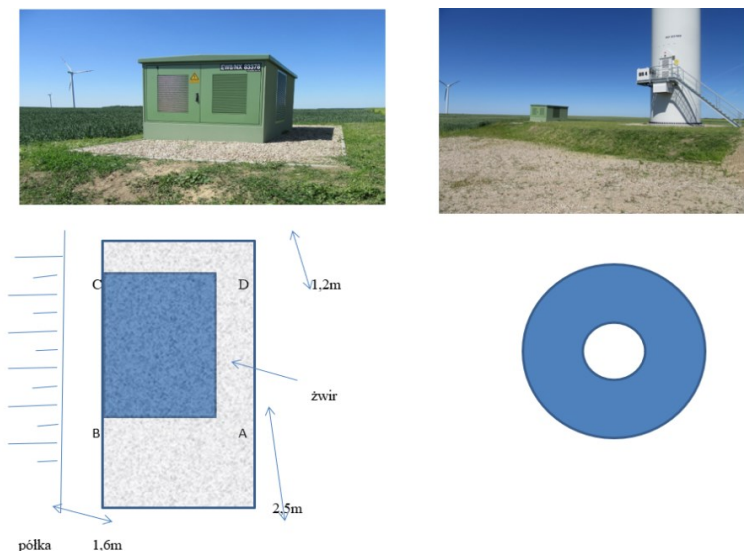
Case study within the aforementioned project included a case-by-case analysis of tilting in reference to transformer station objects due to the displacement of soil under the block foundation of a wind turbine.

Fig. 1. Diagram presenting transformer station and wind turbine system.

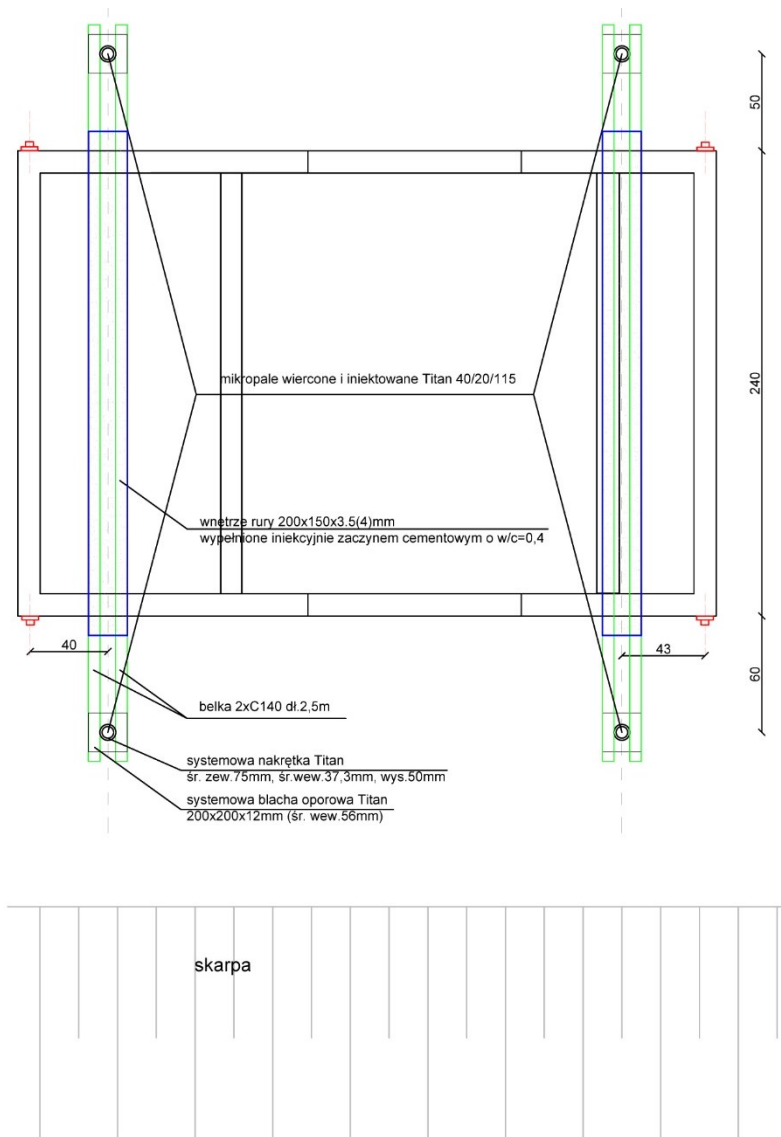
Fig. 2. Projection of the rectified transformer station according to [2].

The project presents a manner of discontinuing further settlements of facilities on their foundation on Titan drilled and injected micro-piles. They ordered straightening (plumbing and levelling) applying controlled lifting of the foundation slab corners using steel beams supported by micro-piles located at their edges. The described procedure was conducted using hydraulic cylinders with load capacity and proper impact adjusted to the existing conditions. The comprehensive technology of stabilizing and rectifying objects utilized the assumption of using small-size machines and devices which are able to operate and move manually by people. The use of heavy machines and equipment was to be limited.

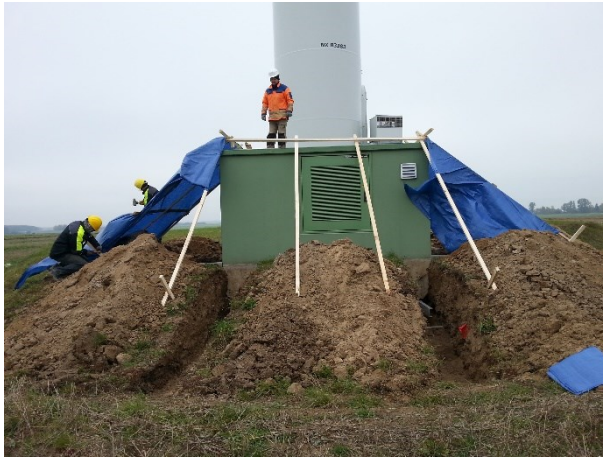
Fig. 5. Rainwater protection concerning the transformer station area.

- ✓ Geodetic measurements concerning the height as regards the bank area around the relevant transformer station,
- ✓ Scraping the covering layer of gravel and preventing its contamination with soil,
- ✓ Excavation of the transformer station in four corners as well as along the installation edge reaching the depth of about 20 cm below the foundation level,
- ✓ Cleaning the bottom surface of the bottom transformer station plate, the widths of approximately 30 cm along the installation edges, by cutting concrete balance layers, thickness ranging from 5 to 15 cm,
- ✓ Installation of temporary rain covers over the facility, this included excavations and soil deposits, polypropylene tarps 6x4 m, coniferous timber 60x40 mm and stranded cables $\Phi 4.5$ mm were applied.

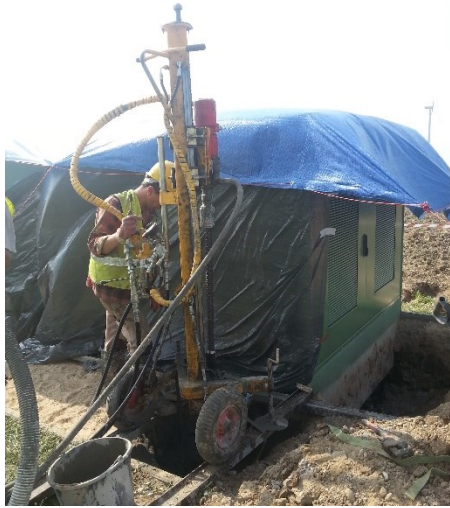
Fig. 6. Installation of micro-piles.

- ✓ Displacement of steel pipes with cement mortar stabilization under dug edges of transformer station,
- ✓ Inspection and verification concerning the ground under transformer station in reference to compliance with the project, it was done by implementing manual geological holes reaching the depth of 6 m along with the documentation of these holes,
- ✓ Location and assembly of 4 items/Titan 40/20/115 micro-piles onto station in the ground, average length of 7 m, applied technology observes ITB Technical Approval no. AT-15-6416-2010.

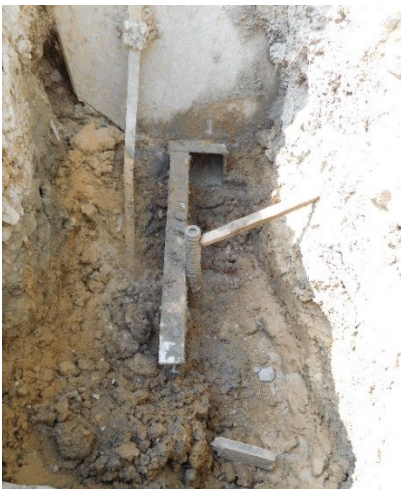
Fig. 7. Installation of steel beams 2xC140.

- ✓ Installation of 2xC140 steel beams in a steel protective tube, pre-support of the edges using Titan sheets and caps, initially lifting the lower nuts reaching the limit of human strength.

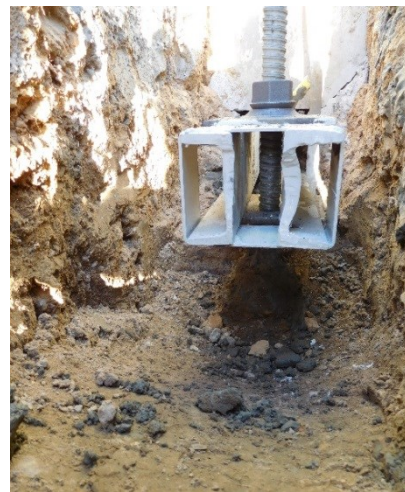
Fig. 8. Supporting support beams on micro-piles.

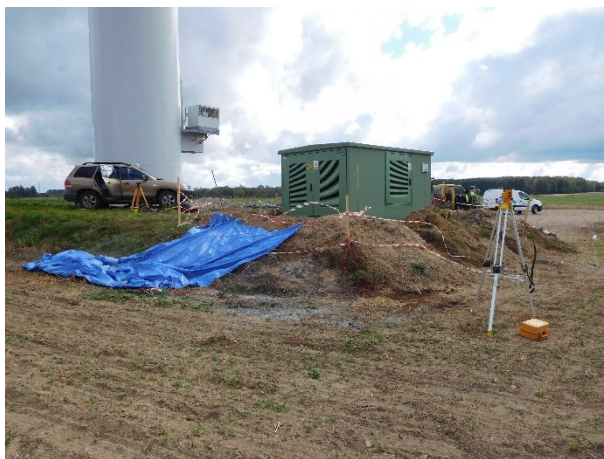
Fig. 9. Control of lifting using two levelling instruments.

- ✓ Placing the servomotors under the steel beams following the instructions of the Works Manager, procedure starts with lifting the corners located at the lowest points by controlled pressure increase using manual high-pressure hydraulic pumps with simultaneous continuous control of the observed transformer movements on two levels adjusted diagonally as regards the object,

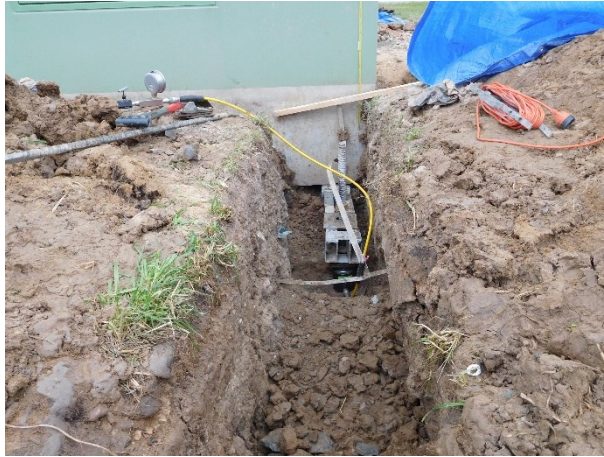
Fig. 10. Lifting the corner using a hydraulic cylinder and a manual pump.

- ✓ Conducting rectification works involving the change of the pressure and the point of applying the forces in the servomotors. At the same time one conducted overlocking and locking of nuts and system plates located on the micro-piles until one obtained the effect of levelling the transformer station or achieved the best effect due to the limited tension of energy cables originating from the ground and entering the inside of the transformer station. Cable tension was tested visually as well as based on the behaviour of nuts on tight cable glands passing through the wall of the facility. Loosening/dislocating the nut served as a signal to discontinue rectification and repair the cable gland. The repair concerned three objects designated with numbers EW8, EW7 and EW6. The process involved unscrewing the cable gland, correcting the position in the hole, applying permanently plastic putty peripherally, then screwing the nut back onto the cable gland. Repair work concerning tight cable routes was conducted based on the request and under supervision of the Representative of the Investor.

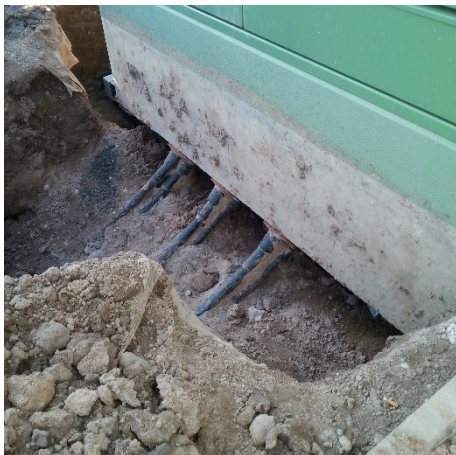
Fig. 11. Tightening power cables.

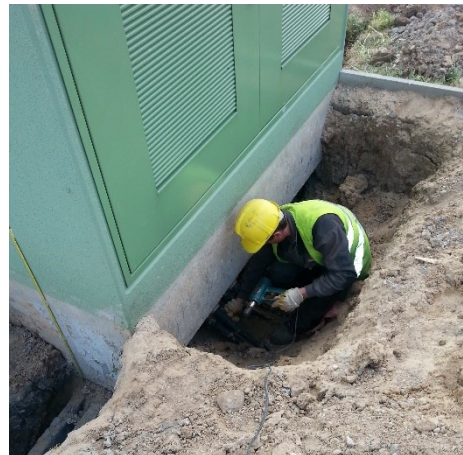
Fig. 12. Sealing cable entries after lifting.

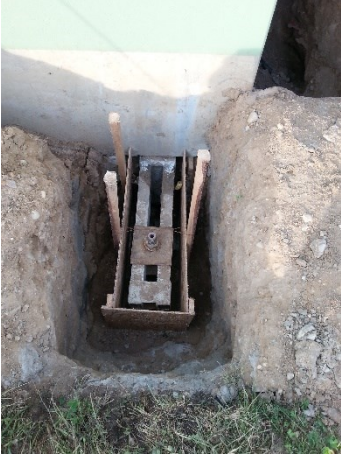
Fig. 13. Formwork for beams after rectification.

- ✓ Altitude control measurements conducted 24 hours after the termination of rectification activities and support on micro-piles,
- ✓ Concreting steel ends of 2xC140 beams within formworks to establish a buffer around steel min. 7 cm using a mixture of C 20/25 W concrete with an admixture of ANTIFROST 45 application of corrosion inhibitor at the construction site using a concrete truck, the amount of 12 kg per 1 m³ of mix.

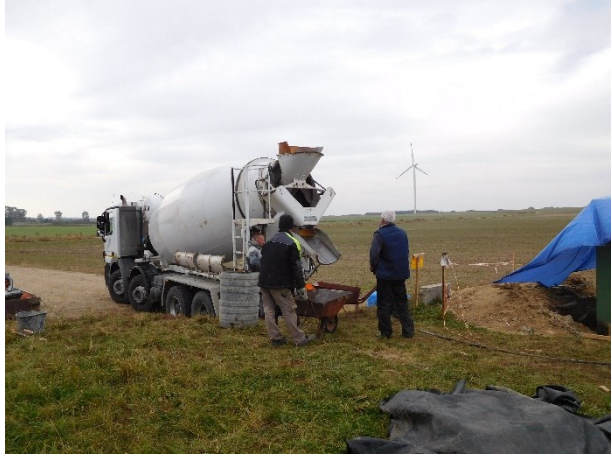
Fig. 14. Concreting.

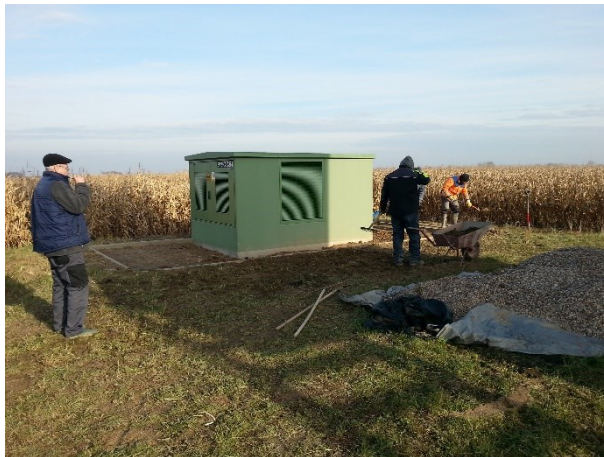
Fig. 15. Backfill after the repair.

- ✓ Covering steel injection-tube beams in 6 points located under the bottom plate of the transformer station and at the transition points, this procedure involved 4 on the lifting side 2 on the opposite side,
- ✓ Backfilling the excavations located around the station using the material originating from excavations, reconstruction of foil signs over cables - red on sN side, blue on the nN side and reconstruction of concrete edges on the concrete bench situated around the transformer station,

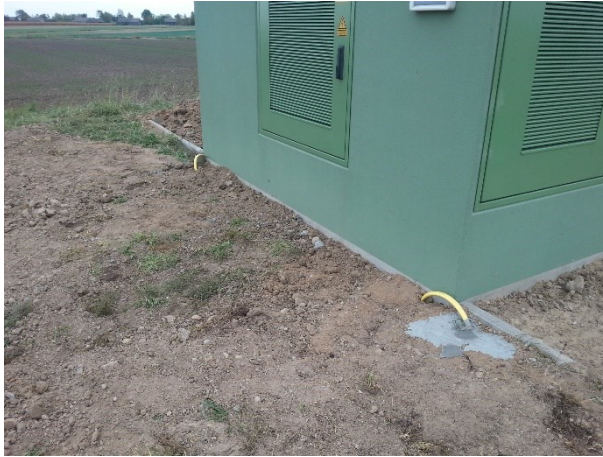
Fig. 16. Injection used to fill any voids under the plate.

- ✓ Conducting the injection of cement paste $w/c = 0.7$, this was done by installing the injection tubes previously covered with earth material. ANTIFROST 45 in an amount of 1% in relation to the cement mass was added during the mixing process. The average consumption of grout per one facility amounted to 400 dm³ and the injection was conducted until one noticed the flow of liquid grout through the tubes placed on the opposite side of the station.

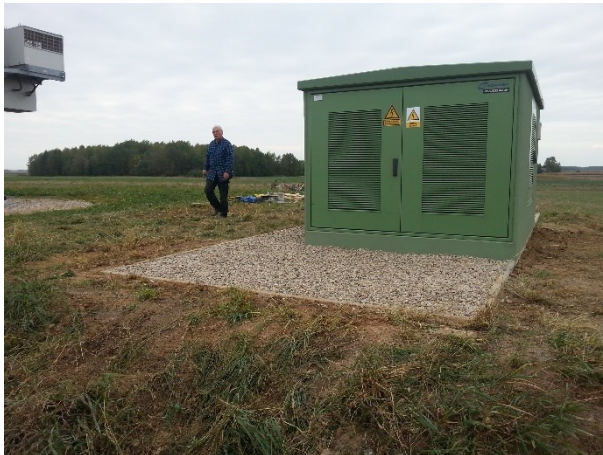
Fig. 17. Restoration of the work area after completing the works.

- ✓ Mechanical densification of the bank, manual levelling as regards the slopes and crowns of the bank, sowing grass.
- ✓ The card below presents the course of the rectification process.
