Causes of failure of a four-storey building and the reconstruction concept

Abstract. The article presents causes of failure of a four-storey building of a complex structure. It reviews the causes related to soil features, foundation works and construction design of the facility. The article rationalizes the concept of soil improvement using the jet-grouting technology and suggests eliminating the process of flooding and damping basements of the building.

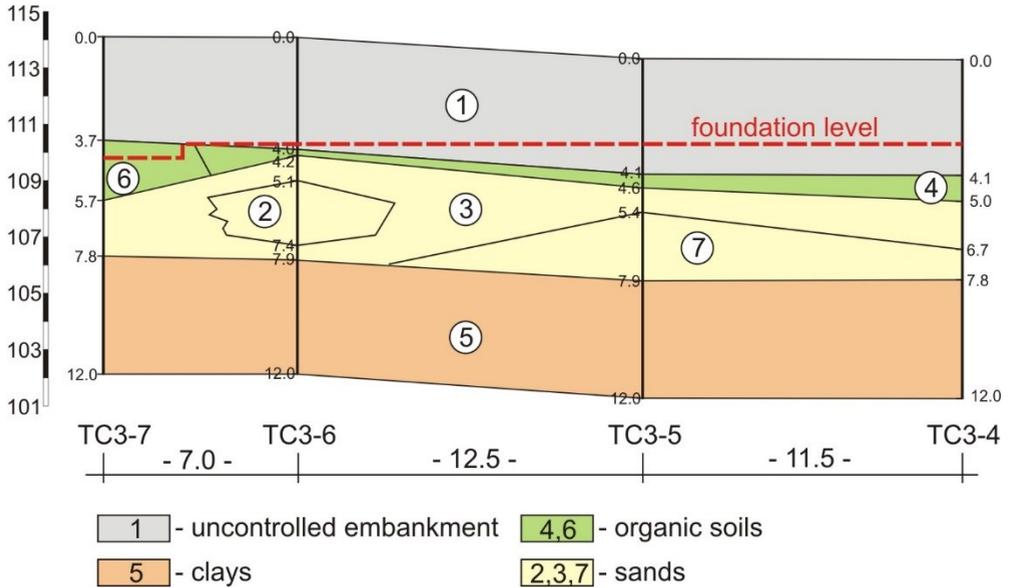
Fig. 3. Geotechnical profile of the soil.

Having examined the geotechnical cross-section (Fig. 3), it is apparent that the foundations of part B of the parish house were placed in the layer of organic soils and embankments of highly unfavorable strength and deformation parameters.

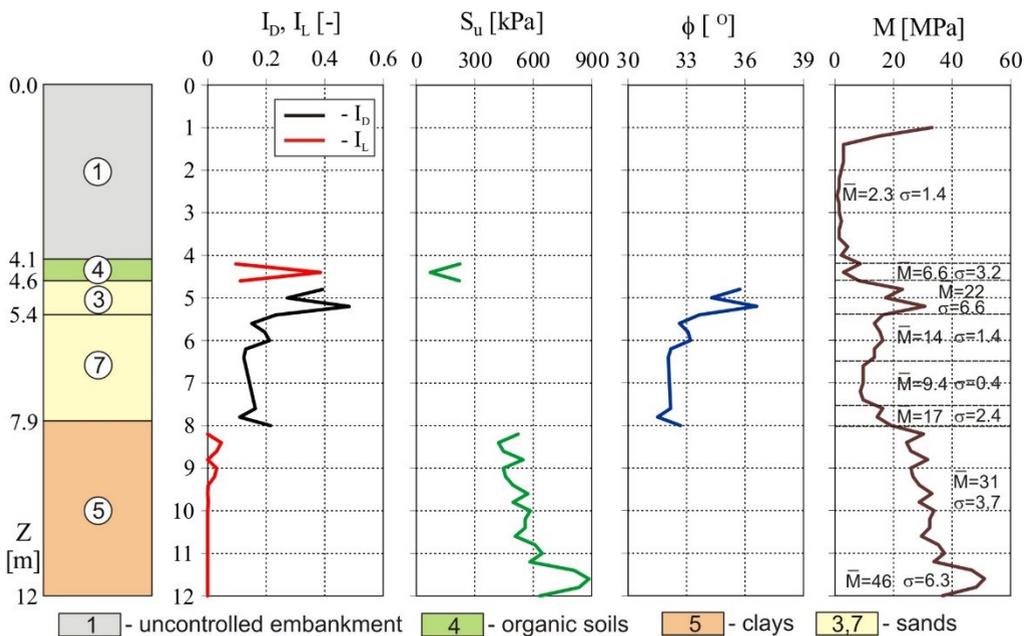
Fig. 5. Strength and deformation parameters of soil from the cone penetration tests.

For the silty sands found in the soil, in layer 4 with an admixture of organic soils, the s_u values were calculated with the $N_k = 19$ factor (Fig. 5). The determined values of s_u in layer 4 classify it as soils of low shear strength according to PN-EN ISO 14688-2, whereas loamy sands of layer 5 can be classified as soils of high or medium shear strength.

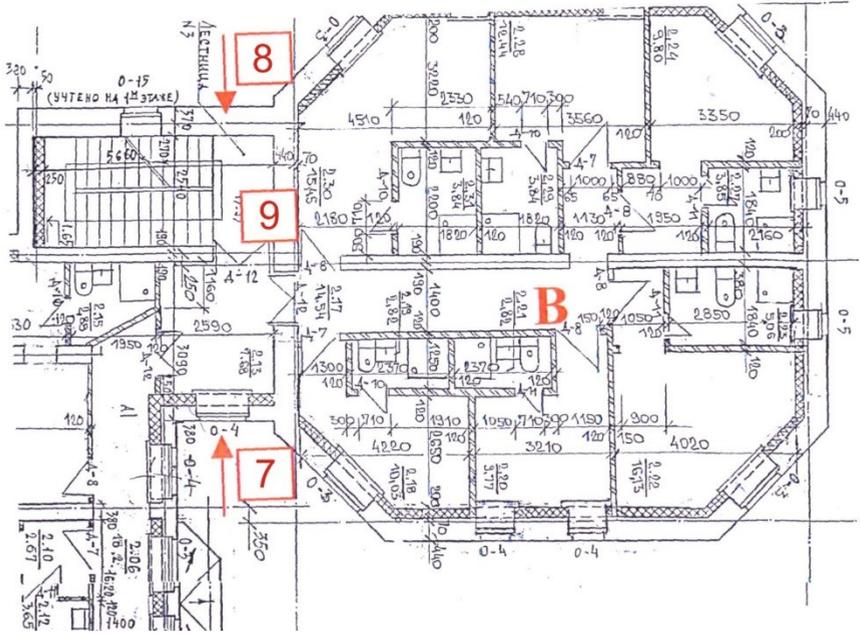
Fig. 6. Location of images 7, 8 and 9 showing scratches on the walls and basement floor.

Particular attention was paid to very characteristic scratches in the area linking the northern part A and southern part B of the building (Fig. 6). The analysis of the nature and type of deformations that ensued on the structure of the linking part lead to a conclusion that both part A and part B of the building behave in a distinctive manner.

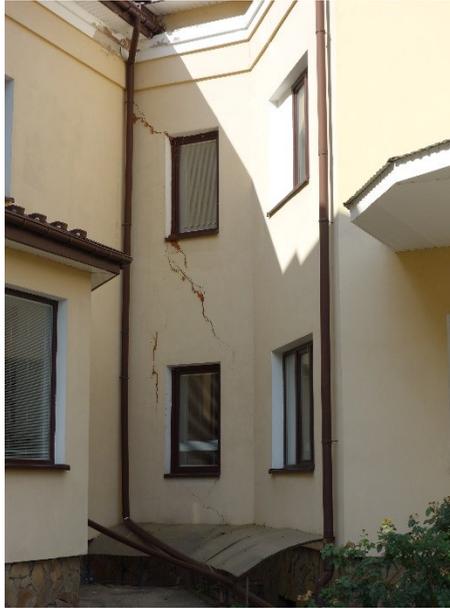
Fig. 7. Scratches on the external wall of the staircase (condition as of 09.07.2018).

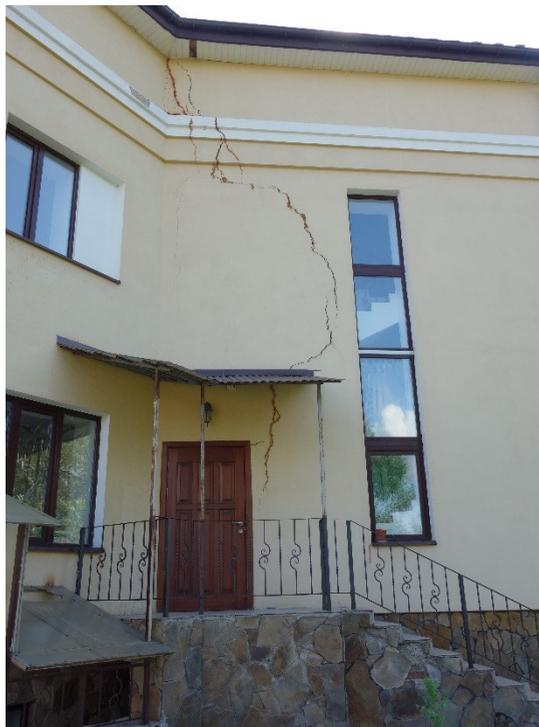
- a higher number of scratches, distributed in different places and rather moderate in size, are characteristic for the northern part A,
- the southern part B is characterized by significant settlement, which is related to the whole octagonal construction of this part of the building; settlement is diversified and the whole construction leans to the south as a result. This only proves the conclusion that soil conditions found under the building foundations are diversified.

Fig. 8. Scratches of the external bearing wall of the linking part between the northern and southern part of the building (condition as of 09.07.2018).

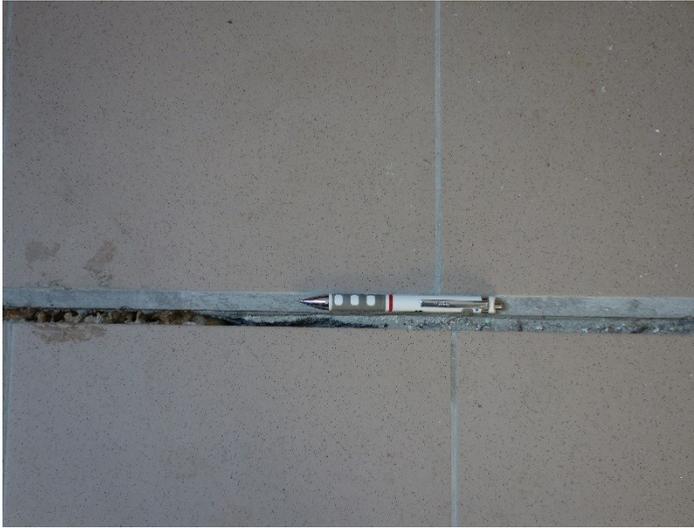
Fig. 9. Crack (approx. 30 mm) found on the floor between the stairs and the ceiling (condition as of 09.07.2018).
