The delayed effects of flooding a residential building – case study

Abstract. The work describes the case of a single-family residential building, which suffered a breakdown due to flooding. Flooded water in the nearby watercourse, did not reach the building directly, but in its vicinity, but raised to a very high level the local groundwater table, which reached locally, even above ground level. This condition was maintained over a longer period of time, causing the soil moisture to rise, and thus its geotechnical parameters deteriorated. The consequence of this, the building underwent an uncontrolled and uneven settlement, which was accompanied by the formation of cracks on the walls. The effects of failure were presented and an attempt was made to identify possible causes of failure. Own study of the substrate was carried out in "in situ" conditions and verification of laboratory tests, and their results are presented on relevant charts and tables.

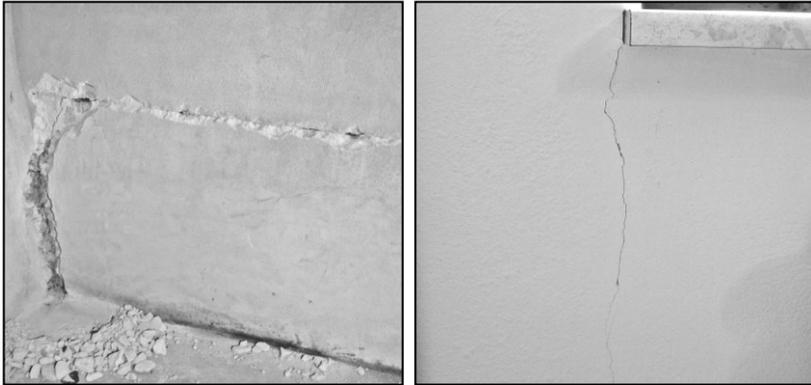
Damage to external walls was mainly observed in the form of "stair step" cracks in north-west corner and horizontal cracks between the windows at the height of the lintel on the south facade. Fine cracks appeared on wall of west facade. Vertical foundation cracks about 3mm emerged mainly in corners of cellar and at the level of horizontal dump insulation they changed direction to parallel to it. Inside the building on the ground floor level, scratches occurred in a different arrangement on all walls. The most serious were the oblique and "stair step" cracks features going through almost the entire wall and changing direction to levels just below the ceiling. Vertical cracks from window corners to floors and independent horizontal at different heights from the floor were also observed. The width of the cracks on the interior walls of the building generally did not exceed 2mm. Due to the wide range and size of the cracks, the investor has taken steps to assemble a simple crack monitoring installation in the form of glass strips glued by resin to the wall and gypsum seals. Observations have shown that the opening of individual fractures is progressive. About 50 seals have been installed from which 70% were damaged. New small cracks and cracks were also observed. This has confirmed that the settlement process of the building has been started and continues. Exemplary cracking of walls of cellar and first floor shows Figure 2 and 3.

Fig. 2. Exemplary cracking of walls of cellar.

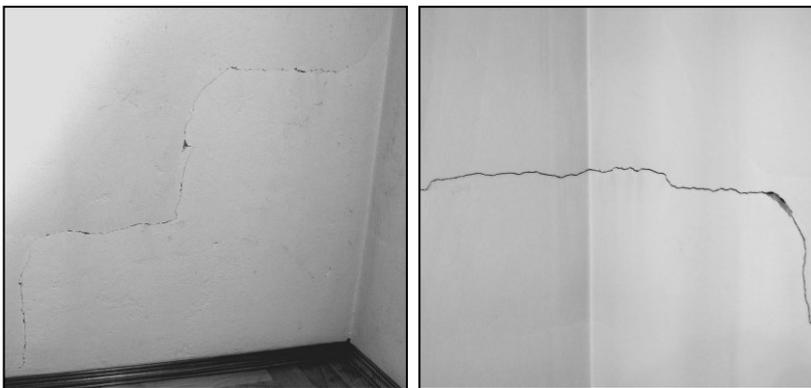
Fig. 3. Exemplary cracking of walls of first floor.

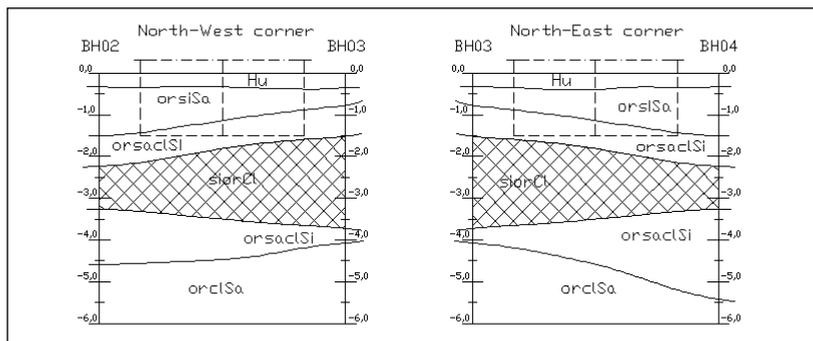
Fig. 5. The exemplary cross-section showing soils layers under N-W and N-E corners of building.

The weakest layer composed of soils with the highest content of organic parts siorCl (silty organic clay - warp) clearly appears on the cross-sections, which has the shape of a lens positioned in the north-south direction. Its largest thickness (1.75-2.25m) was observed on the Borehole BH01-BH03. Additionally, within the Borehole BH01, two further, smaller lenses with a thickness of approx. 0.5 to 0.75 m were located. In the east and west directions of the BH01-BH03 line, the lens reduces the thickness to approx. 0.75 m next to the BH02 and BH04 bores. Layers of soft soil are mainly surrounded by silty soils containing a small addition of organic parts (orsiSa – silty sand with organic substance, orsaciCl – silty clay with sand and organic substance, orclSa – clayey sand with organic substance). During the measurements, the location of the groundwater table level was set at a depth of 2.25 to 3.45 m below soil level. The soil-water conditions were extremely complicated and the building could have been subject to uneven settlement from the very beginning. Laboratory tests have shown that the weakest layer is siorCl with consistency from very soft plastic to plastic. Detailed information on the value of selected geotechnical parameters of the separated layers is presented in Table 2.

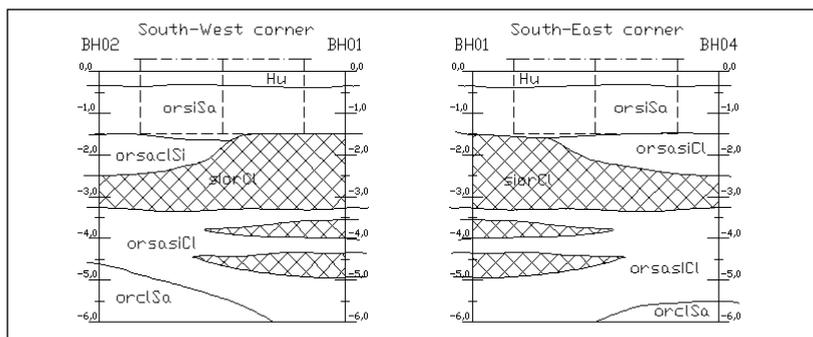
Fig. 6. The exemplary cross-section showing soils layers under S-W and S-E corners of building.
