Discontinuous terrain deformation - forecasting and consequences of their occurrence for building structures

Leszek Szojda^{1,*}, and Grzegorz Wandzik¹

¹Silesian University of Technology, Department of Structural Engineering, 44-100 Gliwice, Polska

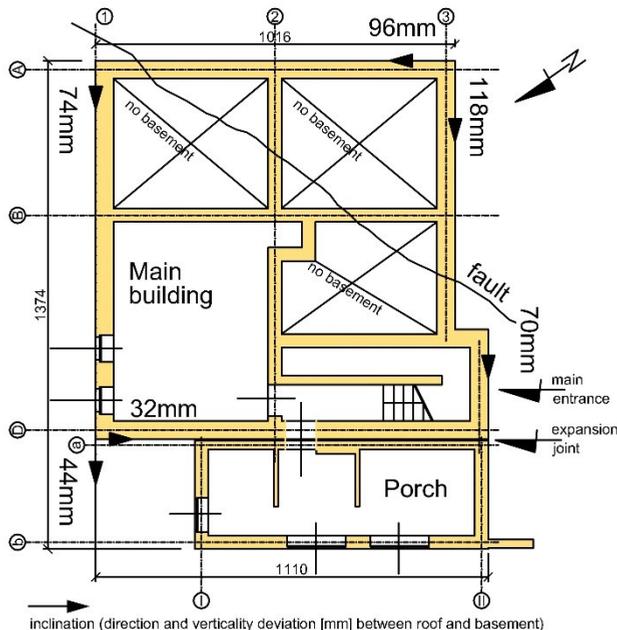
Fig. 2. The basement walls plan and fault location [3].

In addition to continuous deformations (horizontal axial strain and the curvature), a terrain fault directly crossing the building was revealed. The mine have measured the terrain subsidence since 1975. The fault was revealed twice - in 1998 and 2003. The approximate course of the fault is shown in Fig. 2. About 10 cm settlement covers about 70% of the building plan. The fault was resulted by the heterogeneous structures of the rock mass and overburden in this area. The variability of hydrogeological conditions characterized by significant changes of groundwater levels were recognized as an additional reasons of the fault.

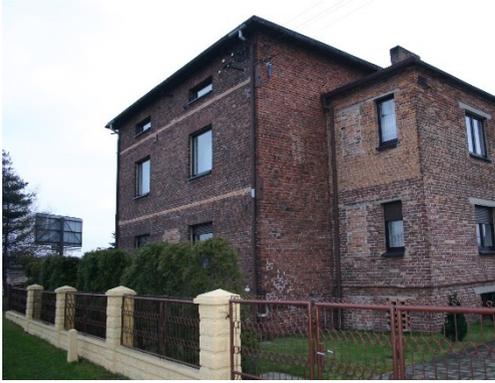
Fig. 3a. View of the building with strengthening in the floor level [3].

There were three kinds of damages observed in the building:

- cracks in walls in all rooms on all storeys,
- leaning of the building,
- damp of walls in the basement.

The repair of the object consisted in renovating of the cracked walls and strengthening the structure by using steel ties in the level of floors. Figures 3a and 3b show complemented wall fragments (brighter fragments). The lean of the building was treated as relatively small and thus object was not rectified. Only the floors were leveled and the joinery was adjusted. The building is still in operation.

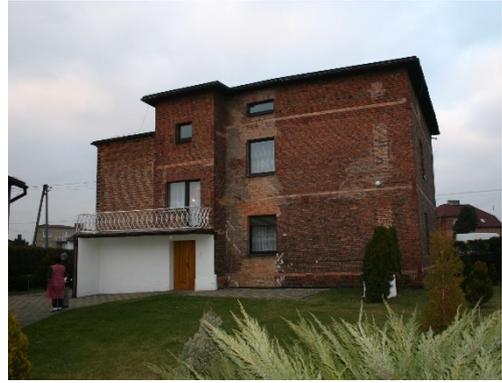
Fig. 3b. View of the building with damaged masonry walls rebuild and strengthen [3].

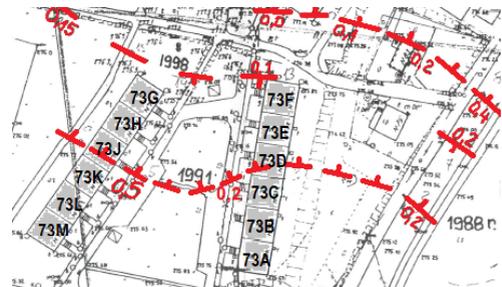
Geological expertise carried out after the completion of the estate have revealed the occurrence of many tectonic faults in this area. In addition, about 200 m north of buildings there is a railway line with a meridian course. It was covered against mining damages using technique known as protective pillar. The whole mining operation took place north of the protection pillar zone. This caused activation of faults due to the concentration of stresses in the rock mass. In the past (1988, 1991 and 1995), 8 latitudinal terrain steps with height from 0.05 m to 0.5 m were registered. Fig. 5 shows faults in the area of estate. The most endangered by terrain thresholds are segments *J* and *C*, under which the height of steps amounted to 0.5 m and 0.2 m respectively.

Fig. 5. Terrain faults with regard to buildings location [4].

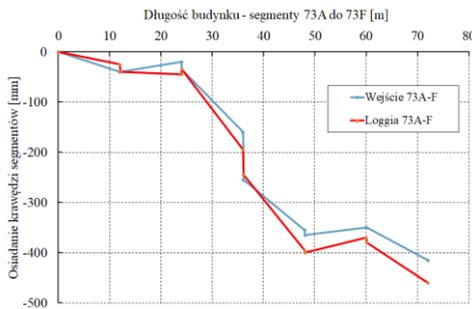
Leveling measurements in the level above the basement floor showed very significant uneven settlements. The most distinct settlement differences were concentrated in the vicinity of segments *C* and *J* (Fig. 6 and 7). The largest displacements correspond to the course of the fault (shown in Fig. 5). Structural damages were concentrated in the basement storey, where the cracks in reinforced concrete walls reached 20 mm. In above-ground storeys, cracks were distinctly smaller and occurred in joints of prefabricated elements - mainly between walls and floor. An exemplary cracks pattern is shown in Fig. 8.

Fig. 6. Settlement of segments 73A to 73F as a result of the levelling [4].

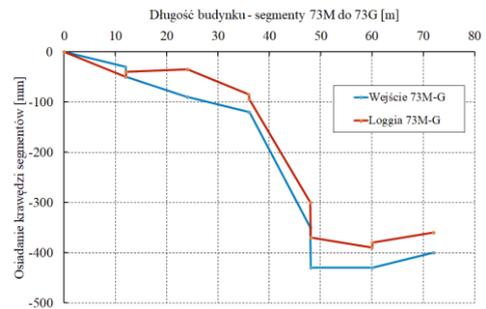
Fig. 7. Settlement of segments 73M to 73G as a result of the levelling [4].

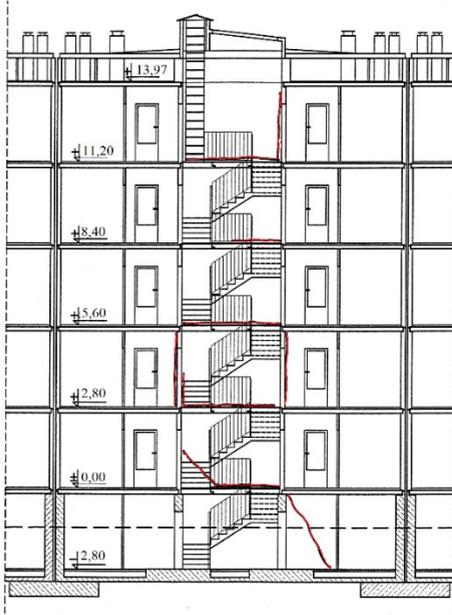
Fig. 8. Cracks pattern in prefabricated panels and joints - segment 73D [4]. **Fig. 9.** Demolition works – segment 73D.

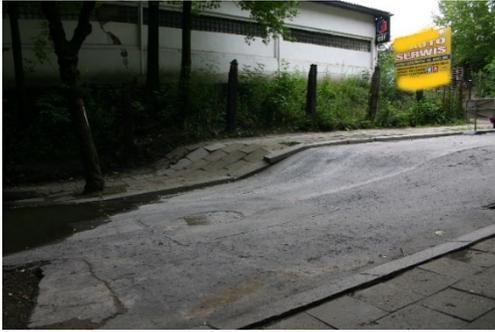
The described landslide was created during one night in the middle of the street. The vertical displacements difference exceeded 1.2 m – see Figure 10. Car workshop building located in the vicinity has been seriously damaged. The statically determinant load-bearing steel structure of the hall was not damaged, but it underwent considerable deformations. Large deformation of non-bearing filling walls supported on the strip foundation caused fractures and cracks opened up to 2.5 cm – see Fig. 11. The floor of the workshop was strongly deformed, and its further use became impossible. The owner had received compensation for the resignation of the workshop use.

Fig. 10. Landslide crossing the street.

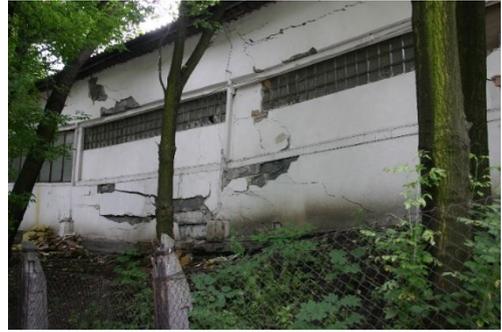
Fig. 11. Damages of the external walls of hall building.
