Causes of damage and methods of repairing floor made on polystyrene concrete

Abstract. The paper describes damages, tests and repair of the floor made on existing ceiling and expanded polystyrene concrete underlay. The floor was built on a reinforced concrete ceiling with an area of about 1050 m². Significant damage in the form of cracks, detachments and unevenness was found in the floor. In order to determine the causes of damage, in situ tests and laboratory tests were carried out. It was found that the damage was caused by numerous performance errors. A test repair of the damage (4.7x6.0 m) was carried out, and then the repair method was applied on the entire floor surface.

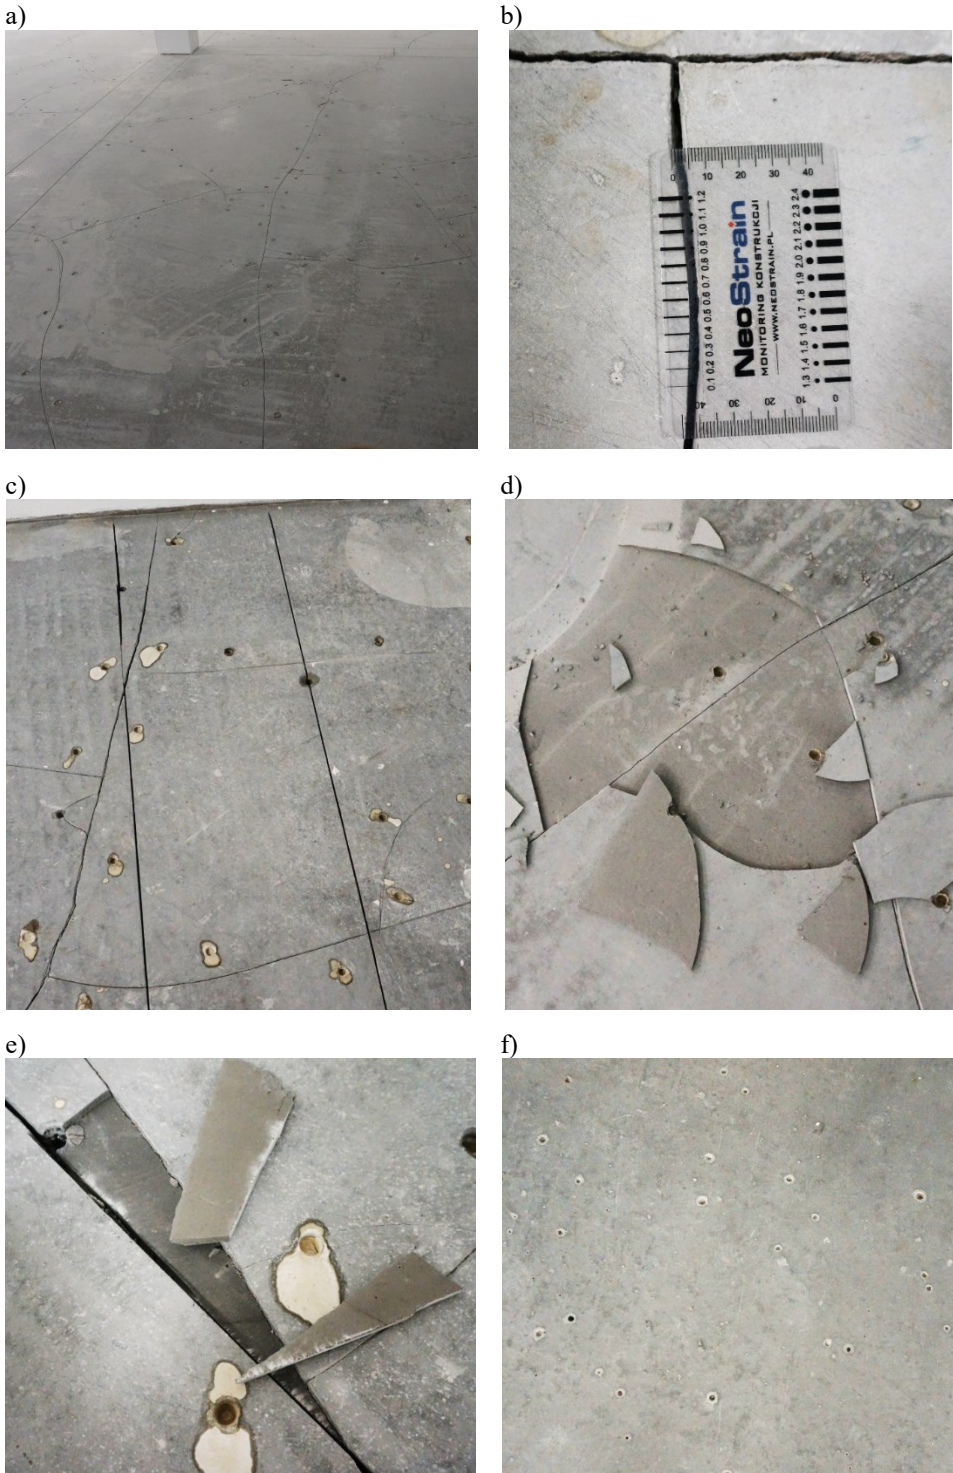
Already a few hours after the screed was made, numerous cracks have appeared on the surface. Additionally, top layer detachment as well as lack of homogeneity were observed. The crack width often exceeded 3 mm. The cracks occurred both on surfaces of self-levelling screed over the EPS concrete layer and concrete poured over reinforced joists. Near the joists the cracks propagated down to the layer of the EPS concrete.

Visual inspection determined several performance errors, including uneven thickness of screed and EPSC, lack of precision in the execution of expansion joints and stratification of the concrete (up to three layers). The floor was clearly uneven - the slope of several slabs reached up to 16 mm/m, while spacing under two-metre-level and floor was up to 7 mm. It was observed that floor cracks protruded beyond expansion joints, which proves that the cuts were made too late.

Fig. 4. Damage type: a) cracking, b) crack width measurement, c) cracks protruding through expansion joint, d) e) self-leveling layer detachment, f) pores caused by improper mixing.

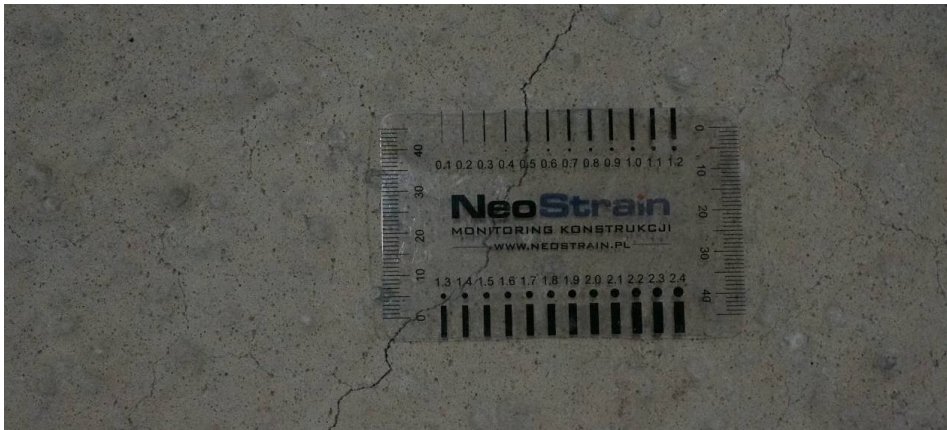
The visual evaluation of the samples was being conducted for over 2 months. The observations lasted over 2,5 times longer than the time in which the cracks occurred in analyzed floor. After 49 days first three samples did not exhibit any signs of cracking. The last sample exhibited small shrinkage cracks. Local width of the crack reached between $0.1 \div 0.5$ mm. The cracks on the surface of the EPSC occurred after two weeks due to lack of curing. The cracks are shown in Fig. 10.

Fig. 10. Measurement of the cracks in sample no. 4.

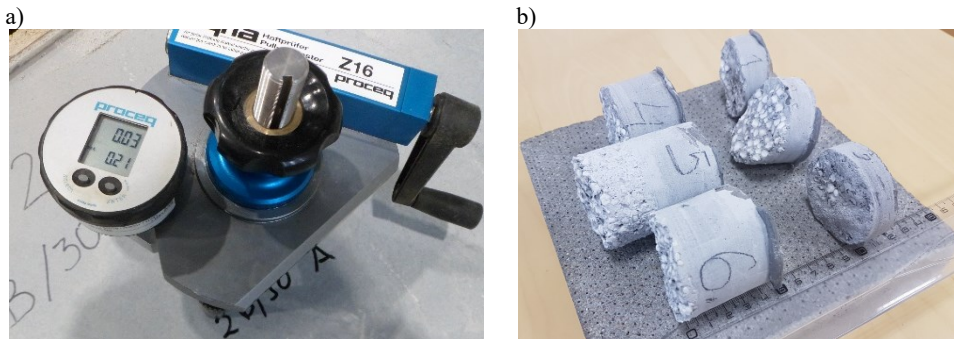
The pull-off tests conducted on the damaged floor resulted in the stress at break between 0.12÷0.34 N/mm². The test concurred previous observation of uneven thickness of the floor screed. The thickness of the screed was between 12 and 40 mm, only in P1 measurement point obtaining desired value. The samples before and after the pull-off test are shown in Fig. 11.

In the performance declaration, the manufacturer declares layer-to-layer adhesion of at least 0.2 N/mm². As seen from the results, the local adhesion did not meet the requirements.

Fig. 11. Sample (no. 2) during the test and afterwards (samples from the damaged floor).
