# Causes of failures of industrial floors and concrete surfaces – case study

**Abstract.** The article presents selected cases of damages to industrial floor and road concrete surfaces. The article presents 3 different objects in which damages were not connected with their excessive service load, but resulted from improper execution, design and underestimation of the effects of forced loads. In each presented case the description of damages was presented, the reasons for their occurrence were analysed and recommendations for repair were given.

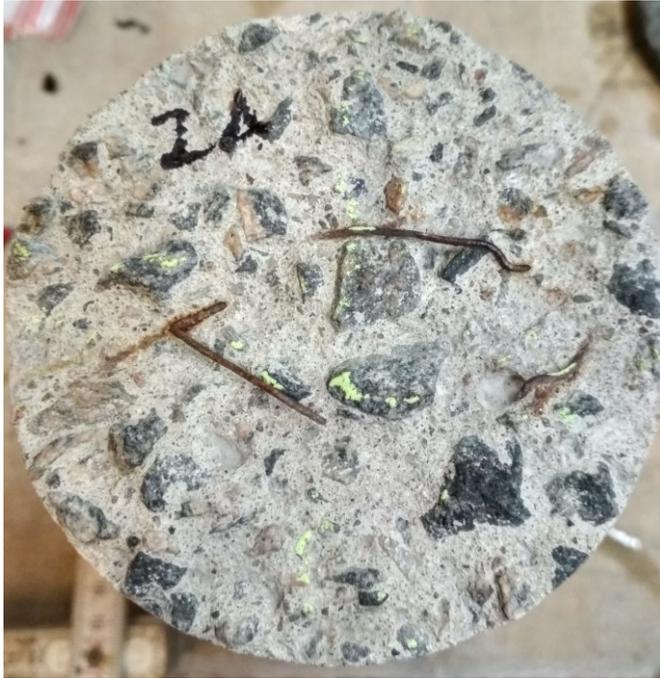
Almost the entire surface showed damage to the top layer of concrete, exhibited as an exposure of the aggregate. The inspection showed that the intensity of the phenomena varied between the spots and was highest on open areas and lowest under the roof. The network of microcracks could be visible after spraying the water on the area where the concrete has not yet worn and peeled off. The surface exhibited also corrosion of uncovered steel fiber that could be easily pulled from the concrete. During the inspection no other damage to the slab was found [Figures 1 and 2].

**Fig. 1.** The surface of the concrete in magnification. Visible corroded fibres.

It was found that the damage resulted from poor concrete quality in the surface layer of the slab caused by a heavy rainfall. Moreover, the analyses showed that concrete of lower strength class than assumed in the project was used for the construction of the slab - the concrete class C25/30 was found as compared to the designed C30/37. Despite this, no cracks were found in the concrete slab that could indicate the wrong choice of its thickness and decreased strength. There were places with a smaller thickness than assumed in the project - locally 18.5-20.5 cm compared to the designed thickness of 22 cm.

One of the reasons for the degradation of the surface layer of the concrete may have been heavy rainfall during concreting. The precipitation diluted the cement paste, significantly increased the w/c ratio. Low strength of the surface layer (approx. 10-15 mm) limits the protective properties of concrete in relation to steel fibres, which are subjected to corrosion. Corrosion of fibres additionally intensifies the process of surface degradation. Degradation of the top layer of the slab causes uncovering of the fibres occurring and their exposure. This caused the fibres to be easily torn out by vehicle tyres. Available technical literature indicates the problem of corrosion of steel fibres in concrete [5] of road surfaces.

The concrete needed to be repaired only in the top layer. It was recommended that the damaged layer be removed to a depth of approx. 15-20 mm. The layer should be replaced regarding road design guides. Consideration should also be given to how to reconstruct existing expansion joints.

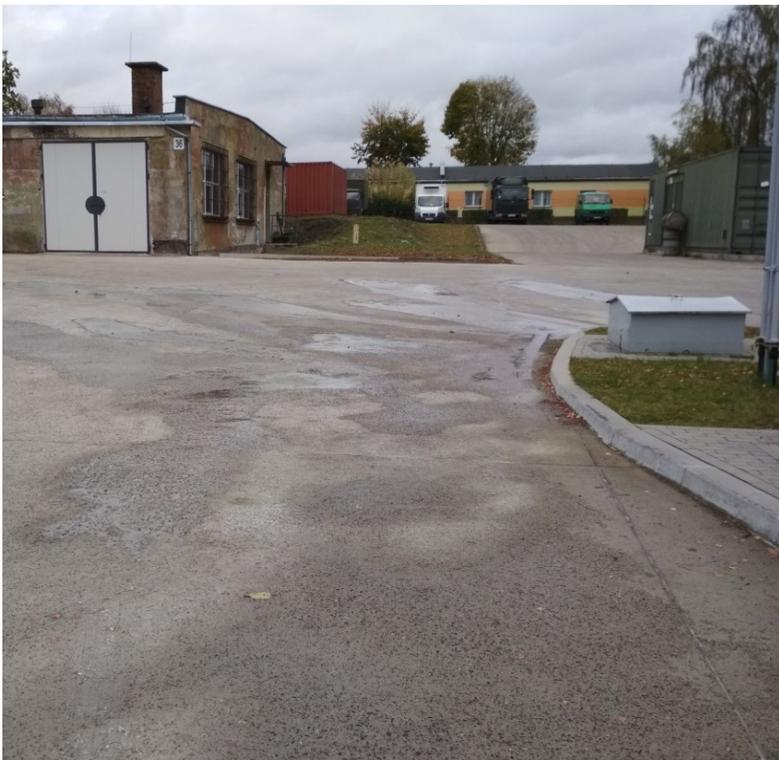
**Fig. 2.** Damaged concrete surface.

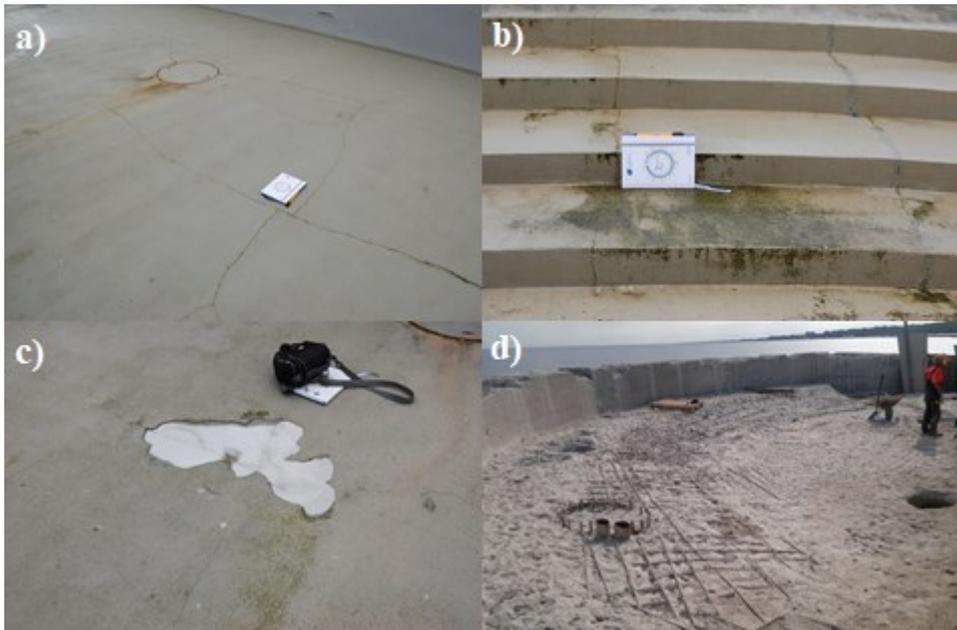
On the basis of information obtained from the contractor, it was established that the first damage to the floor was observed already in the first year of its use. The longitudinal cracks run through whole dilation fields (Figure 3a). The presence of subsequent cracks was particularly visible after the winter. After the occurrence of damages, the cracks were temporarily sealed with resin. After 2.5 years of use, the number of cracks was so large that further temporary repairs seemed unjustified.

**Fig. 3.** a) Typical surface cracks in the pier front, b) Perpendicular cracking of the arched stairs, c) Resin detachment in cracking area, d) Subsurface prepared for top concrete.

Firstly, an inventory of cracks in the concrete pier front was carried out. As a result, it was noticed that the existing cracks with width of 0.1 to 0.5 mm create either an irregular grid with length of 1.20-1.90 m or spread radially from inspection wells (Figure 3a). Near the stairs, the cracks were mainly perpendicular to them. Those spread through the whole length of the run at a distance of about 1.20-1.50 m (Figure 3b). It was also noticed that in the cracked area the resin pulls off from the concrete substrate (Figure 3c). Floor damage is shown in Figure 4.

Cracks in the bottom platform floor on the front of the pier were a result of the adopted concrete casting on rough ground. Execution of a new layer of concrete which tends to shrink on a rough substrate, that is more than 40 years old (Figure 3d), led to tensile stress in the new concrete and consequently to cracking. The design documentation does not address the issue of protecting the floor against excessive cracking. Only the construction logbook mentions the use of shrinkage reinforcement, but does not specify the location of the reinforcing mesh. The contractor placed it directly on the uncovered "old" reinforcement. New reinforcement was therefore placed in the lower part of the concrete slab, so that it did not prevent excessive widening of shrinkage cracks. Even more so did not eliminate the possibility of their formation.

The damages to the resin finish were also caused by the diffusion of moisture through weaker and previously cracked "old" concrete and cracking in the newly laid layer. Visual inspection of the core drillings showed that the sub-base concrete was cracked before the floor was laid. Cracking of the "old" concrete in the bottom resulted in the penetration of moisture from the backfill. After cracking of the surface layer the water vapor pressure increases directly under the resin layer resulting in spalling. During the renovation, no measures were taken to prevent this. The initial design assumed that the slab would be 25-30 cm thick. Core drillings indicate a local reduction in slab thickness by more than 50%.

Considering low service loads in relation to the overall deadweight, it was proposed to repair floor cracks by injecting and "gluing" the cracks with the use of elastic resins. It was recommended to carry out the injection using the gravitational method, or at low pressure due to the risk of detachment of the surface and raising the surface layer of concrete. It was

recommended that the existing resin coatings should be grinded and remade, which allowed to reveal hidden cracks.

In the area where the bottom concrete was heavily cracked, it was recommended to completely remove damaged layers and restore the monolithic slab. Proper injection of the structure was impossible due to cracks running through both layers of concrete slabs. This could result in the resin leakage to the sand backfill.

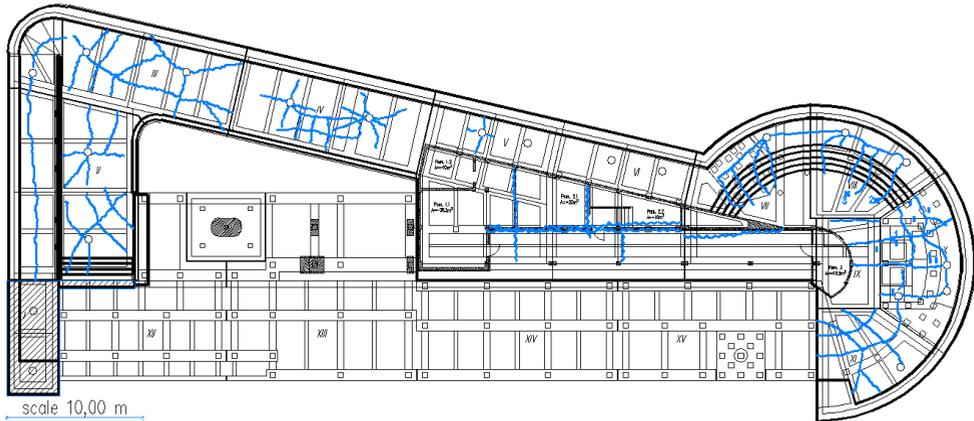
**Fig. 4.** Plan view of the pier with indicated damages location.

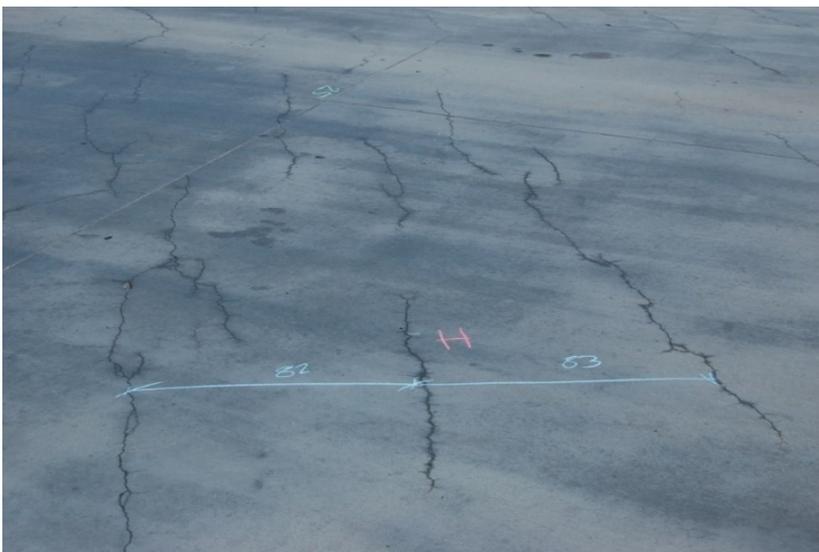
Numerous cracks of 0.5 to 1.0 mm opening and regular arrangement with the dominant direction perpendicular to the slope of the slab were found. It can be assumed that the cracks observed were parallel to each other. The measured crack spacing ranged from about 0.5 to 1.7 m with the dominant value in the range 0.7-0.8 m (Figure 5). The length of the cracks varied from about 0.3-0.4 m to about 6.0 m. Cracking cracks were locally found on the troweled surface. Figure 6b shows the damages and the joints cuts.

**Fig. 5.** Prevalent cracking on the surface of concrete (55-80 cm spacing).

Analyzing the above, it can be concluded that the damage to the concrete surface resulted from the shrinkage of the concrete combined with thermal actions. The large-size surface layer in the plan was solely made of concrete, without reinforcement in the form of bars or fibers. In this type of construction, it is extremely important to make proper contraction joints to ensure the least possible friction between the concrete slab and the subbase. It should be noted that the assumed sizes of dilation fields were correct and amount to < 6 m. In the analyzed case, however, the cuts were too shallow.

The use of geotextile fabric as a sliding layer is also questionable. In case of laying a concrete slab on a lean concrete substructure, the proper solution is to use a single or double layer of 0.3 mm thick PE foil as a sliding layer. During concreting, cement milk penetrated the geotextile and "glued" it to the concrete slab. This phenomenon reduced the effectiveness of reducing friction between the base and top concrete. The lack of reinforcement of the slab, in turn, is the cause of large opening of the resulting cracks.

The concept of repair assumed the injection and filling of the resulting cracks with the use of binders based on elastic resins. It was recommended to carry out the injection using the gravitational method, or at low pressure due to the risk of detachment and elevating the surface layer of concrete. Due to the fact that during the injection works the concrete surface may have been damaged, it was recommended to grind down the existing concrete top layer at the depth of a few millimeters. Additional resin layer on top should be placed while maintaining the water tightness and cracks protrusion. It was recommended to deepen all expansion joints to the correct depth and then to fill them again with elastic material.

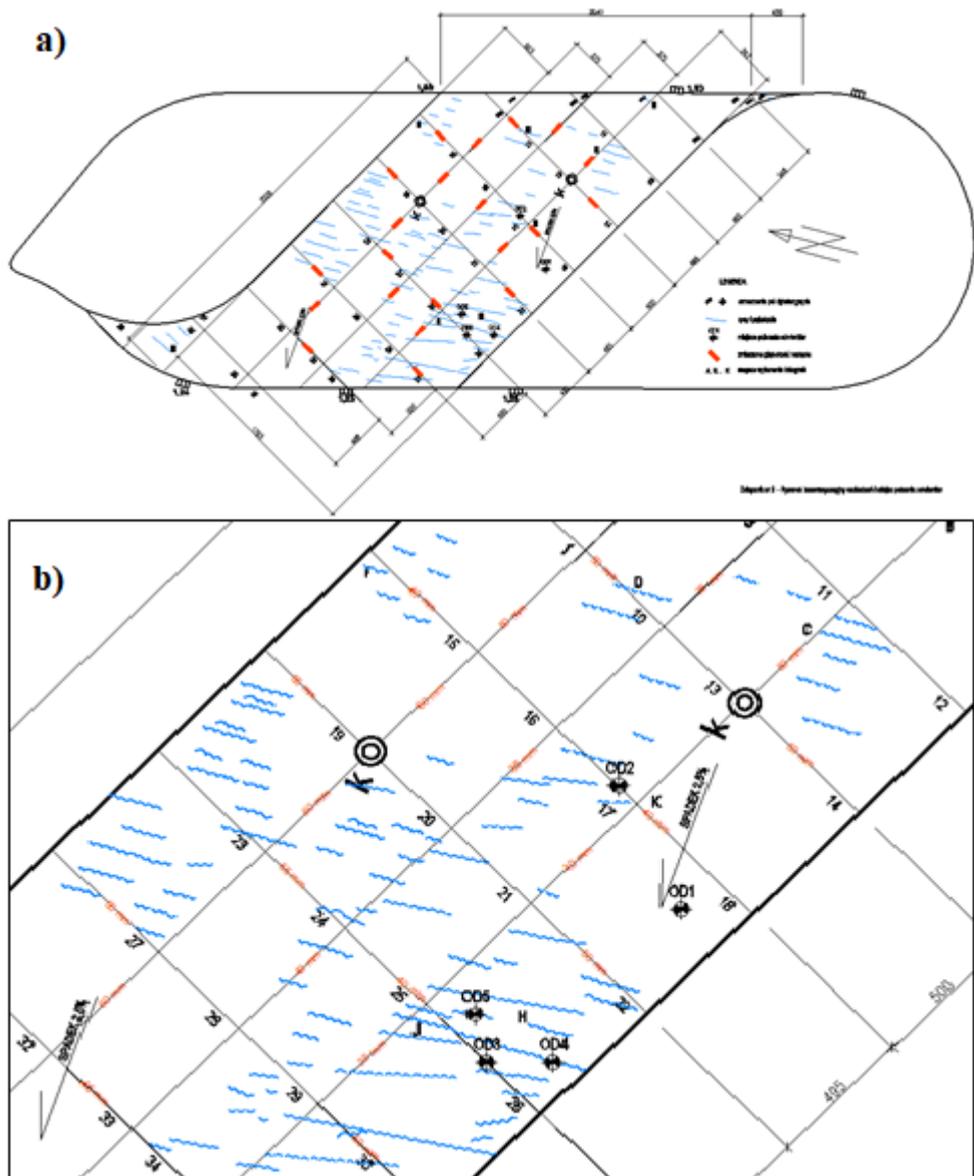
There are visible expansion joints on the surface protected with rubber sealant. The slab was divided into fields with maximum dimensions close to 5 x 5 m. The arrangement of expansion joints is shown in Figure 6 a, b.

In order to verify the correctness of the surface layer execution, the depth of the expansion joints was measured. Measured depth ranged from 35 to 60 mm (usually between of 40-50 mm). Some of the joints had a width corresponding to the width of the concrete diamond saw (approx. 4-5 mm), while some had an opening of approx. 10 mm with visible damages to sealing rubber. It was noticed that the expansion joints were typical for a saw-cuts made in a fresh concrete. No proper expansion joints with bituminous mass or doweled were found.

**Fig. 6.** a) Plan view of the maneuver area b) the dilation fields and cracks are indicated.

A correct cut should reach the depth of 1/4 - 1/3 of the slab thickness [1, 2], so as to ensure that the concrete breaks exactly in the notch. With a slab thickness of 250 mm, the correct cut should be 65 - 85 mm deep. During the review of the expansion joints, the depth of the expansion joints was found to be smaller. The core sample taken through the joint showed that insufficient depth of the cut stopped the propagation of the crack, while numerous shrinkage cracks are visible in the vicinity of the cut. Incorrect cracking of the expansion joints is also evidenced by uneven destruction of the rubber sealant. There are numerous joints in which the joint material is strongly cracked (which is probably appropriate), as well as joints without visible damage.
