# Commercial building flooring failure caused by swelling of the foundation layers

**Abstract.** The work describes the damage, testing and method of repairing the flooring. The flooring formed part of a commercial pavilion covering an area of approx. 1200 m<sup>2</sup>. Significant damage in the form of cracks and elevations of up to a height of almost 80 mm were detected in the flooring. Geodetic, laboratory and geotechnical tests were carried out to determine the causes of the damage. The cause was found to be swelling of the floor base course layers, consisting of embankments made of unburnt colliery shale mixed with ashes. The swelling processes ceased about 5 years after the structure was commissioned.

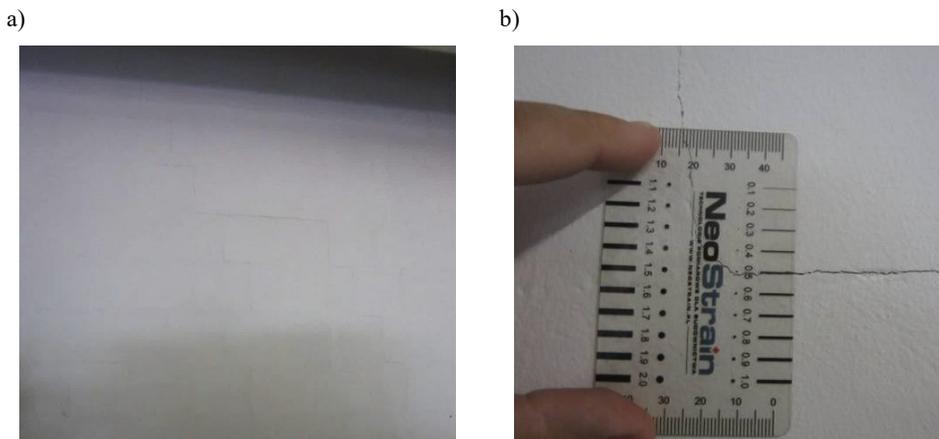
After the structure was commissioned, the following damage and irregularities in the finishing elements of the commercial pavilion were found: wall cracks, floor cracks and unevenness of the flooring, damage to the suspended ceiling and displacement of the door to the storage part. Cracks were found on the structural walls. The cracks were diagonal (stepped) and vertical. The stepped cracks usually occurred near the centre of the wall length (shrinkage of the wall [6, 7]), while vertical cracks were at the junction of the reinforced concrete cores with the masonry wall. There were also typical cracks under the windows [8] and at the lintels [9]. The crack openings were up to 0.5 mm and were partially repaired by filling with mortar. The repaired cracks did not open again. The crack view is shown in Fig. 2 and 3. Damage was also detected in the non-load-bearing wall of the room located at the ticket office, made of plastic. A fracture was found at the door to this room (Fig. 4).

**Fig. 2.** An example of cracking of the load-bearing wall between the storage room and the sales section: a) view, b) crack opening measurement.

All damage described in par. 3 was the result of elevation of the flooring, except for the cracks in the masonry walls and at the junctions of walls with reinforced concrete cores. The latter damage was caused by shrinkage of the wall elements.

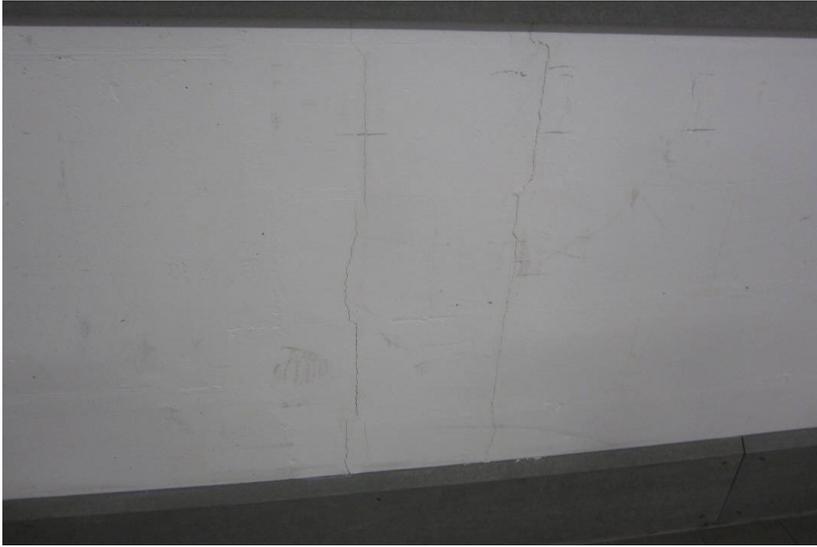
**Fig. 3.** Cracking at the junction of reinforced concrete core and wall.

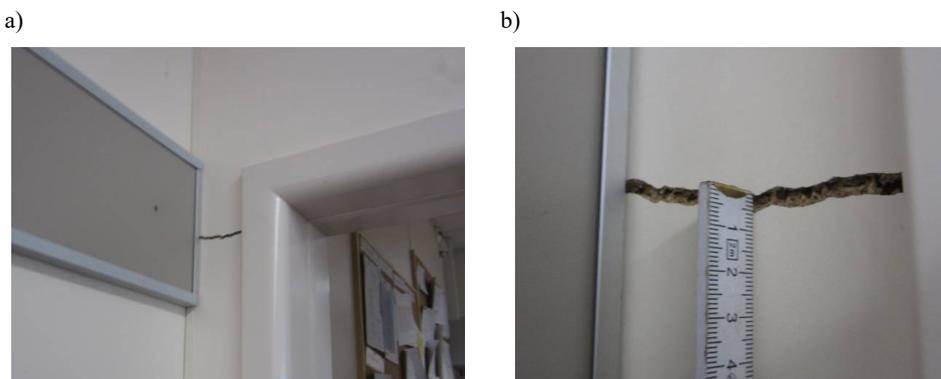
**Fig. 4.** Cracking of the non-load-bearing wall of the store manager's room: a) view, b) crack measurement.

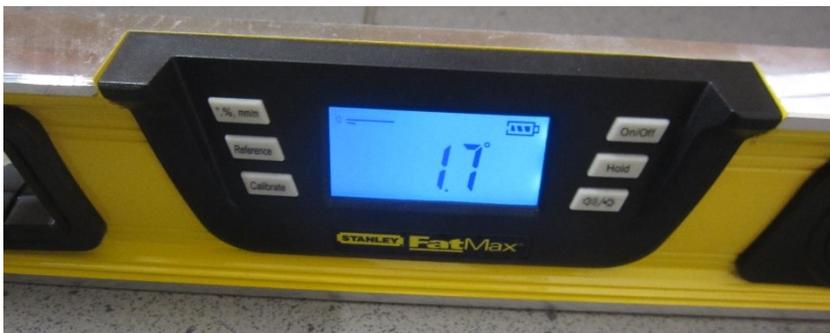
The inspection showed damage to the flooring. The following were found: slope of the flooring of up to  $1.7^\circ$ , i.e. approx. 30 mm/m (Fig. 5), cracks on the surface of ceramic tiles (Fig. 6) and tearing of expansion gap filling (Fig. 7).

**Fig. 5.** Local slope of the flooring.

In conclusion, it was found that the cause of damage was the swelling of the soil under the flooring. This is evidenced by the good compaction of the soil, full contact (no void sections) between the flooring layers and the foundation, as well as the nature of the crack and deformation of the flooring.

Because the ground deformation is blocked by the reinforced concrete slab, the deformations could increase further if it was weakened by grinding. Therefore, repair option I has been recommended.

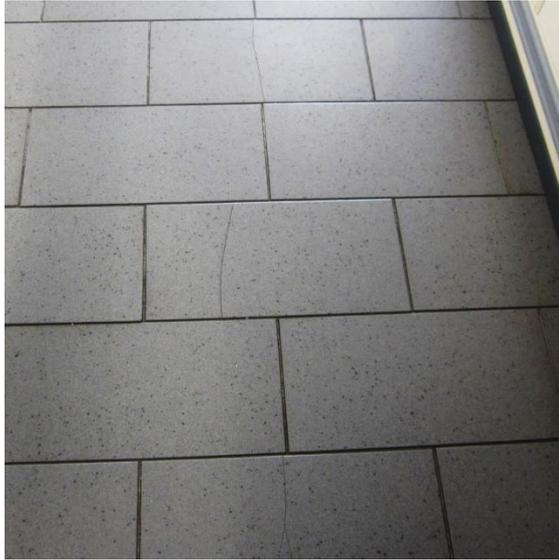
**Fig. 6.** Cracked flooring.

In analysing the results of the flooring level tests, it can be observed that the flooring in the storage room and sales room was elevated locally. This is also evidenced by the character of the flooring crack in its upper part - a crack closing downwards. Such a situation can occur only if the soil layers swell under the flooring. The swelling of the soil may be caused by: frost impact on cohesive soil, occurrence of expansive soils in the ground (some clays), rocks made of clay minerals affected by water, and as a result of chemical reactions in anthropogenic soils (e.g. slags, ashes). The impact of frost can be excluded here due to the positive temperatures prevailing in the rooms. There are clays in the substrate, but in the point of largest deformations they were in a semi-solid state (the same as before construction began) and no groundwater was found in their area. The last material under consideration was the mixture of unburnt colliery shale and ashes. According to Gawlicki and Małolepszy [11], some types of ash containing unbound CaO and MgO can react with water (e.g. rainwater and/or water supplied during development to achieve optimal humidity), and as a result of hydration there is a slow, but increasing growth in the volume of the material, which may lead to deformation of the top layer of the structure, such as a flooring. Unburnt colliery shales containing clay minerals may also swell under the influence of water supplied to them.

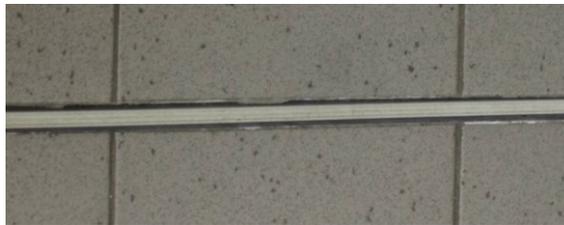
**Fig. 7.** Tearing of expansion gap.

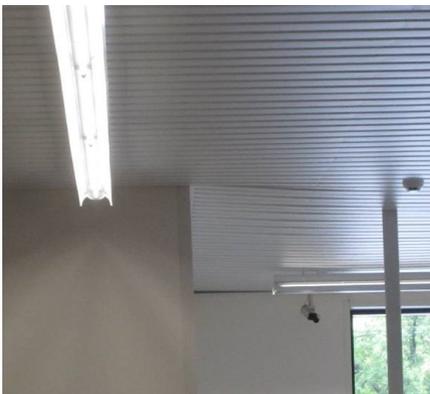
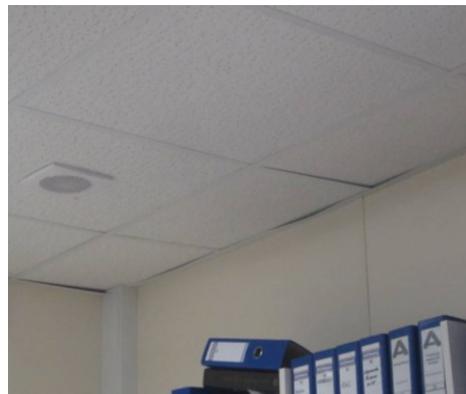
In addition, ceiling damage in the form of deformation was found. The damage occurred in the sales room and in the store manager's room (Fig. 8). The locations of the structural damage are shown in Fig. 9.

**Fig. 8.** Cracking of the non-load-bearing wall of the store manager's room: a) view, b) crack measurement.

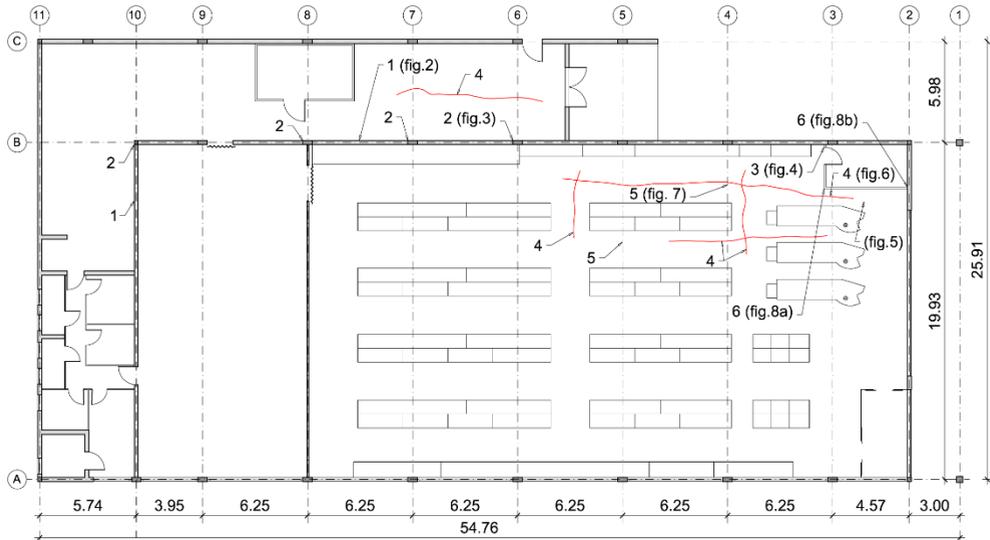
**Fig. 9.** Structural damage: 1- stepped crack, 2 - crack at the juncture of wall and reinforced concrete core, 3 - crack in non-load-bearing wall, 4 - flooring crack, 5 - tearing of expansion gaps, 6 - damage to the suspended ceiling.

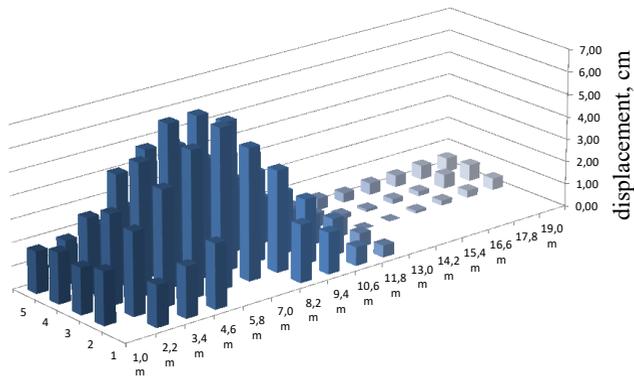
The flooring levels were tested to show the deformation. The tests were carried out in the storage room and the sales room in the areas of the largest deformations (Fig. 10). The test was carried out using a self-levelling level and a levelling rod with millimetre graduation. The measurement accuracy was estimated at  $\pm 1.0$  mm. In the storage room, the test was carried out over a length of 18 m and a measuring grid of 1.2x1.2 m was used. In the sales room, the tests were carried out in the western part over almost the entire length of the room, with a measuring grid of 0.4x0.4 m, this being additionally reduced by half in those areas with the largest deformations. Based on the measurements it was found that the maximum flooring displacement in the night storage room was 5.5 cm, and occurred in the middle of the flooring, while the maximum flooring displacement in the sales room was 7.6 cm (at the corner of the store manager's room). Graphs with the results are shown in Figs. 11 and 12.

**Fig. 11.** Flooring deformation tests in the storage room.

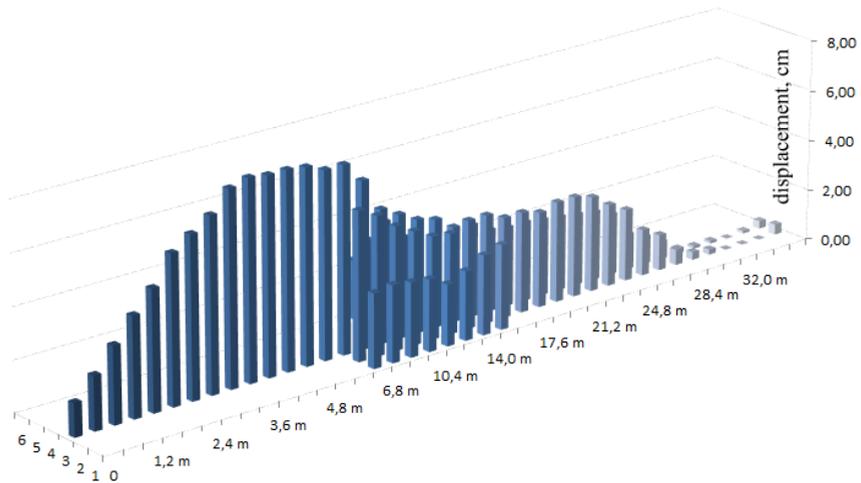
**Fig. 12.** Flooring deformation tests in the sales room.

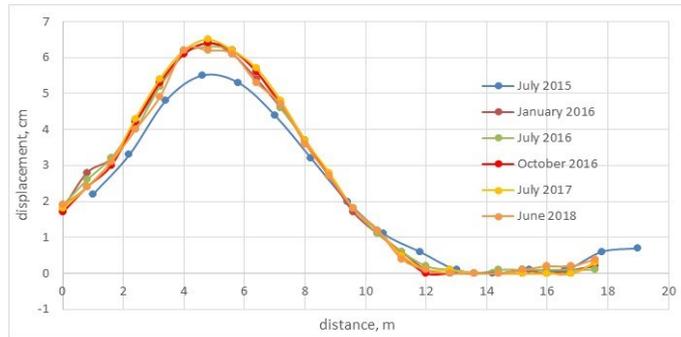
**Fig. 13.** Results of geodetic measurements in the storage room (longitudinal measurement).

Stabilization of the floor deformation was achieved nearly 5 years after its completion. The maximum displacement of the flooring in relation to the lowest measured point in the storage room was 6.2 cm, while the maximum displacement of the flooring in the sales room was 7.8 cm.

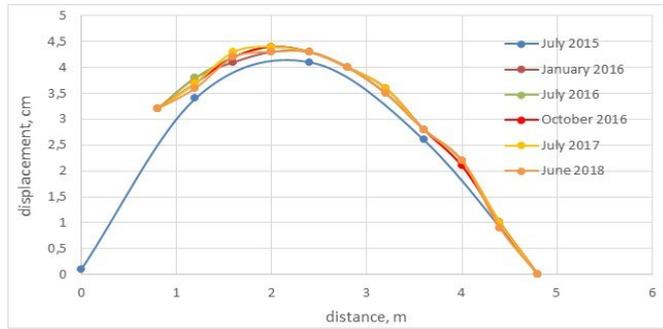
**Fig. 14.** Results of geodetic measurements in the storage room (transverse measurement).

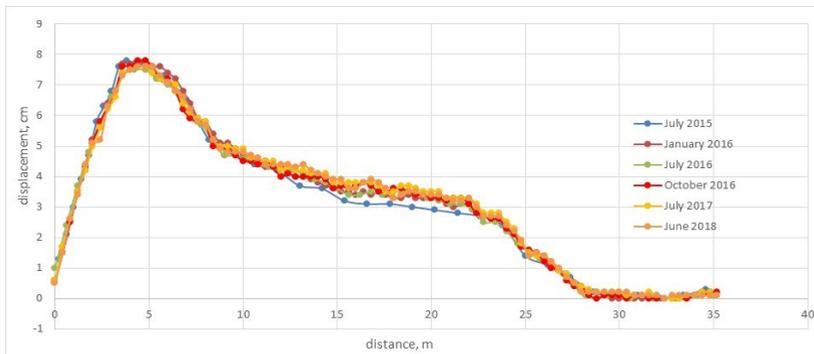
**Fig. 15.** Results of geodetic measurements in the sales room (longitudinal measurement).

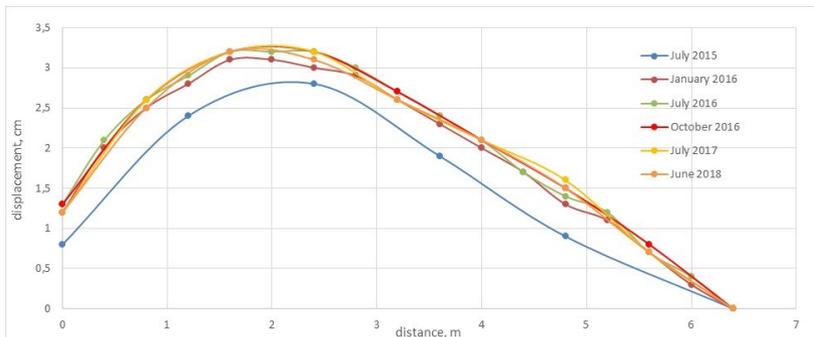
**Fig. 16.** Results of geodetic measurements in the sales room (transverse measurement).

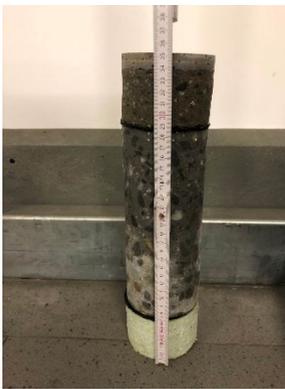
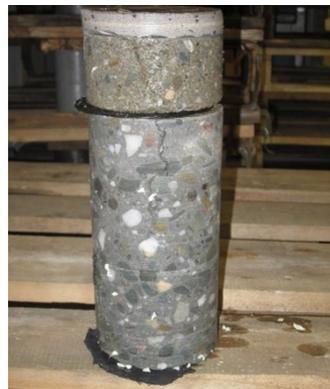
A total of 5 core boreholes, marked S1-S5, were made in the flooring (fig. 10). It was found that the flooring layers were consistent with the design (Fig. 17a). In S1 it was possible to bore through the crack, and it was found that the crack was located in the screed and the upper part of the concrete slab, and was enclosed in the area of half of the sample (Fig. 17b). This indicates the occurrence of a bending condition in the flooring. The strength tests of concrete samples S2-S5 were carried out in accordance with the recommendations [10] and it was found that the concrete grade was consistent with the design.

**Fig. 17.** Samples from core boreholes: a) flooring layers (borehole no. S4), b) cracked sample S1 (the crack runs through the screed and the upper part of the slab).
