Floor defects in quarters over railway tunnel caused by design and construction errors

Abstract. The main subject of this paper is a floor in the quarters located above the railway tunnel in the large-area Shopping Center. The considered floor did not meet the satisfactory safety conditions, as a result of design and construction errors, which were a direct cause of the failure. In the long term, failure could lead to a construction disaster.

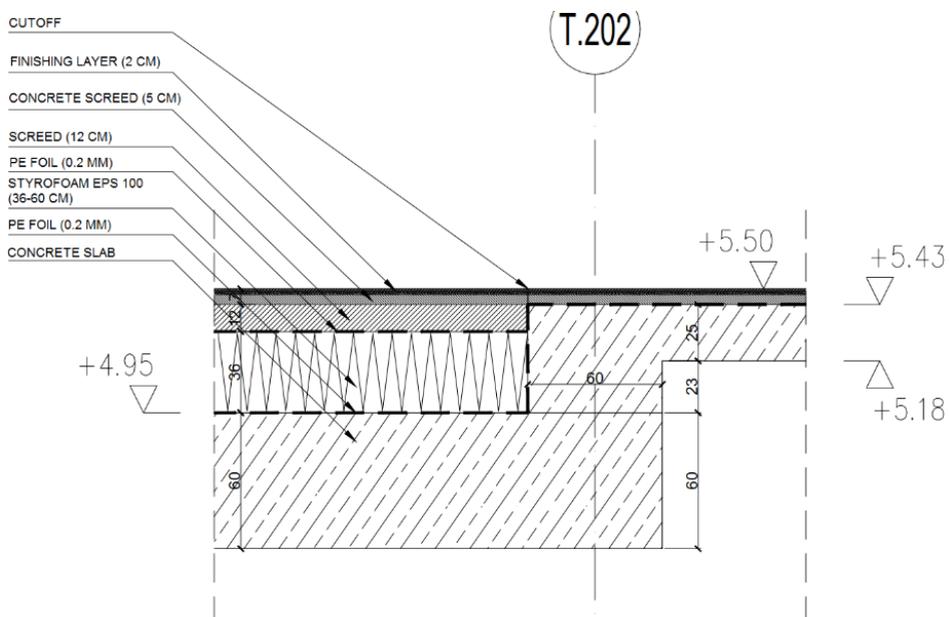
Fig. 1. The designed layout of the floor finishing layers above the railway tunnel according to [1].

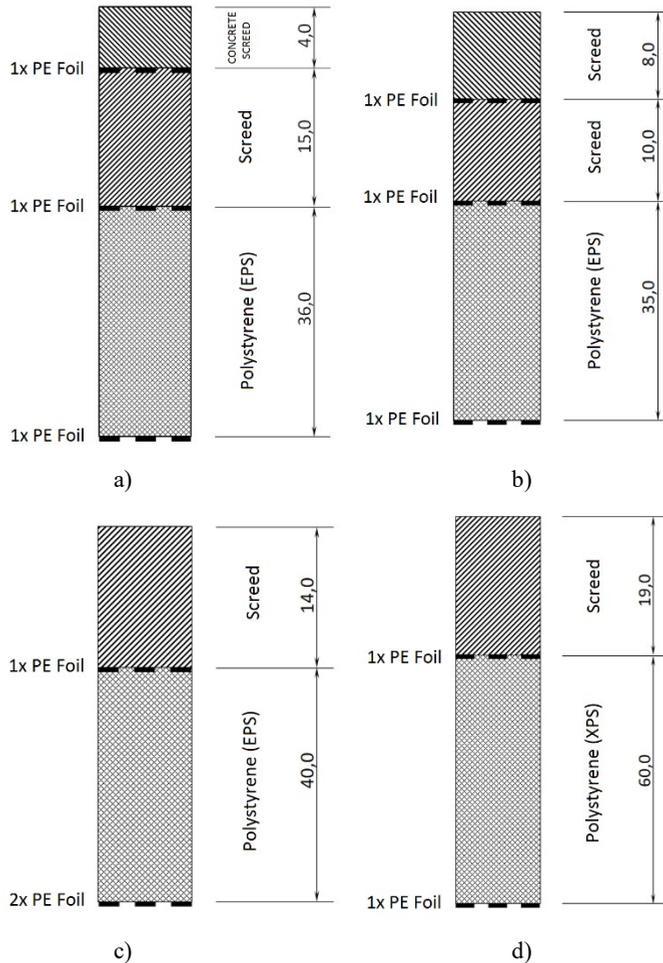
Fig. 2. The layout of the floor layers above the railway tunnel in randomly selected places: a), b) in the rooms of tenants and c), d) in generally open corridors (the drawings do not indicate the construction of the floor slab).

An arrangement of the floor layers in the outcrops did not comply with [1]: the screed thickness was different and ranged from 7.0 cm to 19.0 cm, the screed itself was made in one or two layers separated from each other by a layer of black PE foil. Under the screed, expandable EPS and extruded expanded polystyrene (with different strength parameters) were laid out.

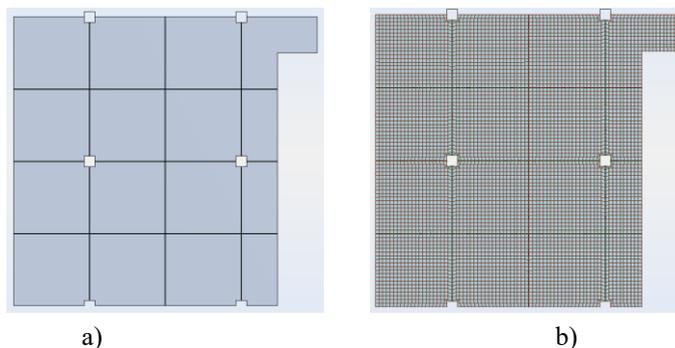
Case I - this was the most unfavourable case (bottom envelope) when as a result of shrinkage the plate (undercoat) cracked all its thickness in the places of apparent expansion joints. The calculation model consisted of 12 independent concrete slabs (Fig. 3) based on a Winkler spring substrate with constant stiffness k_s . The dimensions of individual expansion joints were 4.00 × 4.22 m. It was assumed that the neighbouring slabs would not cooperate in transferring loads.

Fig. 3. Calculation model (case I - independent plates): a) location of expansion joints, b) division into finite elements.

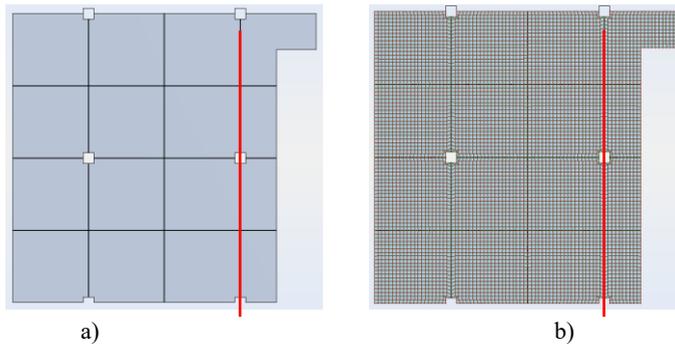
Case II - it was the most advantageous case (upper envelope) when the foundation slab did not completely break in the places of apparent expansion joints. The cooperation of neighbouring expansion fields in transferring loads was assumed. The calculation model consisted of two concrete slabs separated by a brick wall (marked with a red line in Fig. 4), based on a Winkler substrate with a constant stiffness k_s . In the place of the wall, there was an expansion joint, and the neighbouring plates had the freedom of deformation.

Fig. 4. Calculation model (case II - cooperating plates): a) location of one expansion joint, marked in red, b) division into the finite element.

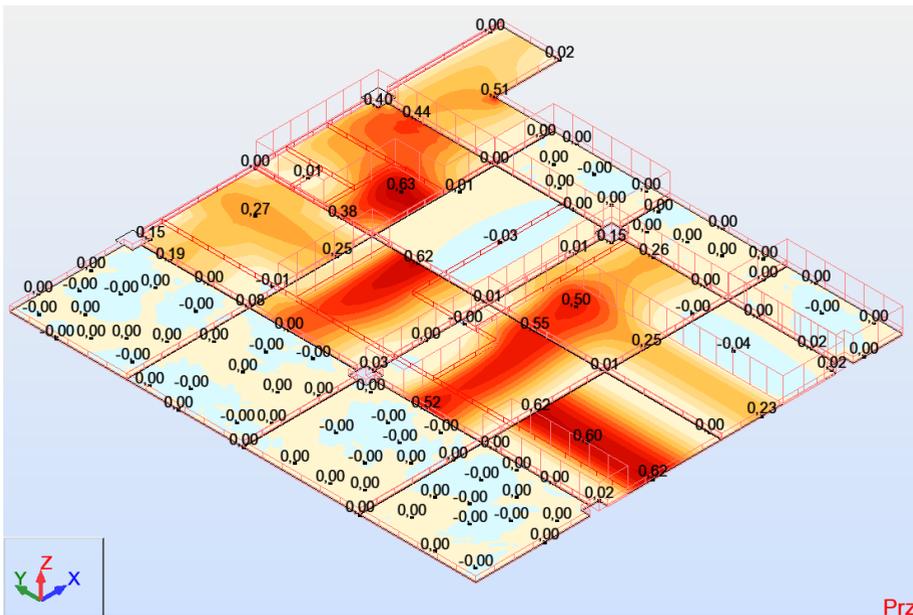
Based on the analysis of the results obtained for case I, it was found that the maximum tensile stress in the screed plate is 0.63 MPa (on the upper surface of the board) and less than 0.93 MPa concrete tensile strength, thus the board fulfilled the conditions of the *Ultimate Limit State (ULS)* capacity [10]. The maximum calculated subsidence of the slab corner was 0.6 cm.

Fig. 6. Principal stresses σ_1 on the upper surface of the underlay for load combinations in the *Ultimate Limit State (ULS)* - case I, independent plates.

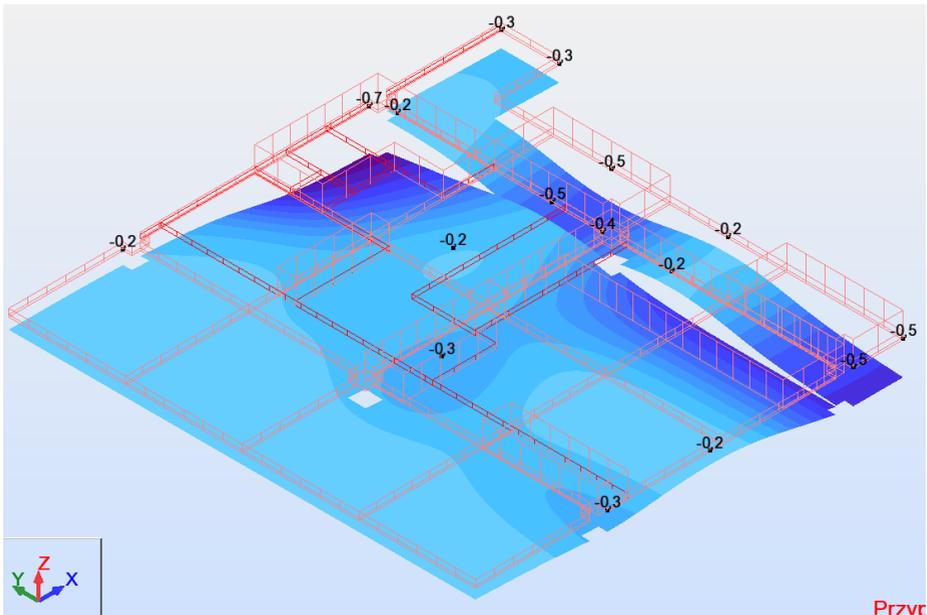
Based on the analysis of the results obtained for Case II, it was found that the maximum tensile stress in the screed plate is 1.13 MPa (on the upper surface of the board) and is 21% higher than the concrete tensile strength equal to 0.93 MPa, thus the slab does not meet conditions of the *Ultimate Limit State (ULS)* [10]. The maximum calculated subsidence in the centre of the slab was 0.7 cm.

Fig. 9. Deformation of the backing plate for load combinations in the *Serviceability Limit State (SLS)* - case II corresponding to the situation when the foundation slab did not completely break in the places of expansion joints (apparent).

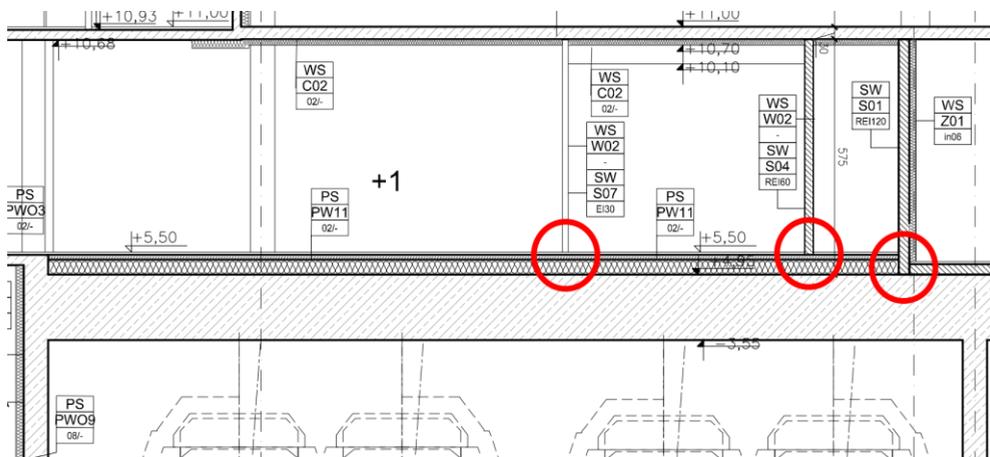
Fig. 10. Method of supporting walls on the ceiling above the tunnel according to [1].

The S04 wall was a partition wall, made of lime-sand brick (silicate) 18 cm thick, which according to the design should be built on the floor construction layer (cement screed 12 cm thick - Fig. 10). However, it was found that the wall was placed on a reinforced concrete floor slab, not on the floor layer. That was inconsistent with [1] but allowed for the continued safe use of this wall. The excavations made revealed intense moisture of all the walls set on the ceiling over the entire height of the floor layers (foamed polystyrene and cement coat). In the dilatation areas of the ceiling slab, expansion joints of the walls were also made, i.e., the dilatation of the ceiling and the walls overlapped, which was a correct solution consistent with the principles of technical knowledge.

The S07 wall was a system partition wall with a thickness of 15 cm made of G.-K. Fastened to system steel profiles with a width of 100 mm, double-sided coated with plasterboard, two plates with a thickness of 1.25 cm on each side). The space between the plates was filled with mineral wool. The S07 wall was set on the floor layer (ceramic tiles or carpet). Additionally, on the floor, in the rooms of the tenants, any arrangement of partition walls made of gypsum-cardboard boards with a height of up to 3.5 m is provided by the arrangement designs.

The design [1] adopted in the project to support the walls S04 and S07 on the ceiling above the railway tunnel provided that they were to be based directly on the floor underlay (screed/concrete screed), which was an erroneous solution with a high risk of failure. In the case of insufficient load capacity of the floor, e.g., due to the low strength of the underlay, which occurred or insufficient stiffness of polystyrene, the adopted solution would fail or even cause a disaster. The contractor arbitrarily, without consulting with the building inspector, built up all the walls directly on the ceiling, which ultimately enabled safe exploitation of the premises by the tenants.
