# Causes and consequences of a construction disaster in a historic church

**Abstract.** Paper concerns a construction disaster, which took place on June 4, 2018 in the 14<sup>th</sup> century St. George church in Hajduki Nyskie (Opole Voivodeship). The object is famous for its well-preserved 15<sup>th</sup> century wall polychromes. During the construction works, the eastern gable wall, part of the barrel vault with lunettes and part of the orchid roof truss collapsed at the roof truss. Some elements of the equipment were also destroyed. As a result of the catastrophe, valuable wall polychromes were directly threatened. Paper presents the causes and consequences of the catastrophe.

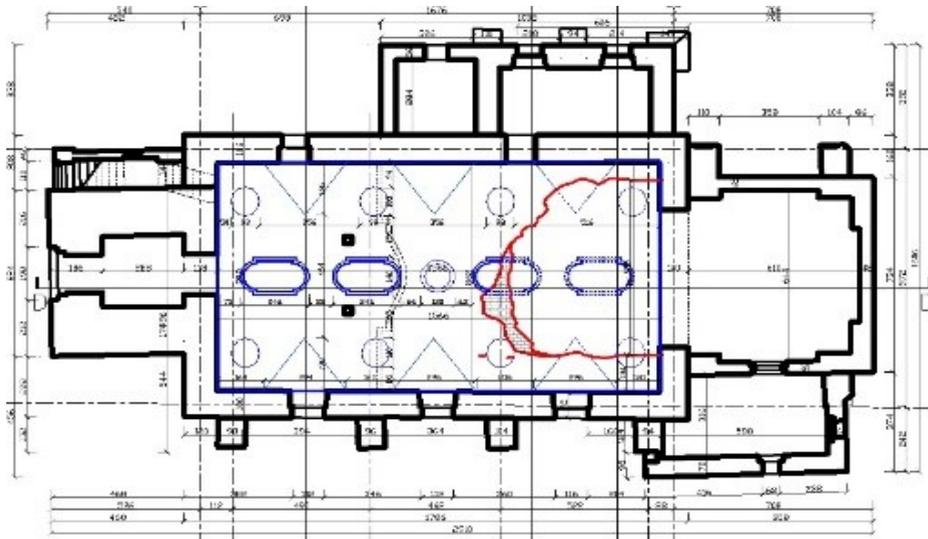
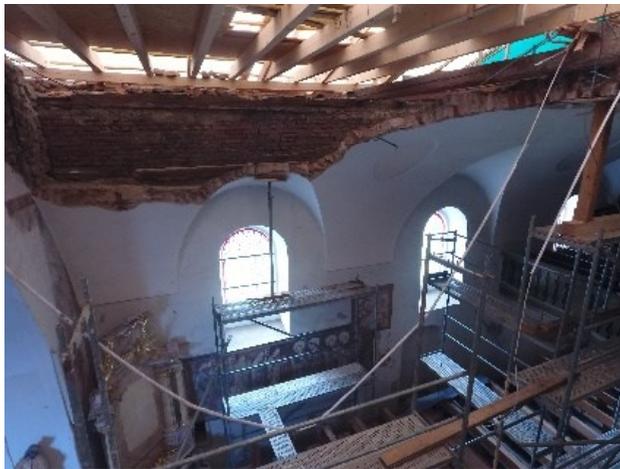
The vault above the nave was made as a barrel with six lunettes (Fig. 3). The cradle was stiffened with the buttresses visible from the dorsal vault. The vault with a thickness of  $\frac{1}{2}$  brick, was made with bricks bonding with overlapping equal to half brick length. A hand-formed, dimensionally irregular brick was used for the construction. The guelster was made of solid brick with a thickness of approx. 25.5-27.0 cm and width from approx. 50 to approx. 80 cm.

**Fig. 3.** The barrel vault, a) plan, b) view after the disaster.

3. The vault above the nave in the part adjacent to the presbytery, along with the first buttress from the side of the presbytery, collapsed. In the middle field of the barrel vault, however, numerous scratches have been observed, which appeared after the construction disaster. During the local vibrations, in the first days after the disaster, before the development of technical expertise and monitoring of scratches, new cracks in the vault were noticed. The visible emergency places are the scratched vault areas in the longitudinal direction, in particular in the upper zone of the keystone and in the lunettes. The vault in this part has not been completely destroyed due to the assumed spines from the dorsal side. At the moment of the construction disaster, vibrations transferred to the vaults locally caused a loss of grip on the surfaces of the bricks in the vault. Some of the broken and welded joints became stuck. Removing the temporary vaulting of the vault may in the future, in particular during the course of repair work, reveal or also generate further damage to it.

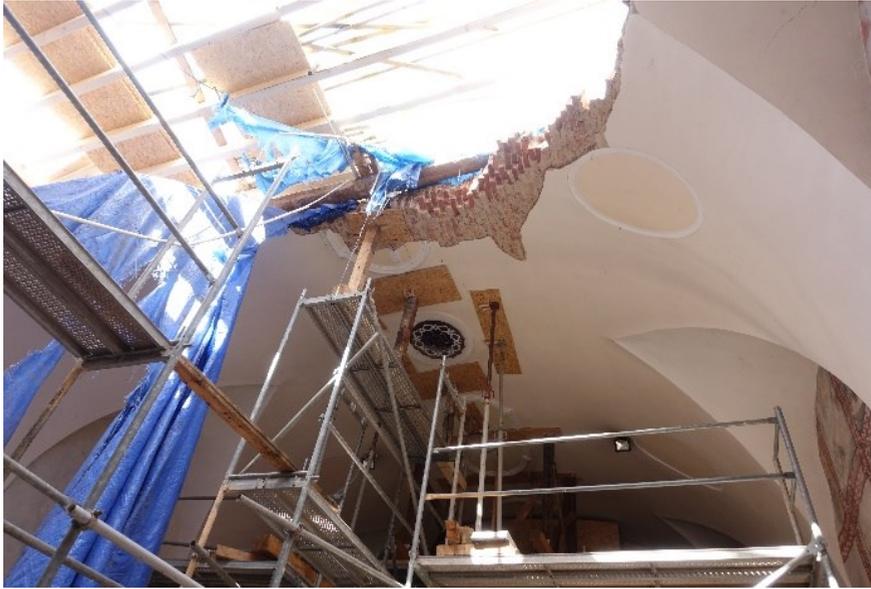
Despite the fact that the contractor of construction works, under the supervision of the construction manager and inspector of construction supervision, he began to implement the securities, they were carried out in a hurry and chaotically. As part of preventive protection after the construction disaster, temporary protection of the vaults and the nave was carried out (Fig. 4 and Fig. 5). The vaults were secured with the use of building scaffoldings and elements of the undone roof truss. The wooden scaffold supports were based, among others on scaffolding platforms. In addition, the vault above the choir was supported by pillars in the axes of the ceiling of the choir. The ceiling of the choir was also stamped. The organs were protected against mechanical damage by chipboards.

**Fig. 4.** Protection the vaults after the disaster.

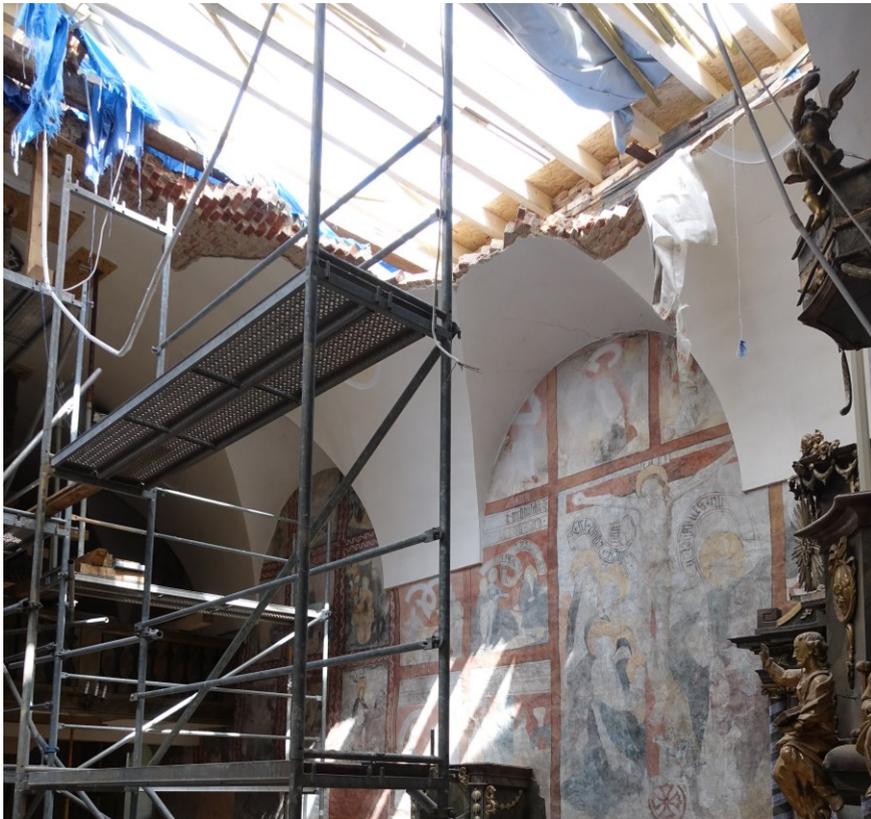
**Fig. 5.** Provisional protection of the vaults after a disaster.

Moreover, the method and arrangement of the floor support will substantially reduce the use of the system scaffolding. The implementation problem will also be the removal of existing stamps and the establishment of a new scaffolding. Vault protection in the described form should be considered as inconsistent with engineering practice and as being likely, especially in winter, to threaten further collapsing of vaults and posing a threat to the health and life of people staying at the facility. The safeguards used do not have the character of static prophylaxis, aimed at partially or completely relieving the weakened structure of the object, including in particular supporting them and holding excessively cracked elements.

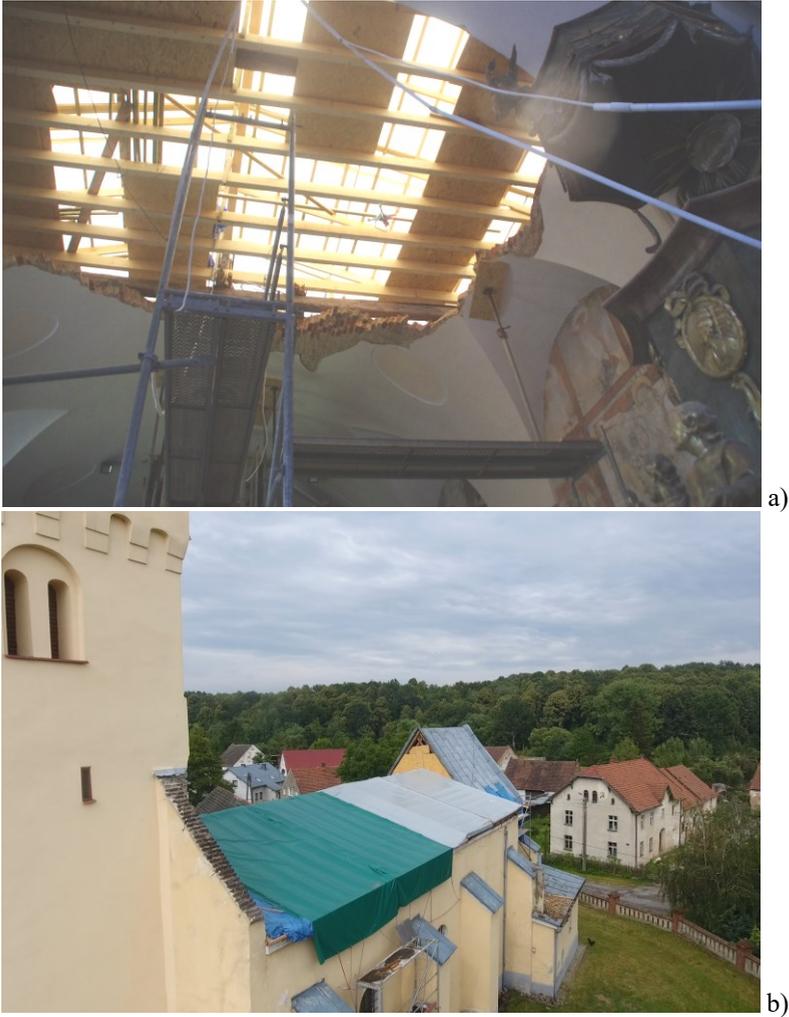
Also, temporary works were carried out to secure the nave of the church, by installing a temporary wooden roof above it (Fig. 6). Tarpaulin covers were opened on the roof structure. The method of this construction was not consulted with the designer, conservation services and the Nysa District Construction Supervision Inspector. Also, it was not preceded by drawing and static and strength analysis. Provisional protection prevents or seriously limits access to the church part above the vaults and to the roof truss above the presbytery. It is also difficult to determine the impact of the protective structure on the safety of the structure.

**Fig. 6.** Temporary timber roof above the nave of the church, a) view from the inside, b) view from the outside.
