Cause-and-effect study of the structural failure of the historic complex of the St. Anna's Church in Warsaw

Ryszard Chmielewski^{1,*}, and Leopold Kruszka¹

¹Faculty of Civil Engineering and Geodesy, Military University of Technology, Warsaw, Poland

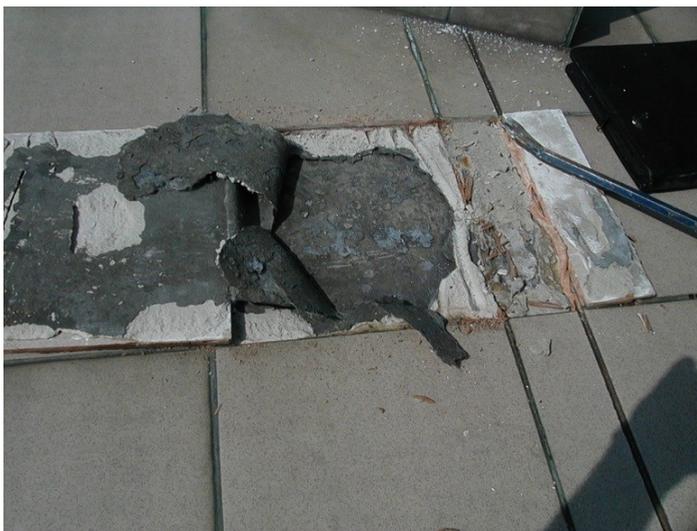
Fig. 1. Moisture of the terrace floor layers.

Particular emphasis was put on investigating and explaining the problem of rainwater migration under the floor of the observation deck. Based on the research, it was found that rainwater leakage, appeared as a result of [4]:

- improper drainage of the rainwater from gloriette flashing,
- incorrect attachment of the flashing around the tower terrace,
- incorrect sealing of the gloriette balustrade posts.

All sub-terrace layers have been soaked. Therefore, their weight has significantly increased and an additional load was applied on the supporting structure of the tower roof. The resulting load together with accelerated technical degradation of the structural elements were the primary causes of the element failure. In the next step, a decision was made to make a new waterproofing insulation with a flat roof of the tower building [4]. This design solution was in line with the recommendations indicated by the cultural heritage conservator, who clearly advised to take immediate actions to remove the cause of rainwater leakage into the masonry structure of the analysed building.

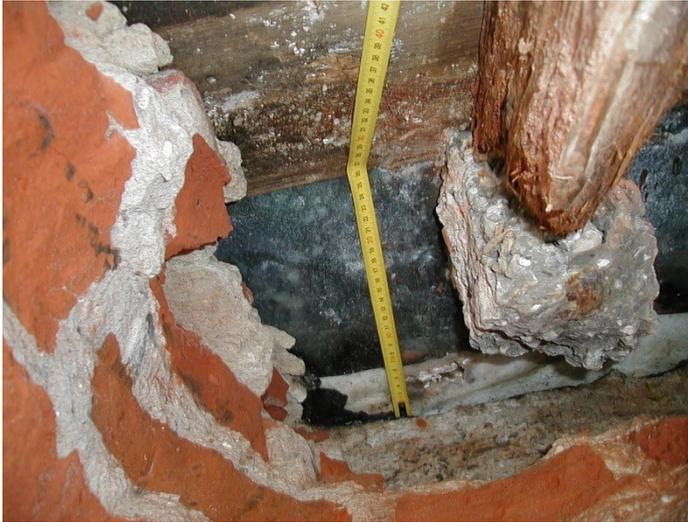
Fig. 2. Moisture in the fixing of the wooden post of a gloriette balustrade - the improper insulation of the wall, the terrace floor as well as the gloriette roof.

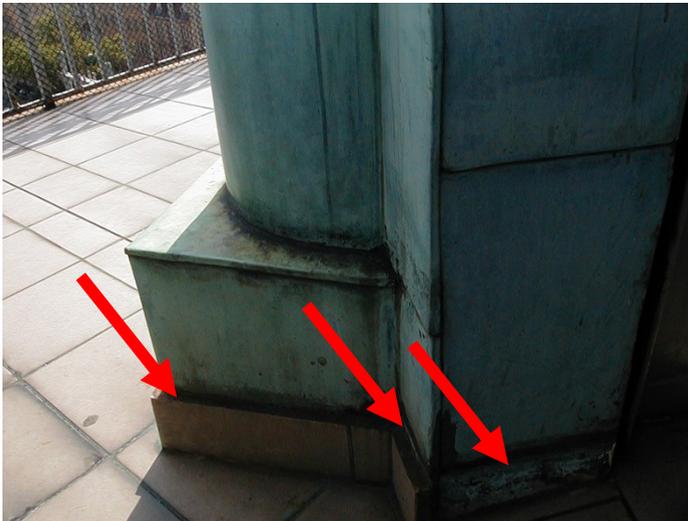
Fig. 3. Flashings of the lower part of the gloriette - visible rainwater leaks and the migration path of the rainwater to the terrace floor.

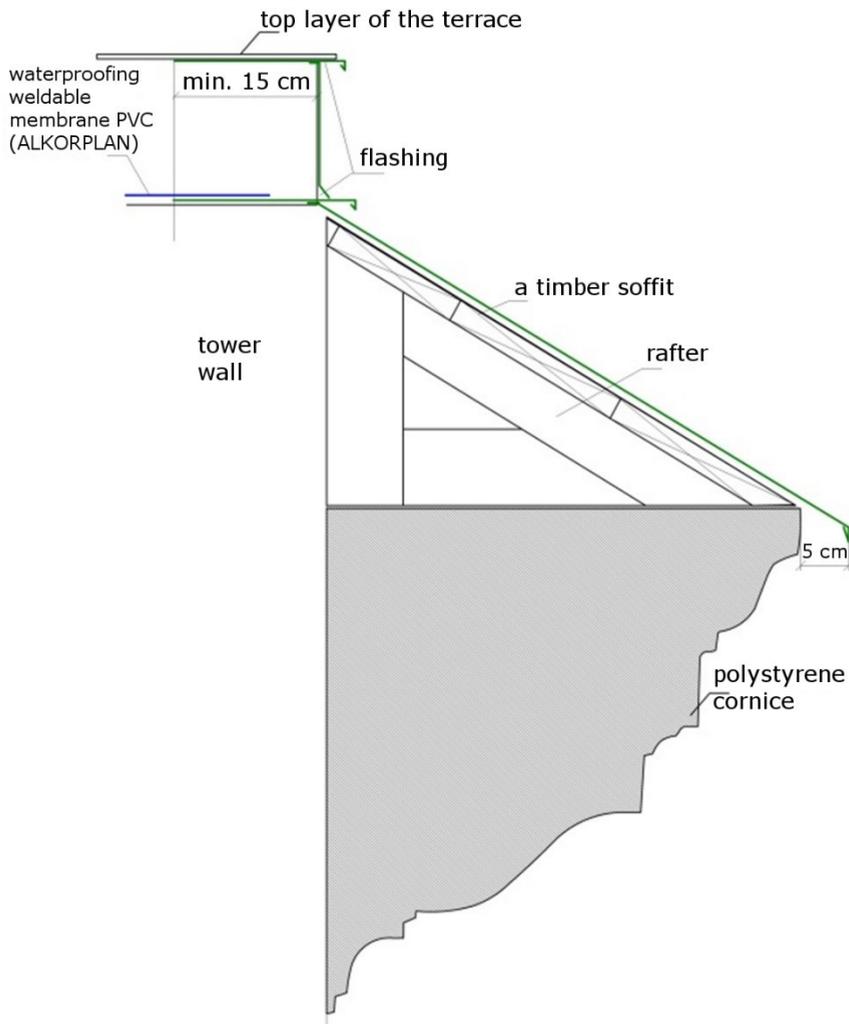
The technical condition of the tower walls under the cornice was characterized as bad. The visible cracks with width up to 3 mm were diagnosed. Built-in bricks were locally wet and were in a very poor technical condition. As a result of organoleptic macroscopic investigations, it was found that the tensile strength of these bricks was low. These bricks could be crushed in the hands under the very low pressure.

Fig. 4. Cross-section of the repaired cornice of the tower [4].

Due to the poor technical condition of the tower walls under the viewing terrace, the restoration of the cornice made of clinker brick would be a very difficult task. This would have required many steps and special treatments related to reinforcement of the weakened masonry foundation, soil, as well as the reconstruction of the complex system of cornice anchoring in the walls of the tower. The investor decided to renew flashing over the entire cornice of the tower together with the rotten wooden soffit elements.

Firstly, the damaged cornice and all the flashings together with the timber soffit elements were removed. The surface of the wall in the place of the removed cornice was levelled by making the rendering coat. Then the new plasters were applied. A crucial milestone of the works was the repair of the flashing of the gloriette to prevent further penetration of the rainwater into the floor of the terrace. All terrace layers had been removed to the level of the tower ceiling. The anchoring of the gloriette balustrade posts was then sealed. New terrace layers were laid on the ceiling with its existing slope. The waterproofing insulation in the form of a weldable, flexible membrane was tightly joined with the new column anchoring insulation (liquid foil) and rolled over for flashing - Fig. 4.

Then, after levelling the surface of the supporting structure of the flat roof, new flashings were made and a new waterproofing of the terrace along with insulation of the roof of the tower. A cross-section of new terrace layers is shown in Fig. 4.

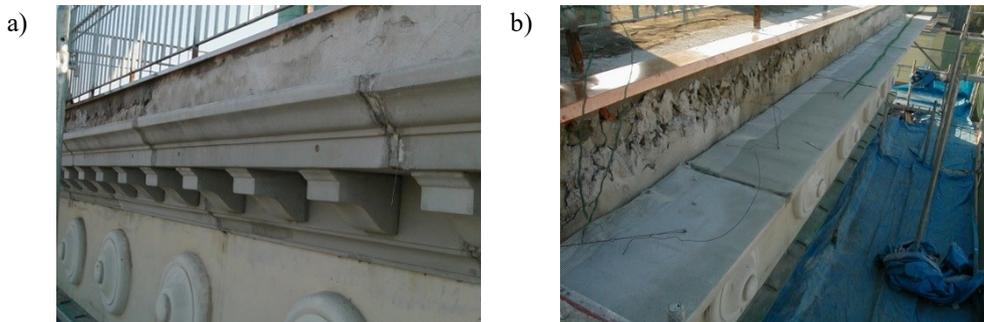
Fig. 5. New cornice of the observation tower, a) bottom view with visible holes for mechanical connectors, b) top view with flashing of the tower ceiling.

A new flashing of the cornice was carried out and based on a new support structure (timber soffit). Cornices and decorated corbels were made of hard Styrofoam, which was covered with a glass fibre mesh and then anchored with mechanical fasteners - Fig. 5. The last stage was the performance of a new flashing. Finally, the cornice was painted with a silicate façade paint in the colour of the existing façade.

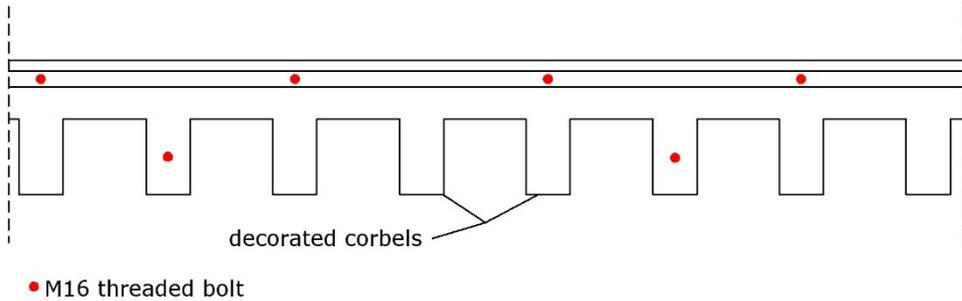
Fig. 6. Scheme of cornice anchoring on each façade with mechanical fasteners.

In order to calculate the necessary number of fasteners for fixing the cornice, the design load was determined by the wind pressure [4]. In these calculations, the height of the tower, the exposure coefficient and gusting were taken into account. The number of fasteners was designed not due to the tearing off, where two fasteners (M16 threaded bolt) were sufficient to transfer the load over the length of one tower wall, but due to the pressure surface. One wall should have $15 \div 16$ connectors (M16 threaded bolt). Their layout has been designed in accordance with the scheme presented in Figure 6.

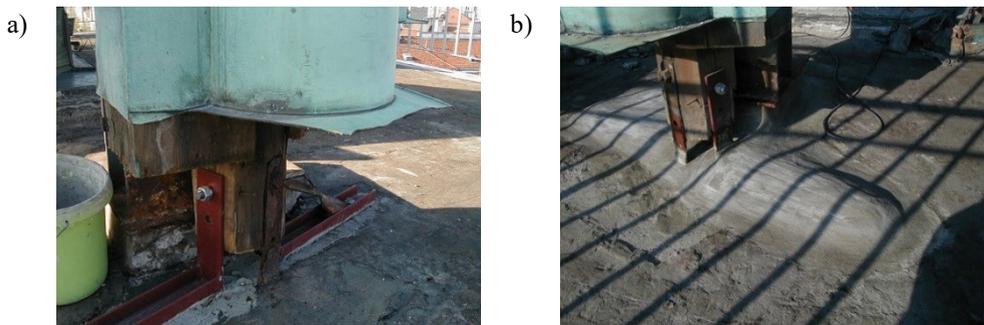
Fig. 6. Designed foundation for gloriette pillars, a) steel anchors, b) protection of the anchor with the airtight concrete.

Due to the fact that after the renovation in 2001, the leakage of rainwater was observed, the new drainage system was designed in order to avoid a similar structure failure in the future. A very crucial element of the repair works was to ensure the proper safety of the foundation of the gloriette pillars as well as the supporting structure of the bells. According to the technology approved by the investor, the repair of the observation deck was carried out after previous disassembly of all existing layers of the terrace. Firstly, the foundations of the balustrades around the terrace as well as the pillars of the gloriette were reinforced. This required the removal of the lower part of the flashing of gloriette pillars up to a height of approx. 30 cm along with the cutting of the timber soffit. The foundation reinforcement of the columns was made by using steel anchors (two by each pole) bolted to the roof of the tower [4]. In order to obtain continuity of waterproofing, the designer proposed the steel anchors of terrace columns to be protected by the airtight concrete and the liquid foil - Fig.7.
