# The method of strengthening the church building in terms of the planned mining exploitation

**Abstract** This article describes the method of strengthening a church building in Ruda Śląska against predicted effects of mining exploitation. The building had been already exposed to effects of 22 mining incidents which significantly damaged walls and vaults. Therefore, it was decided to strengthen the building before new exploitation works. Strengthening works included longitudinal walls support with the tendon system built over the vault support. Additionally, ribs were strengthened by suspending them to new reinforced concrete ribs placed over the existing ones. And precast concrete cube elements were used in new ribs.

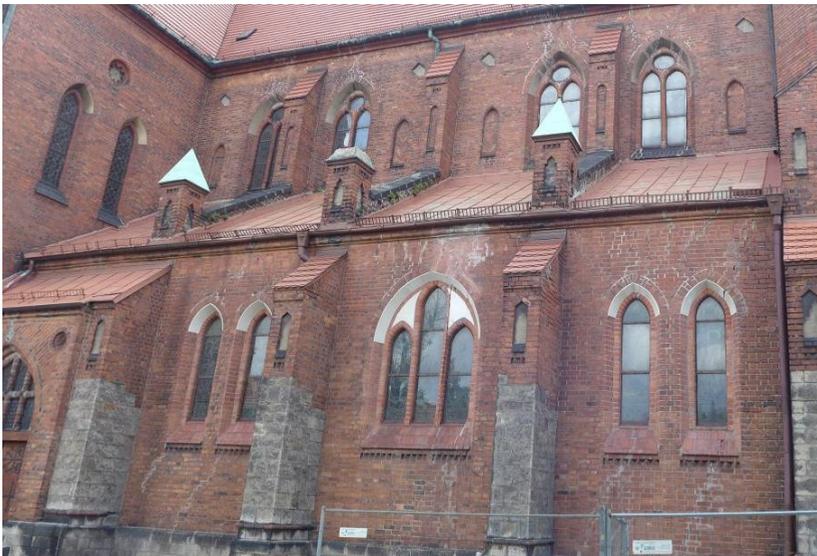
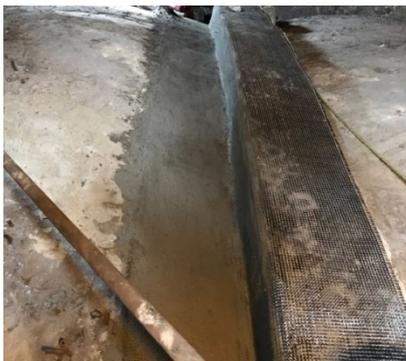
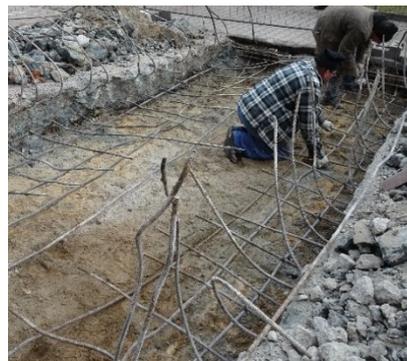
The building has been exposed to effects of exploiting 22 seams since 1930 [3]. In the 1970s, a reinforced concrete plate was performed around the church at the ground level according to the concept of prof. Ledwoń [4]. Further works just focused on eliminating effects of other exploitation works. Wall repairs were the most common. They included crack filling, rebricking, crack stitching with the helical reinforcement, and injections of cracks in vaults. In 2017, walls and extreme vaults from the tower side were considerably damaged by the tower tilting from the building. The reinforced concrete band was cracked and damaged (failure of the reinforcement continuity). Wall cracks were stitched with reinforcement and rebricked (Fig. 4a). The vault was repaired by injecting cracks and strengthening ribs from the upper side with FRCM (fiber reinforced cementitious matrix) - a carbon fibre grid embedded into the cementitious matrix. And the reinforced concrete plate was broken down. The reinforcement became again continuous by welding new inserts and recementing. More information about this repair is described in the paper [3].

**Fig. 4.** Strengthening works executed in 2017: a) remarks after repairing cracks in the elevation, b) strengthening ribs in the vault with FRCM system, c) repair of reinforced concrete plate.

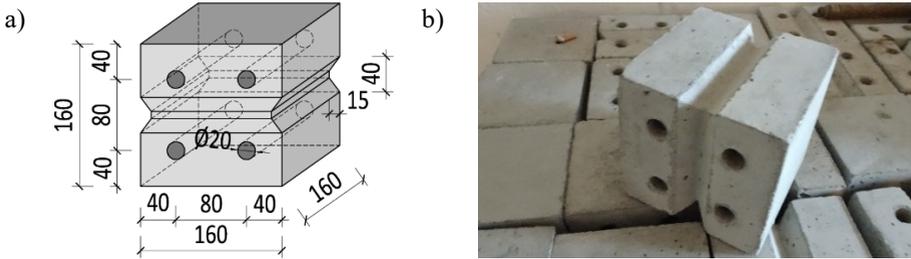
**Fig. 5.** Precast cube to strengthen the rib: a) dimensions, b) a view.

However, concreting even so small ribs in the church vaults may be troublesome, particularly during the transport of concrete mix over large distance and at height. To eliminate these difficulties, ribs were expected to be partially composed of precast units in the form of cubes with openings for rebars and intentionally prepared surface to anchorage normal concrete. A view and dimensions of the cube are shown in Fig. 5. Cubes are assumed to be arranged in the axial spacing every 32 cm, and space between cubes will be filled with normal concrete. Also, anchorage at the existing rib will be performed in these zones.

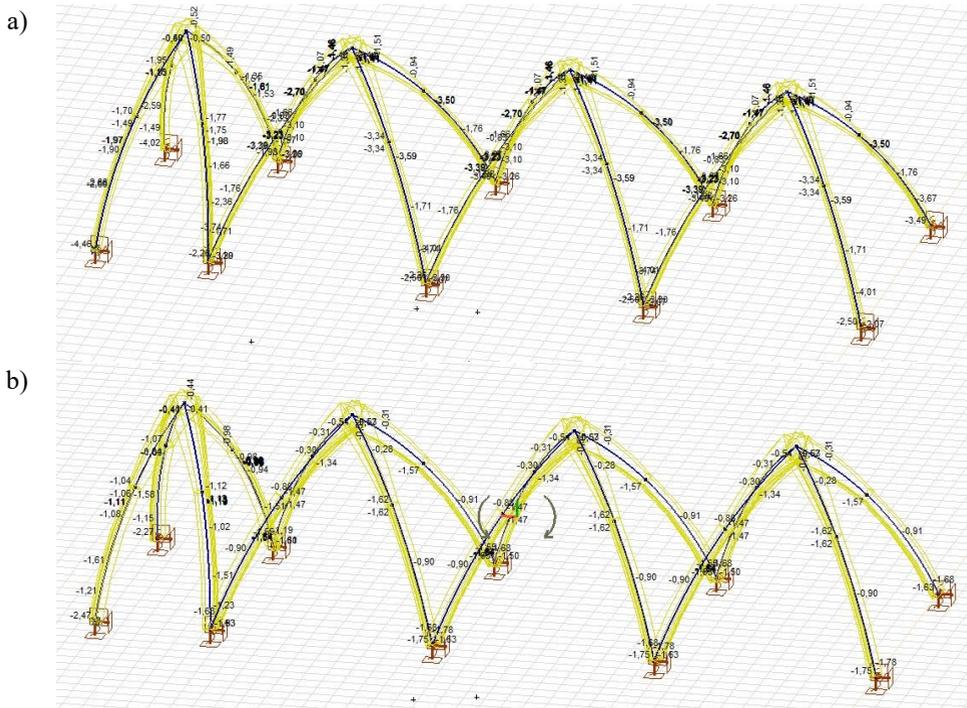
Fig. 9 presents computational results. Under existing conditions, maximum tensile stress is 3.59 N/mm<sup>2</sup> (Fig. 9a), and drop to 1.62 N/mm<sup>2</sup> after strengthening works. Tensile strength of the masonry [5] can be assumed equal to its bending strength from the plane at failure to the plane perpendicular to bed joints, that is  $f_t = f_{xkl} = 0.1$  N/mm<sup>2</sup>. Therefore, significant cracking of vaults will be observed in case of no strengthening. Otherwise, stress at ribs will be reduced by 50% and will be carried by strengthening elements. However, tensile stress will be still higher than tensile strength of the masonry. It means that designed strengthening should provide safety of the building, but cannot guarantee the lack of cracks in vaults.

**Fig. 9.** Tensile stresses in: a) the model without strengthening, b) the strengthened model.

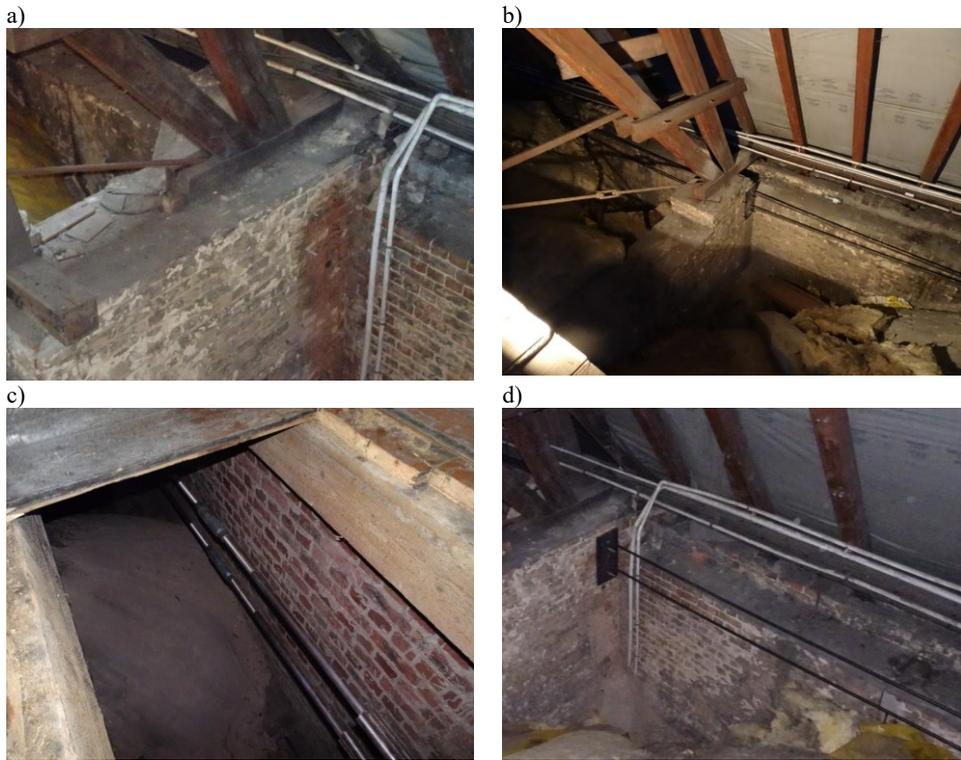
**Fig. 12.** Strengthening stages of the aisle with tie rods: a) making holes, b) placing tendons, c) placing stretching screws, d) stretching tendons.

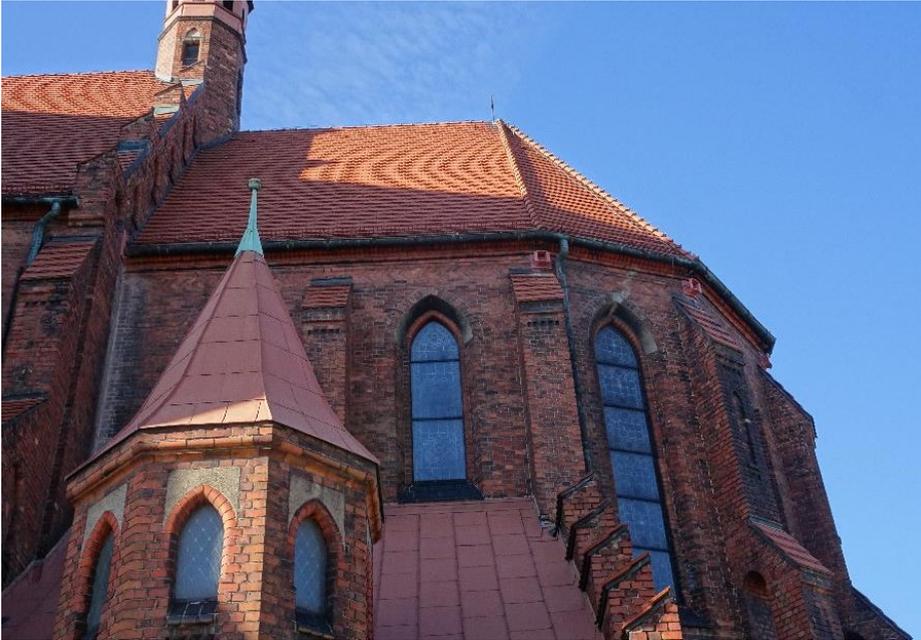
**Fig. 13.** A view of tendons outside the presbytery.

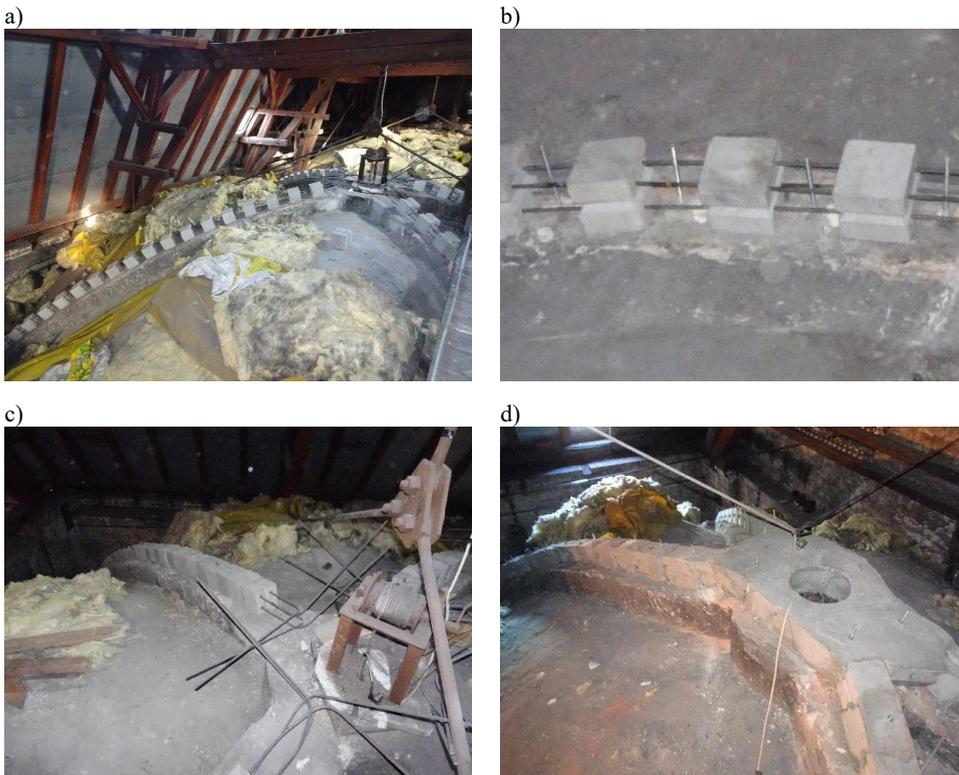
**Fig. 14.** Strengthening stages of ribs: a) placing cubes and reinforcement, b) assembly of anchors, c) concreting, d) concreting of keystone.

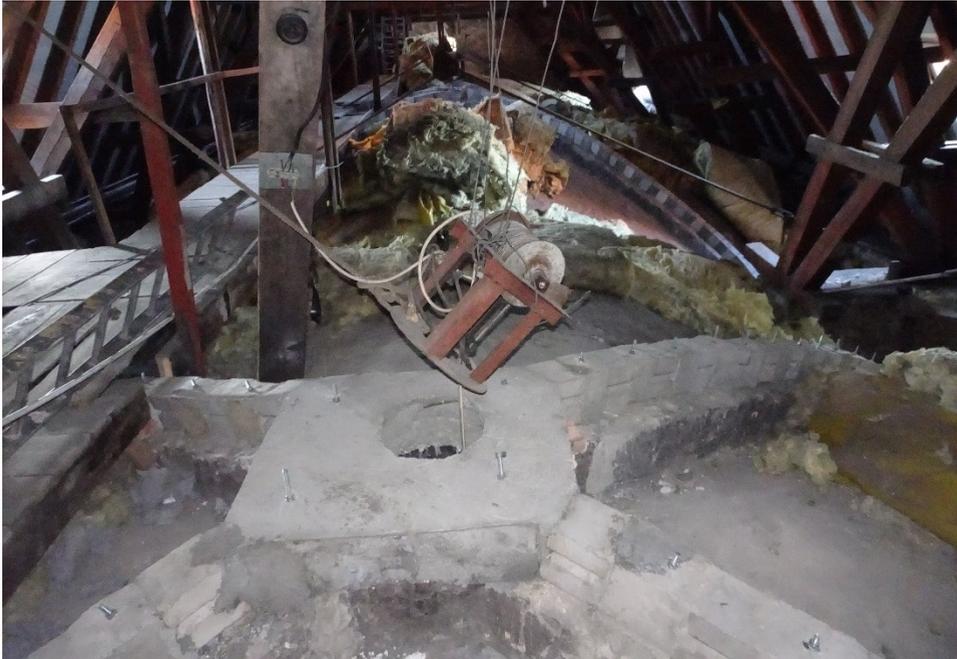
**Fig. 15.** A view of strengthened ribs.
