# Analysis of removal method of a 19<sup>th</sup> church's deflection

Krzysztof Gromysz<sup>1,\*</sup>

**Abstract.** A historic mid-19<sup>th</sup> C. church building is located on the area affected by the impact of underground coal mining. In the past, the building was secured many times against an adverse effect of the mining area deformation by providing massive reinforced-concrete reinforcements. As uneven depressions have emerged, caused by underground coal mining, the structure has become vertically deflected by 39 mm/m in the eastern direction. With the building length of 51 m, the corners have been vertically displaced in relation to each other by 1.99 m. The existing deflection impedes the structure's usage, decreases its value and threatens the stability of its furnishings. The deflection should therefore be removed. Due to the building's historic character and the presence of massive reinforcements installed already during its operation, three scenarios of deflection rectification were assessed. After the assessment, a scenario was chosen where the building is detached with the use of hydraulic jacks in the floor level, and then straightened by uneven raising. The lift

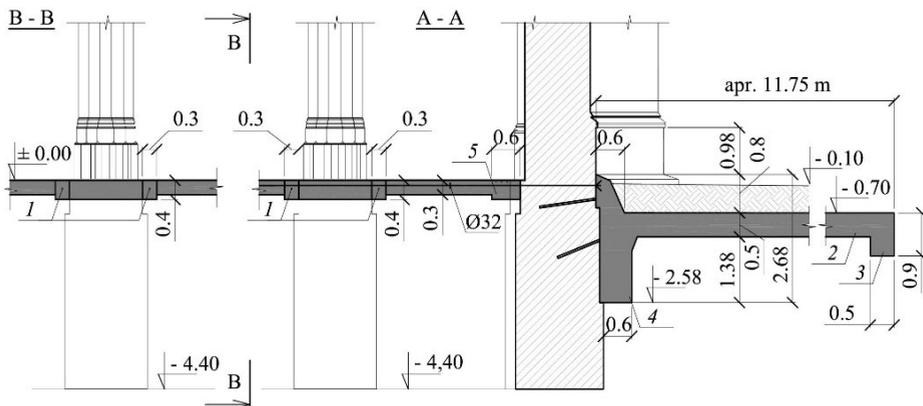
Apart from provisional repairs, the building was strengthened three times. First, ties were mounted underneath the church interior floor in 1955 – 1958. These are reinforced-concrete components with their cross-section (b/h) of 0.3 / 0.4 m, reinforced with a single bar with the diameter of 32 mm (*I* - Fig. 2). The ties are aligned parallel to the church axis and

Such strengthening has proved to be unsatisfactory when subsequent effects of mining have emerged [3]. Another reinforcement, installed outside the building under the ground level and under the floor inside the building, was thus executed in the mid-80's of the 20th c. A 0.5 m thick and 6 m to 16 m wide reinforced-concrete slab was constructed outside, at a depth 0.8 m below the ground level (2 - Fig. 2 and 2 - Fig. 1). The slab runs around the church and has an oval shape in the outline, which can be inscribed into a rectangle with the sides' length of 64 m and 46 m (Fig. 1). From outside, the slab is ended with a groin with the cross-section of 0.9 m / 0.5 m (3 - Fig. 2). From the side of the church, the slab is ended with a reinforced-concrete ring with a height of 2.68 m and width of 0.6 m (4 - Fig. 2). Moreover, inside the church under the floor, along the walls, a reinforced-concrete ring with the cross-section (b/h) of 0.6 m / 0.4 m was built in (5 - Fig. 2) and the hollows between the ties (made in 1955 - 1958) were concreted. The reinforcements described above were inventoried based on the uncoverings made outside and inside the building. For such uncoverings, boreholes had to be performed in a 0.5 m thick reinforced-concrete slab outside the building (Fig. 3 a,b) and a concrete layer had to be broken up between the ties installed inside under the floor (Fig. 3 c,d). The elements dismantled during uncoverings were restored.

**Fig. 2.** Building reinforcement outside the structure, below the ground level and reinforcement under the floor (position of cross-section A - A is shown in Fig. 1); 1 - reinforced-concrete ties reinforced with bar with diameter of 32 mm, 2 - reinforced-concrete slab, 3 - reinforced-concrete groin, 4-reinforced-concrete ring outside the building, 5 - reinforced-concrete ring inside the building.

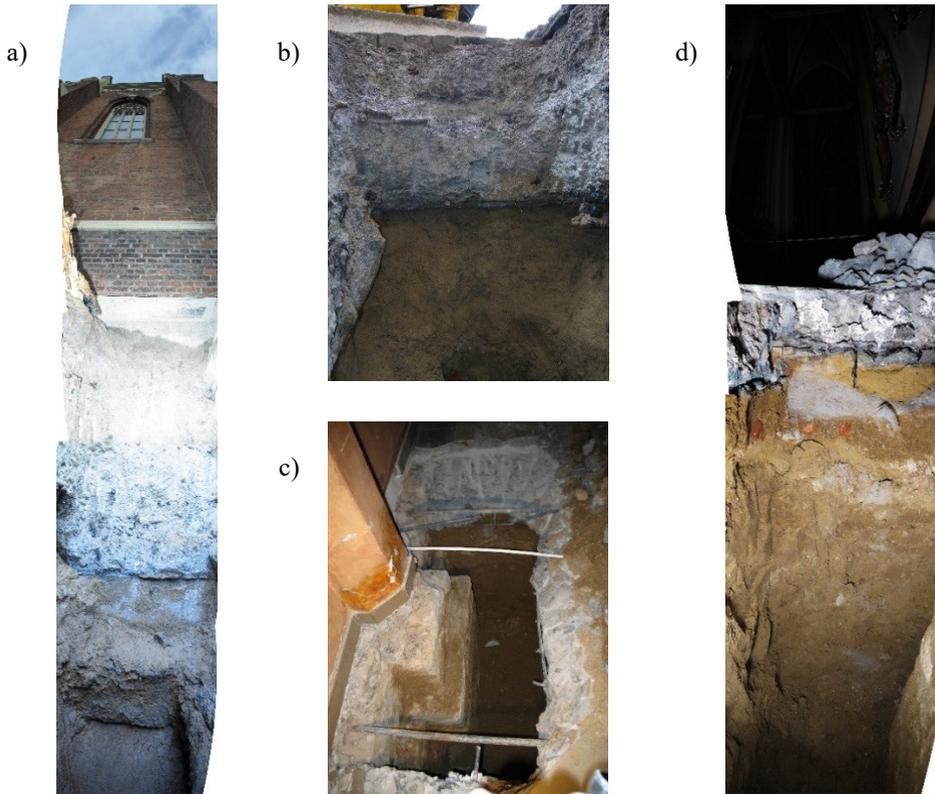
The church is founded on 2 m wide foundation walls made of stone and brick. The uncoverings (see Fig. 3) and measurements made show that the base of such walls is 4.40 m below the floor level. A roof structure over the church is made of a wooden frame with a double suspension system. The roof is covered with zinc-plated sheeting laid on full boarding.

**Fig. 3.** Uncoverings made to take an inventory of reinforcements and building foundation (uncoverings were made in the place of the cross-section A - A from Fig. 1): a), b) reinforcement situated outside, below the ground level, c), d) reinforcement situated inside under the floor.

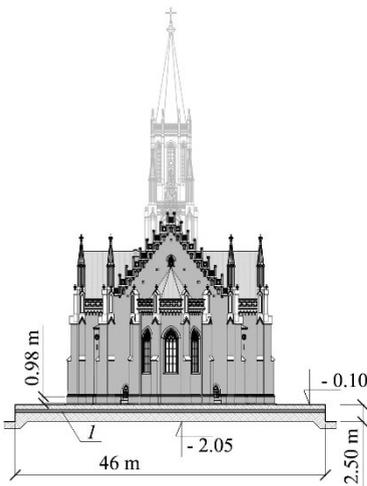
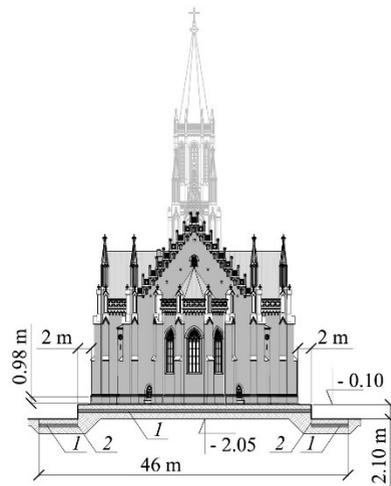
**Fig. 4.** Alternative methods of uneven raising of the church building – view of eastern façade: a) a scenario where the building is straightened with the whole reinforced-concrete reinforcement, b) a scenario with deflection removal from part of the reinforced-concrete slab, after its cutting at the distance of 2 m from the wall edge; *I* – reinforced-concrete slab with the thickness of 0.5 m, 2-the cutting surface of the reinforced-concrete slab.

Three scenarios of uneven building lifting were considered. In the first scenario, the building is raised together with reinforced-concrete reinforcements situated under the church floor and below the ground level outside the building. A neo-Gothic church building was straightened this way, for instance [4]. However, for the structure covered by this work, as a result of such a procedure, the eastern edge of the reinforced-concrete slab - representing an external church reinforcement - would have been 2.5 m (64 m × 39 mm/m) above the ground level situated directly by the cemetery (Fig. 1). A 2.5 m high wall would then be created in the eastern part of the building (Fig. 4a), which would impede the traffic of pedestrians and vehicles around the building. This scenario was rejected for those reasons, although, as

Another considered scenario was uneven raising of the church building together with a separated part of the reinforced-concrete slab outside. It was assumed for this aim that, reinforced-concrete reinforcement would be cut at a distance of 2 m from the edge of the building (Fig. 4b). This way, the plan of the reinforced-concrete slab attached to the church walls could be inscribed into a 55 m long (51 m + 4 m) and 34 m wide (30 m + 4 m) rectangle. The church building, with part of the slab contiguous to the building, would be lifted unevenly in the considered scenario. Up to 2.1 m (55 m × 39 mm/m) high wall would thus be formed around the church in the eastern part – Fig. 4b. Such a wall would however greatly interfere with the historic character of the structure and its surroundings. As a result, this scenario was also rejected.

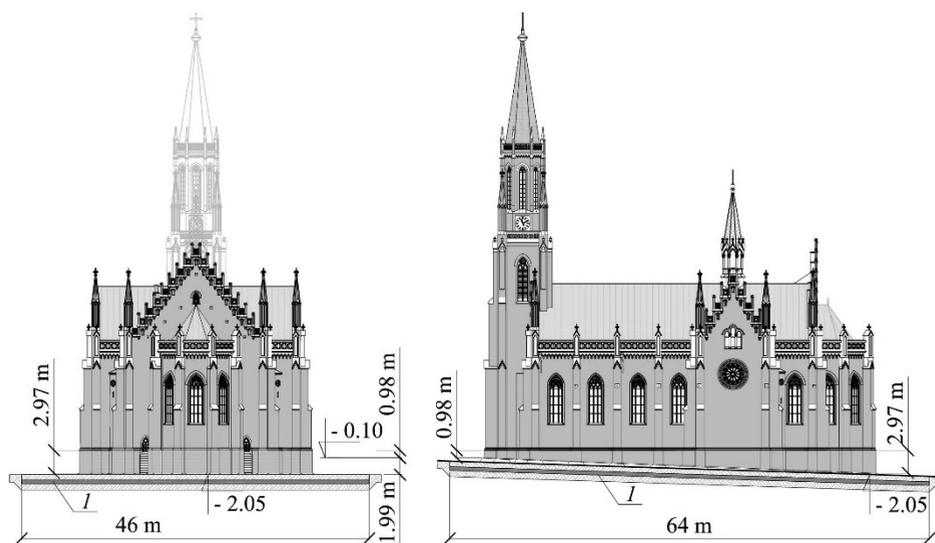
**Fig. 5.** Adopted method of uneven raising of the church building: *I* – reinforced-concrete with the thickness of 0.5 m.

The third considered scenario of rectifying the building deflection is to detach it, in the floor level of naves and presbytery, and then to lift unevenly only the above-ground part of the building situated above the detachment plane. In this scenario, all the reinforcement components situated below the floor and the ground level are not lifted and no interference with their construction takes place. The eastern edge of the building is raised by 1.99 m (51 m × 39 mm/m) with such procedure. As a result, the height of the plinth, which originally was constant and was 0.98 m, will increase from 0.98 m in the western side to 2.97 m in the eastern side (Fig. 5). A vertical position of the front entrance to the church, leading through a tower, will not change when the deflection is eliminated. Additional stairs and ramps will be provided by the side entrance to the building leading through a transept and by entrances to the sacristy.

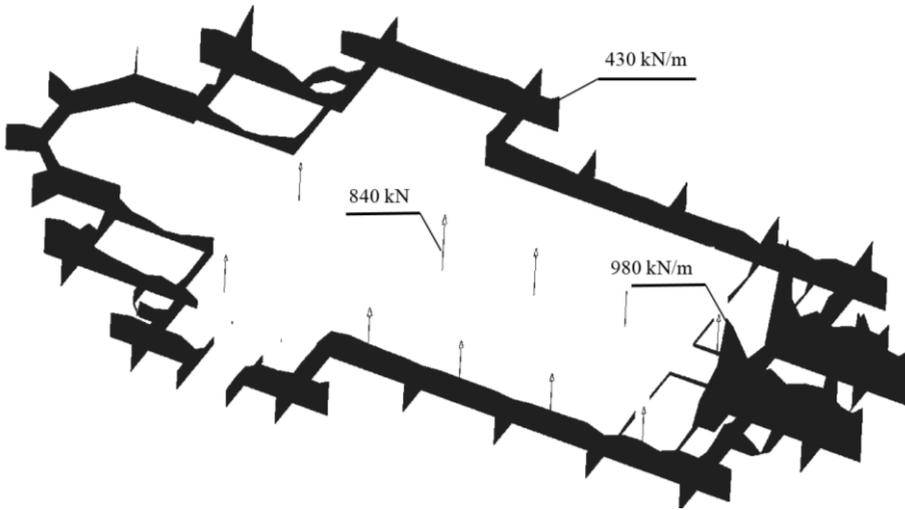
It was assumed in the first stage that the walls and columns are mounted in the level of the proposed building detachment (level 0.00). A distribution of reactions, transferred from the above-ground part of the church onto the foundation walls, was obtained for such scheme (Fig. 7). Maximum reactions in the linear supports of nave walls amount to 430 kN/m and in linear supports of the tower walls to 980 kN/m. On the other hand, maximum reactions in the brick columns of the building amount to 840 kN. When the distributions of reactions were known, the jacks were started to be positioned. It was assumed that for uneven building lifting, jacks working in two modes, active and passive, will be used. Upward displacement of the building will be forced with jacks. The jacks will be installed in brick columns, pilasters and in parts of walls with no door and window openings. A force with the constant value of 50 kN will be excited in passive jacks. The jacks will be mounted in walls in the region of window openings. The task of passive actuators will be only to balance the weight of some of the walls situated under window openings. 113 active jacks with the load carrying capacity of 700 kN, 46 active jacks with the load carrying capacity of 1500 kN and 19 passive jacks were proposed for removing the building's deflection (Fig. 8). The jacks with the greatest load carrying capacity were mounted mainly under the tower.

**Fig. 7.** Distribution of reactions transferred onto the foundation walls at the level of  $\pm 0.00$  m.

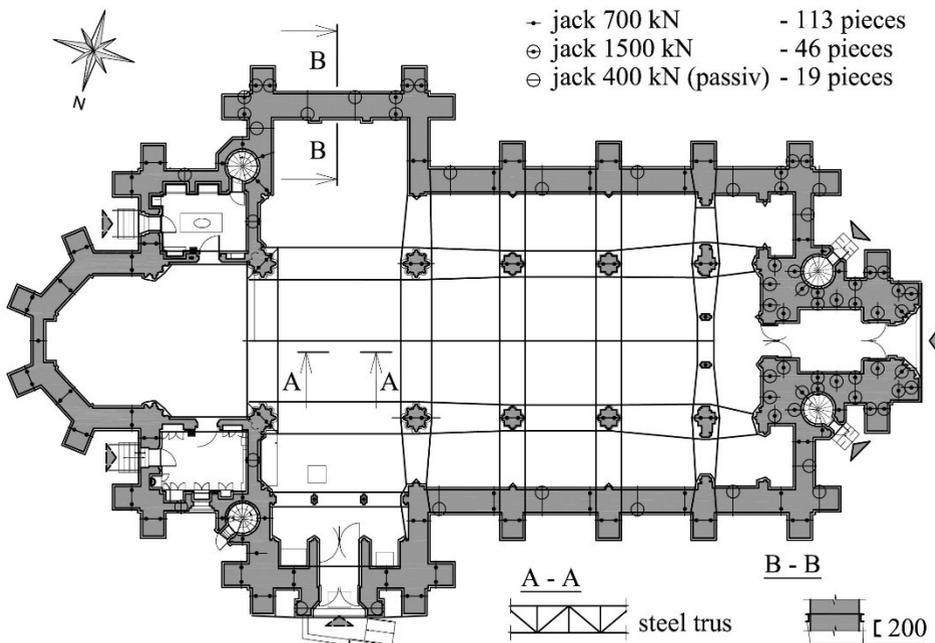
**Fig. 8.** Proposed reinforcement and layout of jacks.

The church should be strengthened prior to the start of uneven raising. Two types of steel reinforcements were adopted: a configuration of I 200 profiles running on two sides by the walls and elements in the form of trusses led inside the building parallel and perpendicular to the axes of naves (Fig. 8).

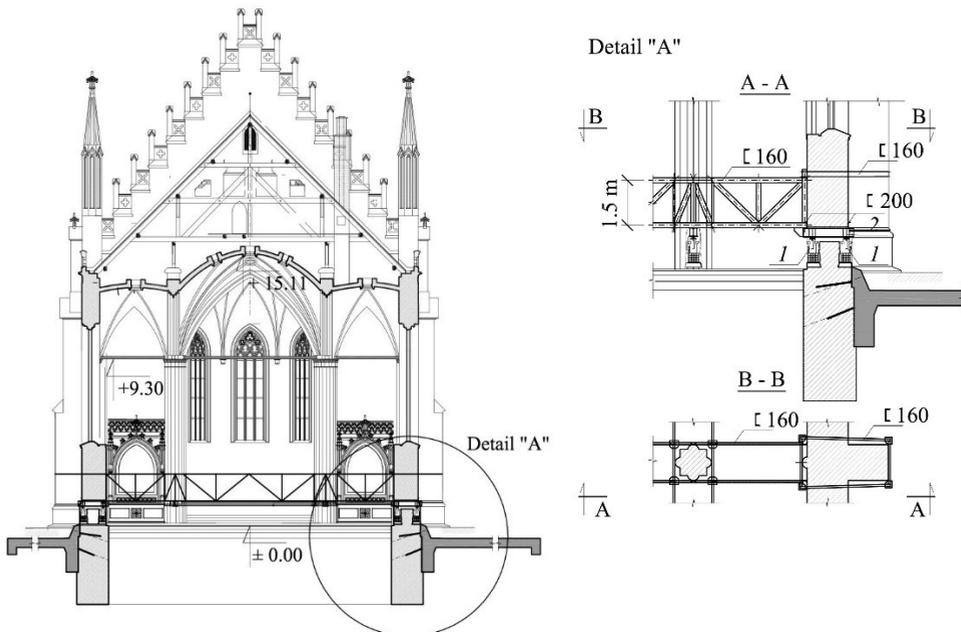
**Fig. 9.** Reinforcement with a truss and a method of transmitting a force from the jacks onto the walls; 1 – jack, 2 – HEB profile.

interlinked profiles are hence acting as lintels. The truss elements though, ensure the stability of the construction's elements during uneven raising. Their role, therefore, is in particular to reduce the buckling length of the brick columns separating the naves when they rest on jacks. The truss elements will also transmit forces caused by second-order effects. Second-order effects will arise due to the eccentric transmission of the load by jacks and as a result of material inhomogeneities of the brick columns. In such case, each of the columns, on the detachment level, from four sides, will be connected with reinforcements represented by truss elements.

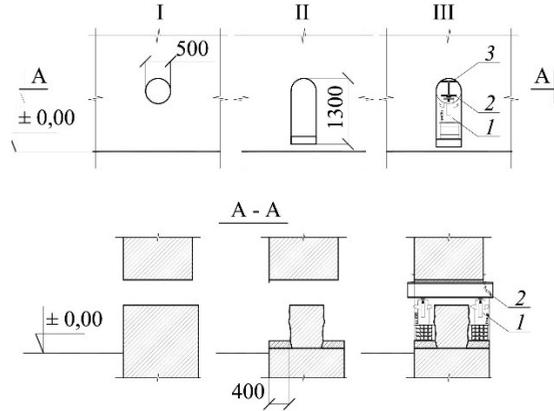
**Fig. 10.** Phases of jacks' installation in the walls (I, II, III); 1 – jack, 2 - rolled HEB profile, 3-layer of mortar.

An opening with a diameter of 500 mm will be drilled through the entire thickness of the wall in the first place (Phase I - Fig. 10). Then, in the outer parts of the wall, the opening will be expanded by elongation to the floor level in such a manner that jacks are placed there from both sides (Phase II - Fig. 10). Part of the wall thickness will then be enlarged only, ca. 400 mm from each side. Then (Phase III - Fig. 10) an HEB profile will be inserted into the opening and lifted with jacks to the opening edge. The space between the circular part of the opening and the HEB profile will be filled with mortar. In order to stabilise the position, the HEB profile will be welded to a reinforcement consisting of 200 profiles.

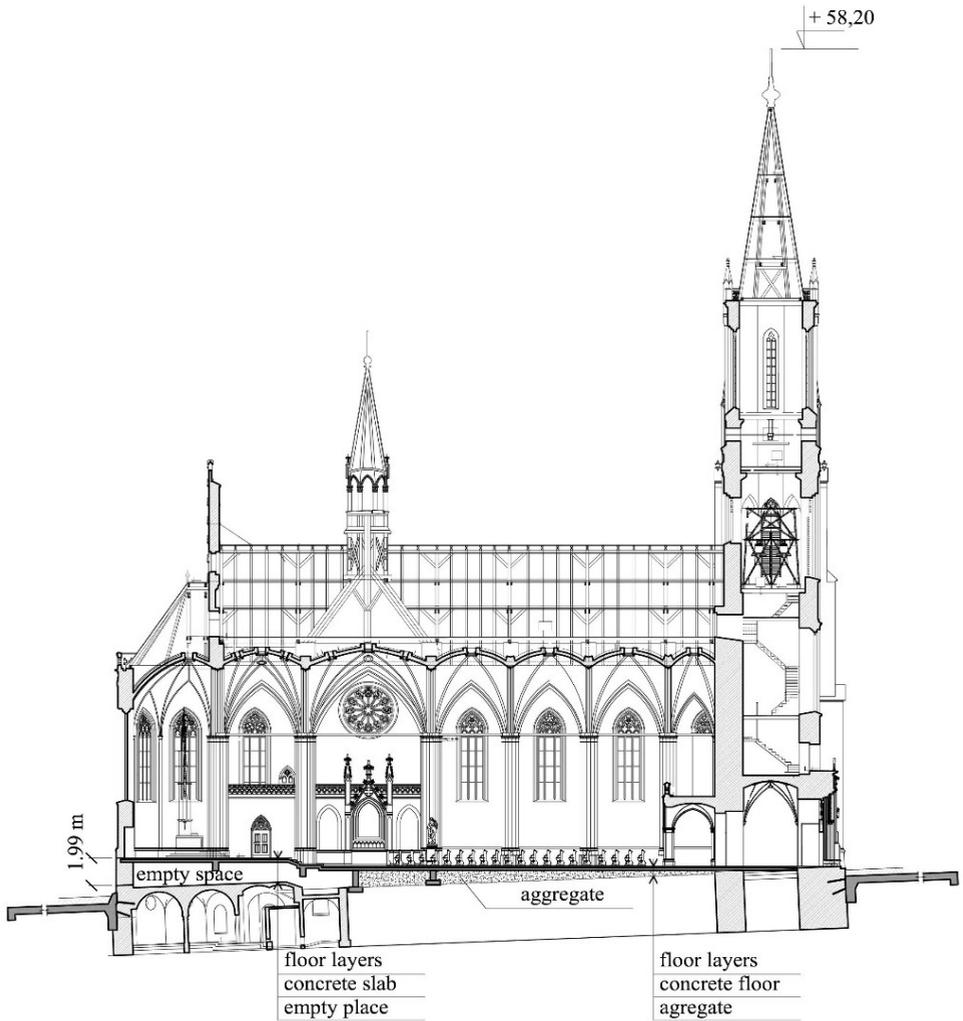
**Fig. 11.** Building cross-section after straightening.

The reinforcements described are temporary and will be dismantled after removal of the structure's deflection. After straightening, the walls in the presbytery will be elevated by up to 1.99 m. A new reinforced-concrete ceiling will be constructed to counterbalance the floor level in the church presbytery and in the part of the transept (Fig. 11). The ceiling in the presbyterial part will be rested on outer walls. In doing so, the original ceiling over the basement part will not be loaded. A hollow will be formed between the existing ceramic ceiling and the new reinforced-concrete ceiling. A new reinforced-concrete floor will be created on the remaining part of the church.
