Cracking of the Vault in a Church Building and Activities Undertaken in the View of the Further Mining Exploitation

Abstract. The paper concerns a church building, where as a result of mining exploitation a number of damages have been observed, including cracking of the nave. The method of repairing the damage was presented. Taking into consideration the further planned mining exploitation, a concept was put forward to reinforce the church with steel tie rods at the level of the vaults over the nave, which will provide for its protection against adverse impact of the tilt of the land surface.

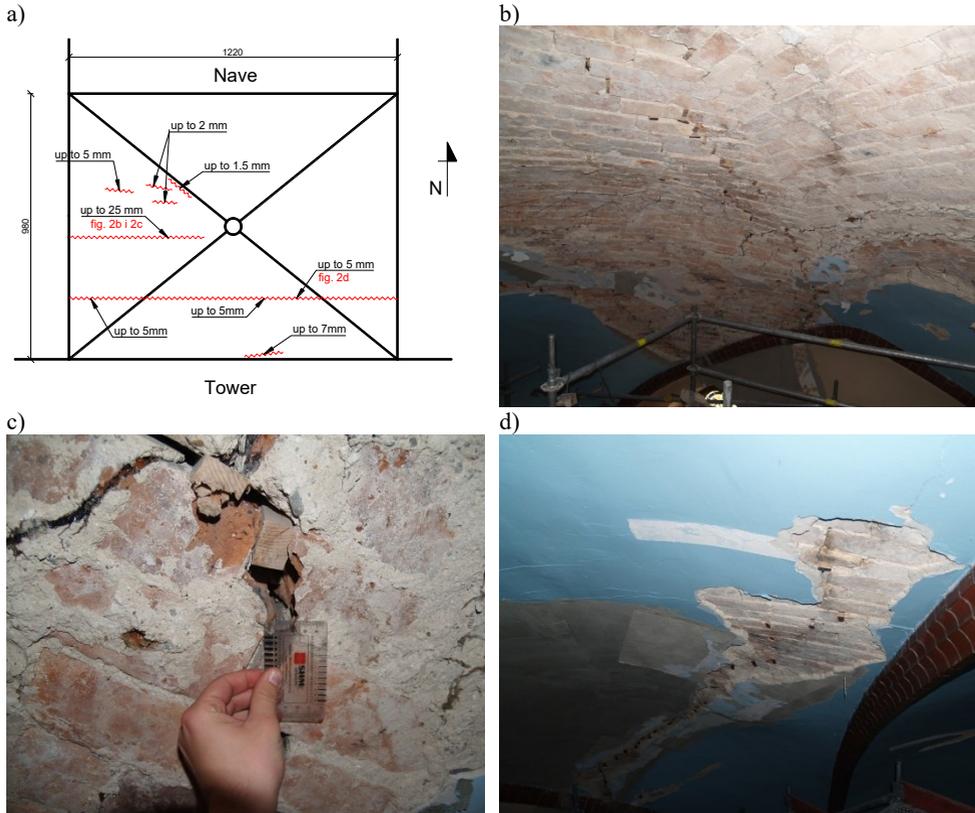
As a result of the different directions of inclination of the church and the tower, in the first vaulted field adjacent to the tower significant cracks shown in figures 2a – 2d occurred.

Fig. 2. Inventory of the vault cracks: a) the crack location and aperture width (dimensions in mm), b) ÷ d) a view of the cracks.

- as a temporary measure oak wedges were installed in the cracked vault,
- injecting from the top of the cracking of the first vaulted field of the nave with a swelling hydraulic cement (cracking with aperture >5 mm) or epoxy resins (cracking with aperture <5 mm),

- from the bottom, the vault was covered with a layer of adhesive, steel and plastic fasteners were used to fix steel mesh to the vault, which was then covered with a layer of adhesive to embed the mesh,

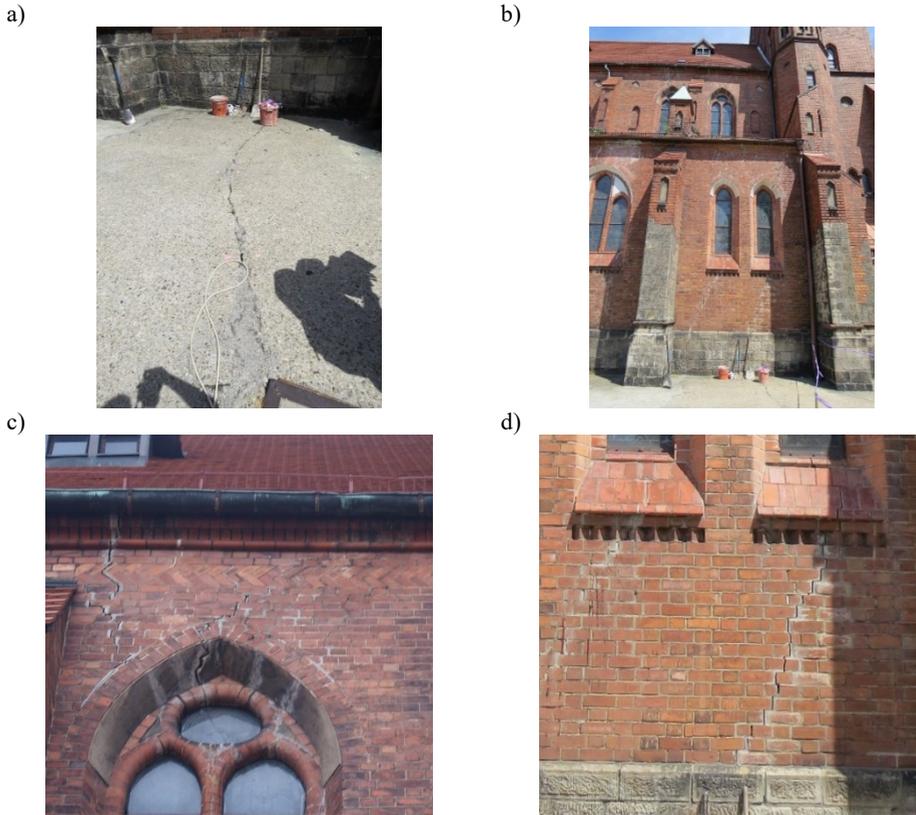
In addition to the vault damages, cracking with a width of 20 mm of the perimeter slab were recorded outside of the church which are visible at the western side of the church building at the location of the expansion gaps (Fig. 3a) as well as cracking of the nave walls (Fig. 3b) in their upper parts (Fig. 3c) and of the aisle walls in their lower parts (Fig. 3d) with a maximum aperture starting also from 20 mm.

Fig. 3. Examples of damages recorded outside the church: a) cracking of the reinforced concrete slab, b) diagonal cracking of walls, c) walls and lintels of the nave, d) walls of the aisle.

- rebuilding and reinforcing with spiral rebars and two prefabricated ceramic lintels of the cracked eastern wall of the nave from the inside of the church,

- rebuilding and reinforcing with spiral rebars of the cracked western wall of the nave from the inside of the church,
- rebuilding and reinforcing with spiral rebars of a fragment of the western wall of the aisle in the sub-window and lintel section,

- welding of rebars to the ripped bars of the reinforced concrete slab at the western side of the church, after which the hammered-off part of the slab was concreted,

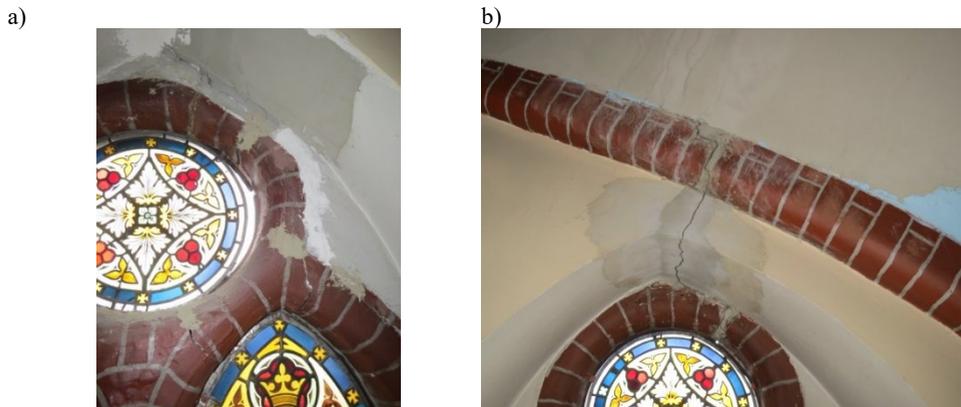
Inside the church, damages within the plate traceries (Fig. 4a), cracking of walls, lintels, ribs and arches with an aperture of 4 – 20 mm (Figs 4b, 5a, 5b) and cracking at the joint of vaults and ribs have been observed.

Fig. 4. Examples of damages recorded inside the church: a) cracking of the plate traceries, b) cracking of the lintel.

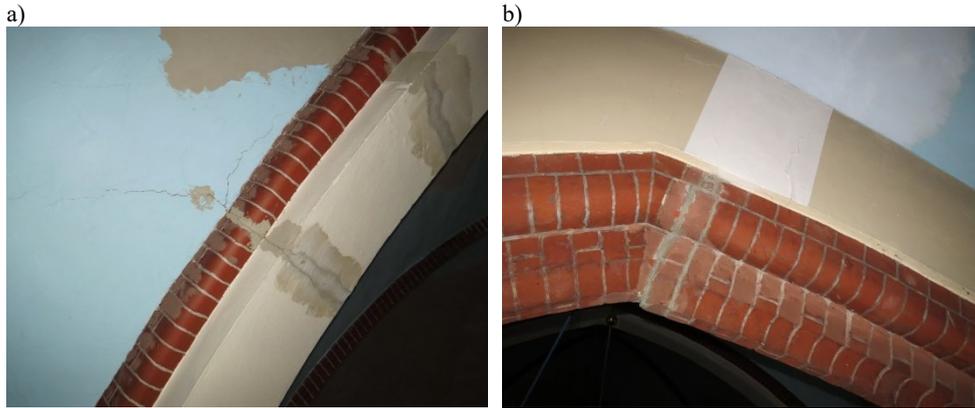
Fig. 5. Examples of damages recorded inside the church: a – b) cracking of ribs and arches.

- reinforcing the rib of the vault with a system of carbon fiber meshes according to the scheme shown below (Fig. 6). Fragments of the carbon fiber mesh left after the rib reinforcement were placed on the previously cracked surfaces of spannings.
