About problems with cast iron columns of the revitalized post-industrial buildings

Tadeusz Urban¹, and Michał Goldyn^{1,*}

¹Lodz University of Technology, Department of Concrete Structures, al. Politechniki 6, Łódź, Poland

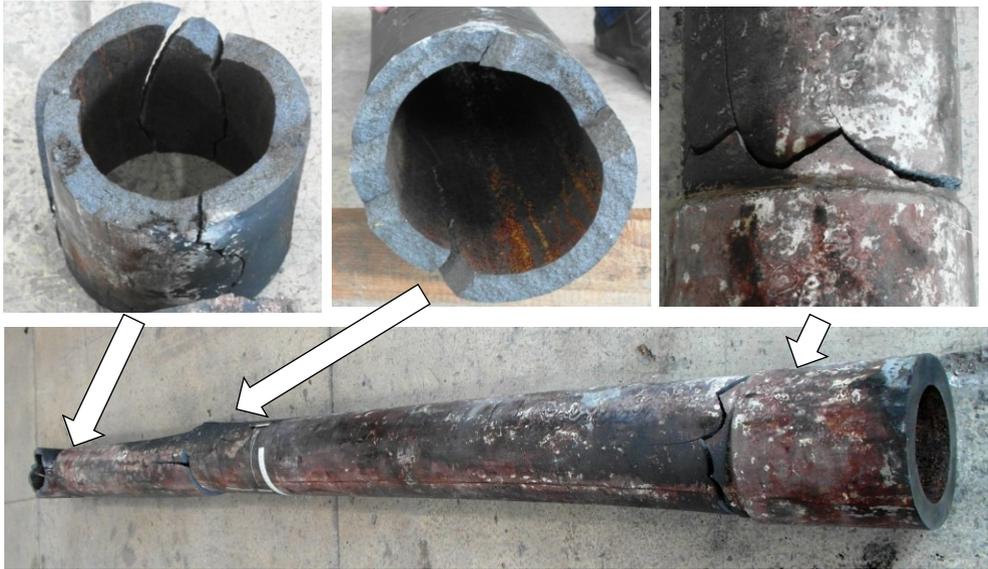
In the initial phase of the test, uniform shortening of the column related to loading was recorded. At about 70% of the destructive force that gradual deformation (bending) of the column was visible. Immediately before the failure the deflection of the column with respect to the original axis was a few millimeters. Failure was a result of the loss of stability (buckling) at a force equal to $F_{max} = 2605$ kN. In the Figure 5 the column after folding from parts, in which was divided into as a result of the explosive destruction, was presented. It broke in three locations: at the base, in $2/3$ of its height and in the vicinity of the upper head.

Fig. 5. View of the column after end of the test.

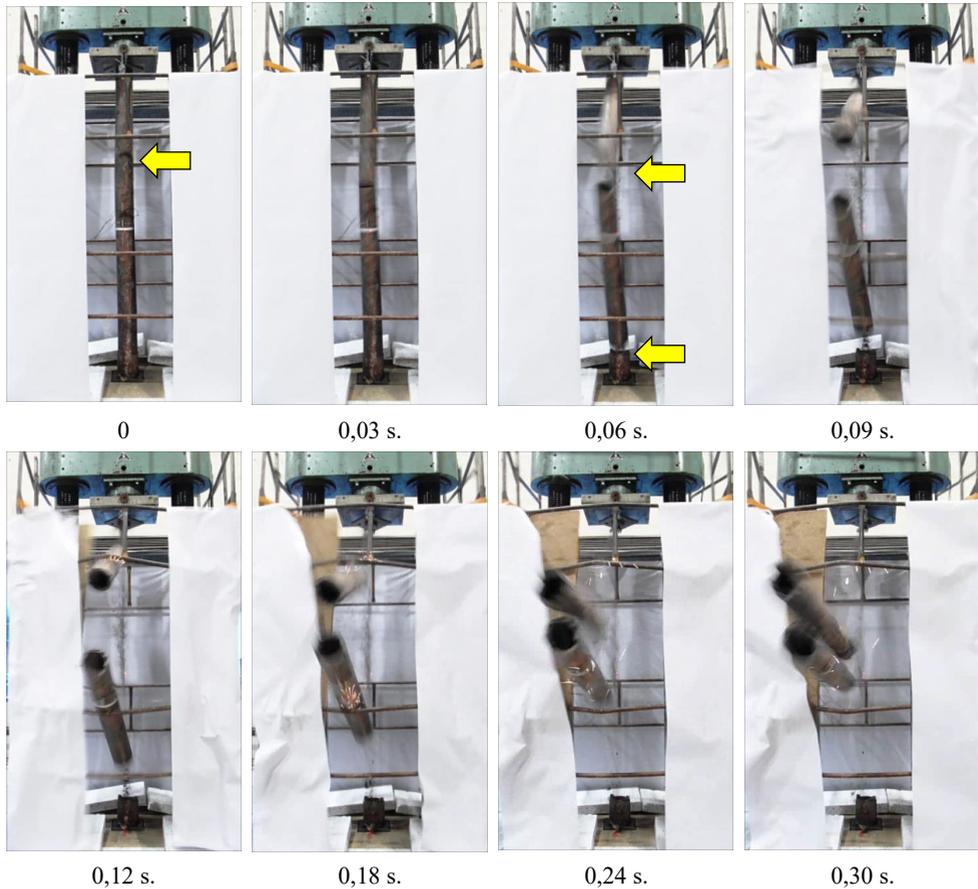
The destruction was extremely violent and occurred within fractions of a second. This is clearly seen in the time-lapse analysis carried out after the test – see Fig. 6. The failure was initiated by a crack formed in $2/3$ of the column's height (the place marked with a yellow arrow in Fig. 6). Immediately after the occurrence of the first crack, another one was observed adjacent to the column base. The energy released during the fracture was so high that fragments of a large size were found a few meters from the test setup.

Fig. 6. The course of column destruction - time measured from the moment of the first crack occurrence.

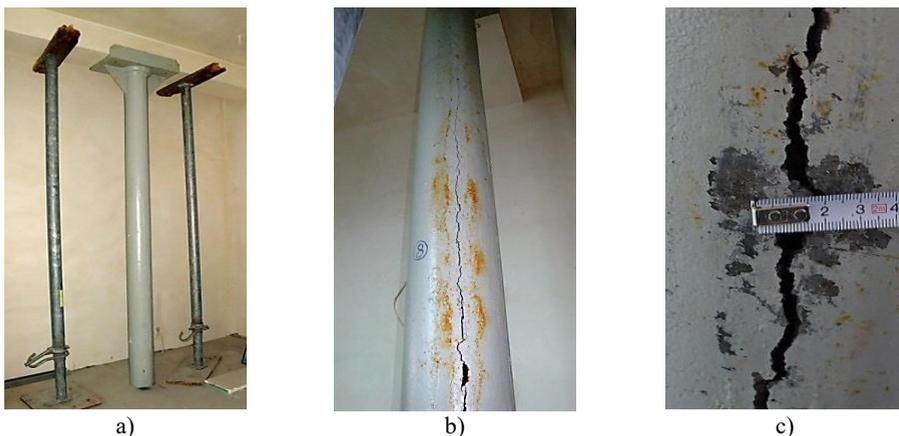
Adaptation of the existing cast iron columns may sometimes encounter significant difficulties. One of the examples of such a situation was the revitalization of post-industrial building at Tylna street in Łódź. Due to the change of use of the building for residential purposes replacement of wooden ceilings with reinforced concrete slab while maintaining the original layout of cast iron columns, was planned. In winter time, at temperatures of about -20°C , as recorded in 2013, vertical cracks of a width up to several millimetres were noticed in some of the columns on the ground floor – see Figures 9a and b. The width of the largest cracks reached about 7 mm – see Fig 9c. These cracks resulted from action of the mixture of water, oil and cement paste which froze and increased its volume inside the columns. The oil was a remnant from the period of functioning of the spinning mill, while water got inside the columns probably during the demolition works and casting of the floor slab. The contractor undertook an attempt to repair the damage by welding the vertical cracks. However, because the cause of the cracks was not removed, new cracks soon appeared, in the vicinity of previously welded joints.

Fig. 9. A view of the one of damaged columns on the ground floor of a revitalized building: a) a view of the temporary props, b) the vertical crack, c) width of the largest crack.

After an unsuccessful attempt to repair, expert advice was sought. In places of cracks, the introduction of steel clamps, welded with single-V joint has been proposed. In order to ensure good adjacency of the rings to the column during the welding, temporary clamps with a flexible washer were used. The number of rings was selected individually depending on the extent of cracks.

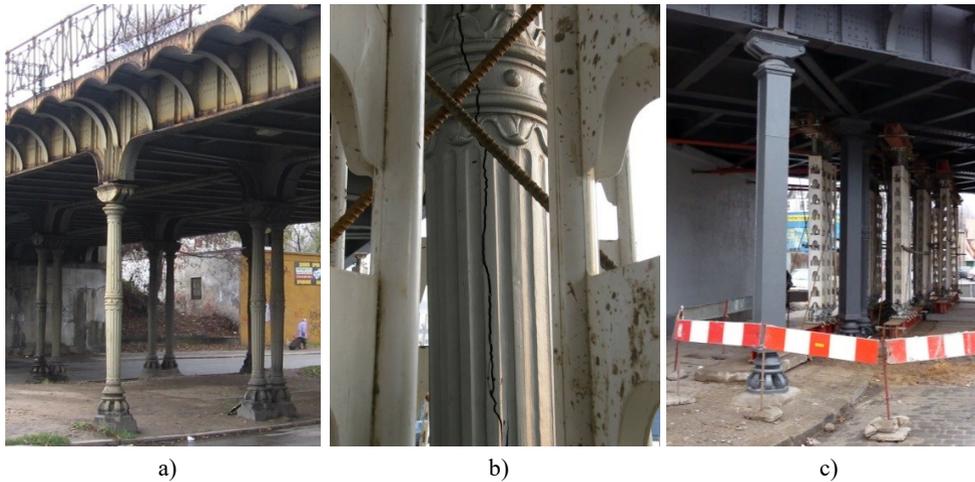
A very serious failure of cast iron columns took place also in December 2009 in Wrocław. As part of works related to the modernization of viaducts within the active railway line, the decision was made to strengthen the Hartung columns (*Hartungsche Säule*) – pinned-pinned columns constituting the span supports – see Fig. 10a. According to the original assumptions of detailed design, cast iron columns were to be strengthened by filling them with a coarse aggregate concrete mix, while the defects occurred after casting concrete were to be filled with epoxy resin. This kind of strengthening was previously used in Germany, where over 300 columns were successfully strengthened [6]. The high effectiveness of strengthening by filling cast iron columns with a concrete mix was also confirmed by the results of experimental investigations carried out at the Berlin University of Technology on elements taken from the S-Bahn city rail overpasses. As was reported in [7], the load capacity of columns was increased from 16 to 19%, while the deformation was reduced by 15 ÷ 35%.

Fig. 10. Supports of the railway flyover in Wrocław: a) before modernization works, b) after damage by freezing water, c) during replacement with new steel elements.

The strengthening carried out in Wrocław was however unsuccessful. This resulted from changes in the type of mixture as well as the replacement of an epoxy resin with a polyurethane resin, requiring the use of water to wet the substrate. Unfortunately, the above changes in combination with a significant drop in air temperature to several degrees below zero resulted in the damage of several columns – see Fig. 10b. The vertical cracks were the result of bursting by the water inside the columns. After several days, at the beginning of the thaw water began to flow out of from the cracks.

This failure caused significant difficulties in rail traffic, because it required temporary shut-off of the viaduct and the introduction of temporary supports – see Fig. 10c. One of the considered methods of repair was the use of carbon fibre wraps. Such a strengthening method was considered in experimental investigations of *Marcinowski* and *Różycki* [8]. They considered four cast iron columns subjected to eccentric compression. Two of them were wrapped with carbon textile. By using CFRP jacket the increase of the destructive force of about 70% was obtained. Ultimately however, the contractor replaced in Wrocław all of the cast iron columns (also the undamaged) for steel, with the shape corresponding to the original one.
