The analysis on causes of failure and strengthening of foundation slab with pre-tensioned CFRP stripes

Abstract. The paper presents an example of failure of the foundation slab of a complex of multi-storey buildings and an analysis of the complex reasons of its origin. In addition, the method and technology of the repair was presented in conditions of continuous, though limited operation of the facility, taking into account the existing limitations. The repair involved the necessity of performing specialized preparatory works, proper assembly and protection of the designed strengthening.

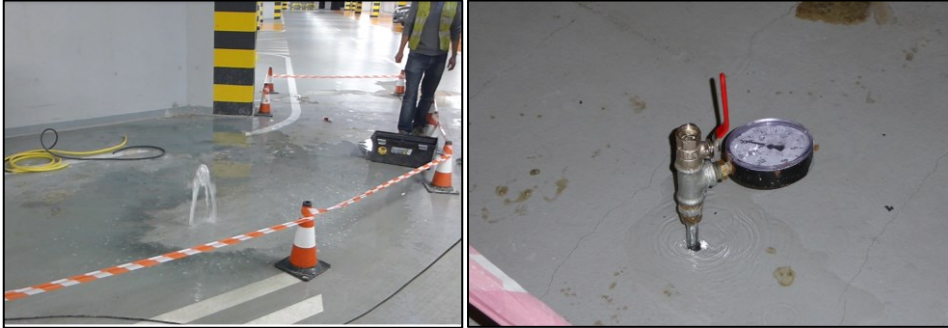
Before the object was put into operation, the appearance of cracks in the upper surface of the foundation, leaks and local water seeping through the foundation slab had been observed. Lack of tightness mainly occurred in the span areas between columns, but also in places of heads of removed temporary columns. During the sealing work, it turned out that in some areas under the foundation slab there is water under considerable pressure. The increase in the extent of damage on the upper surface of the slab along the perimeter of the building parallel to the diaphragm wall was observed (Fig. 2, 3). The local rise of the foundation slab

was stated after the geodetic survey. Attempts to seal the foundation slab by high pressure injection with materials based on polyurethane and acrylic resins did not bring the expected results.

Fig. 2, 3. Drilling through the foundation slab and water pressure measurement.

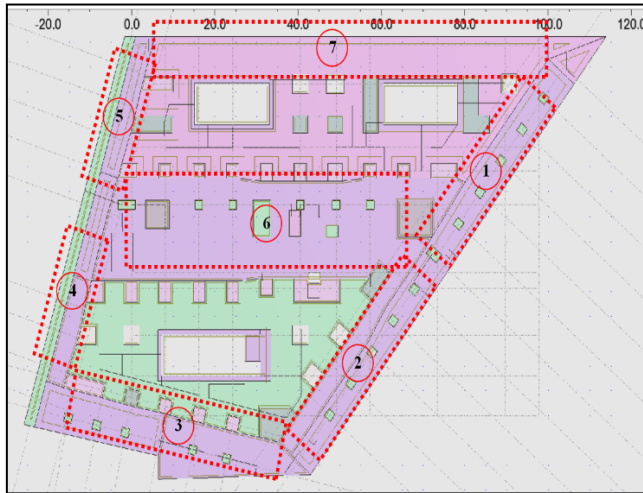
Fig. 4. Foundation slab plan – „-3” storey with 7 zones of strengthening works marked.

The slab was divided into 7 zones (Fig. 4). In particular zones there was an insufficient bearing capacity due to SLS or ULS and SLS together. The division into zones and stages was connected with the need for continuous, but limited operation of the garage.

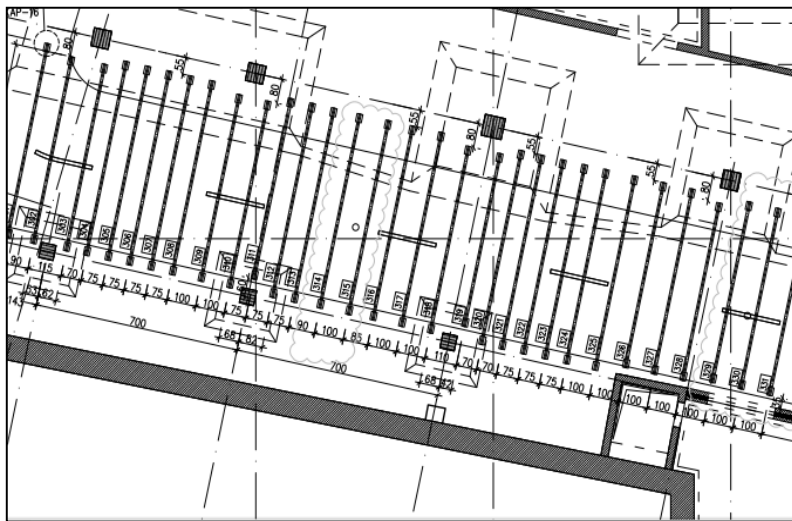
Fig. 5. Fragment of „-3” storey slab – pre-tensioned stripes layout.

In particular zones, by means of subsequent iterations, the required composite reinforcement was determined to obtain the expected capacity for the strengthened slab and that the crack size does not exceed 0.30 mm. Strengthening stripes with a minimum elastic modulus of 170 GPa and a cross-section of 140 mm² (Fig. 5) were assumed to be assembled.

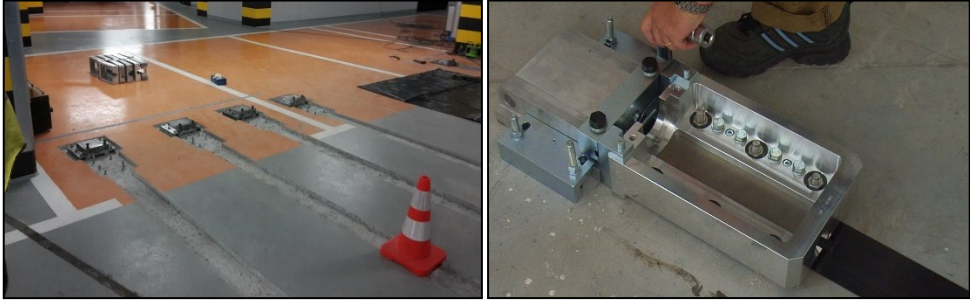
Fig. 7, 8. Assembly of the active and passive anchorage elements.

After installing the drainage system and performing the injection to pre-protect the strengthening zone against flooding, prestressing was started. Since the entire facility was operated during the repair, all loud works were carried out at night. The assembly of stripes was planned in the spans of a 0.40 m thick slab perpendicular to the existing cracks. In order to place the pre-tensioned stripes in the slab's structure, narrow cuts were first made in the top concrete cover to a depth of approximately 30 mm (Fig. 6). Then the anchoring elements were prepared and the stripes were assembled using prestressing force in the range up to 120 kN. Initial prestressing was achieved by hydraulic jack (Fig. 7, 8), and the level of prestressing was controlled by means of a manometer on the jack and by controlling the deformation of the stripe. The tension control was carried out on the base section between passive and active anchorage. The beginning of the base section at the passive anchorage was the place where the stripe was clamped in the clamping jaws, while the end of the section and the point of strain measurement was the area in the direct vicinity of the active anchorage. Due to the local occurrence of leaks, the epoxy resins binding in a moist environment were used during assembly of the stripes.

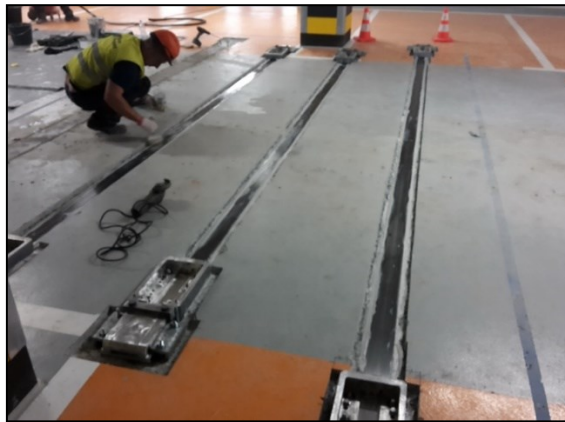
Fig. 9. View of the stripes after prestressing – preparation to reprofiling of finishing layer.

Prestressing of CFRP stripes positively influenced the reduction of crack opening and, as a result, the tightness of the structure. All elements of the reinforcement system were made of stainless steel, so no additional anti-corrosion coatings were used. After assembly and formal acceptance of the stripes, the upper surface of the slab was reprofiled with PCC mortar (Fig. 9, 10). After the prestressing, the last stage of the crack injection was carried out, and finally the resin floor of the garage was recreated. Since the completion of the works described, the building is continuously operated.

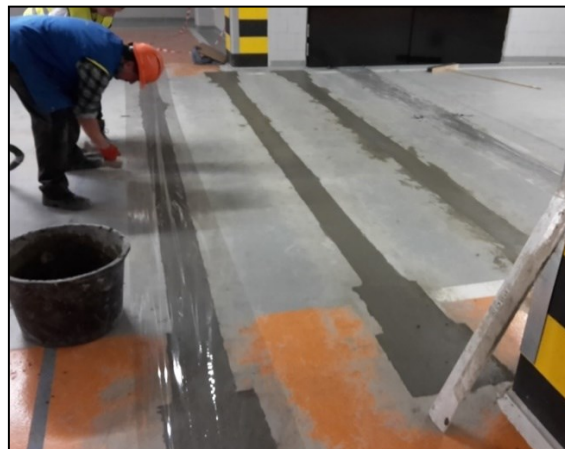
Fig. 10. View of the floor after reprofiling with PCC mortar.
