# Considerable cracking in the foundation slab in a multi-storey underground garage

**Abstract.** Multilevel underground garages are often an ambitious geotechnical task in urban agglomeration. Lower levels of foundation slabs are often located below the groundwater level, which requires effective protection of the structure against groundwater invasion. The constructor's task is to design slabs and walls so that no cracks will form to allow groundwater infiltration. In practice, this requires the development of a correct recipe for concrete; moreover, all factors affecting the total state of normal and tangential stresses as well as technologies allowing for correct execution of the facility must be considered. Additionally, long-term destructive factors ought to be taken into account. The article presents problems that arose during the use of an underground garage, which occurred as a result of failure to take into account at the design stage some rheological processes, as well as the assessment of the possibility of using the facility despite the damage.

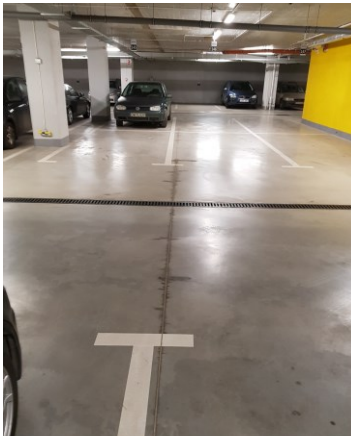
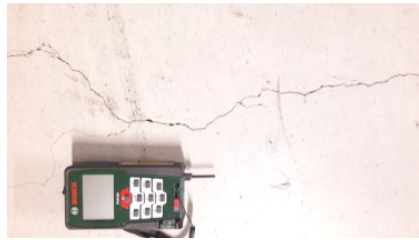
**Fig. 1.** Cracks in the parking slab with a width of over 0.6 mm.

In addition, an ongoing process of crack propagation can be observed (according to the interview carried out with the user's representative); their number, width and aperture is gradually increasing. The distance between cracks, in places strongly outlined, the width of which is more than 0.1 mm, is on average 0.40 m.

In his calculations, the designer allowed the creation of structural cracks in the slab with a width of up to 0.3 mm. The majority of cracks observed in the surface of the concrete slab have a width greater than the assumed critical width.

Appearance of cracking reduces tension in the slab. It is therefore justified to carry out repair (sealing) works on an ongoing basis. Because contraction processes and hydrostatic stresses can increase over time, it should be expected that repair of a particular element will not be a once-off process. Analysis of contraction stress indicates, however, that the number of new cracks appearing will eventually go down.

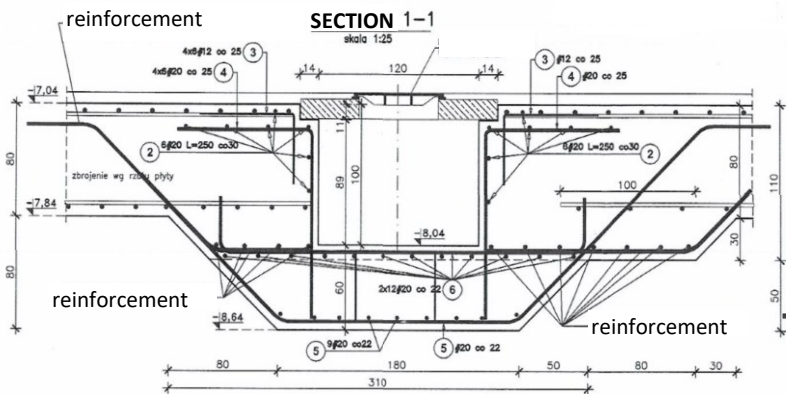
Reinforcement of the foundation slab (Fig. 2) is compatible in terms of elasticity and resilience with a large amount of reinforcement in thickened parts of the slab and at the location of reinforced concrete pillars. In the middle of the span between pillars, the static and anti-shrink reinforcement combined in both directions, at the bottom and at the top (double symmetrical and orthogonal reinforcement) is  $\phi 20$  every 22 cm, which gives  $\rho_1 = \rho_2 = A_s / A_c = 0.2\%$ .

Fig. 2. Typical reinforcement of slab in the place of column.

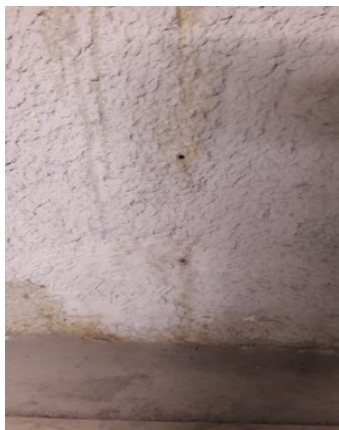
After every major rainfall, leakage of groundwater through the diaphragm wall is observed. This indicates damming up of groundwater and the difficulties it has flowing around the building during atmospheric precipitation as well as leaks in the connections of individual segments of the diaphragm wall. Local dampness is also observed at the connection points of the diaphragm wall with the foundation slab (Fig. 3). This means penetration of groundwater through some expander connections and through the walls. Leaks in the floor over the foundation slab are shown in Fig. 4. After every major atmospheric precipitation, it is necessary to perform injections in order to seal the walls in places of leaks.

**Fig. 3.** Dampness in the connection between the diaphragm wall to the foundation slab.

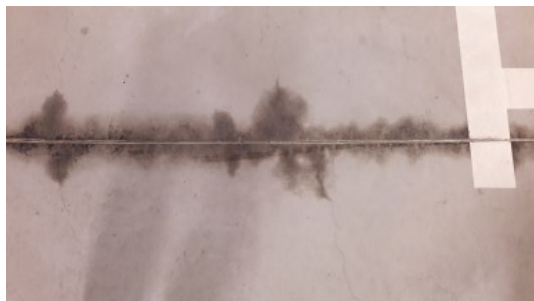
**Fig. 4.** Leaks in the floor over the foundation slab.

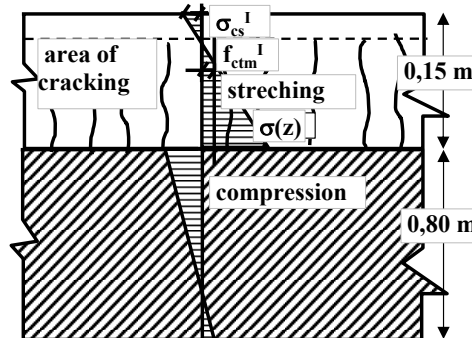
**Fig. 5.** Distribution of stresses in two slabs; the lower slab is older and the upper slab is younger and still maturing.

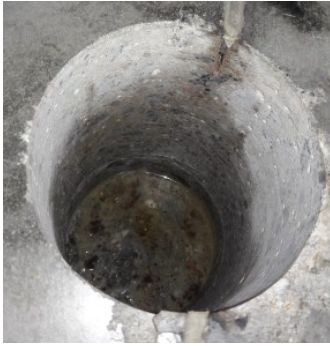
**Fig. 6.** Place of borehole with water.

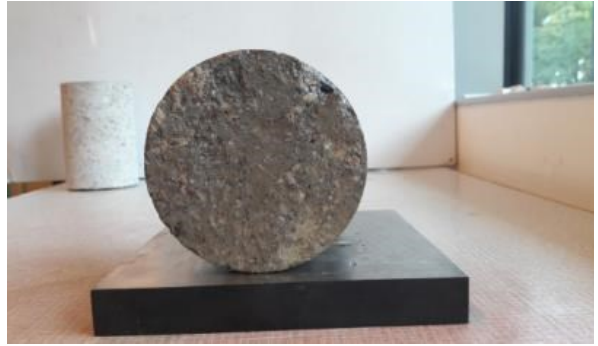
- In one of the samples, separation of the foundation slab from the floor was observed, which may indicate that the bonding layer had been cut.

**Fig. 7.** Sample cut from the concrete slab, bonding layer.

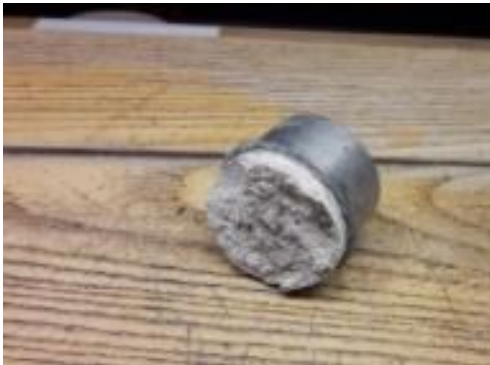
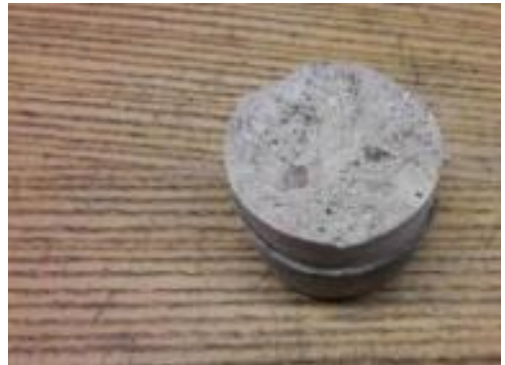
- floor class C20/ 25 (higher than the planned one)
- class of concrete slab C30/ 37 (also higher than designed)

**Fig. 8, 9.** ‘Pull off’ samples for strength tests.
