Analysis of the causes of damage to the RC floor slab in the underground garage

Piotr Matysek^{1,*}, and Michał Witkowski¹

¹Cracow University of Technology, 24 Warszawska Str., 31-155, Cracow, Poland

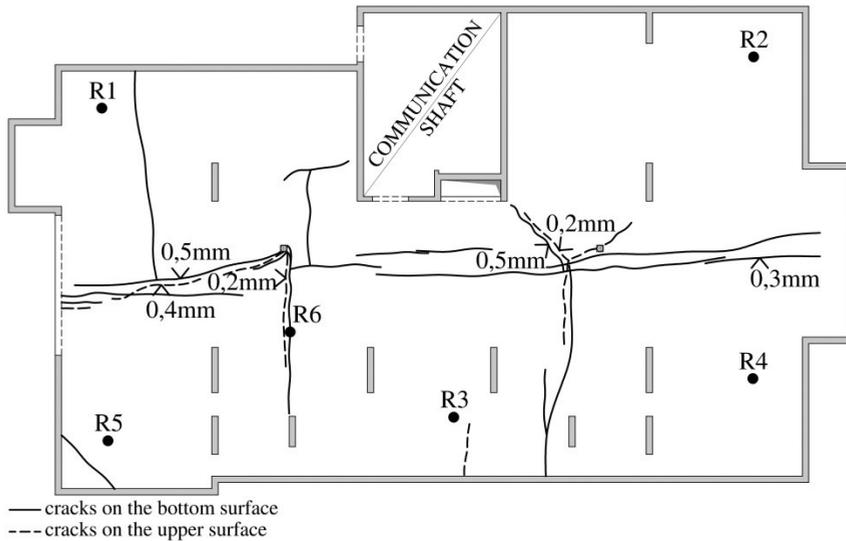
Research was carried out about 2.5 years from the moment of slab execution. During the local viewings, numerous cracks were seen in the garage slab. Cracks were visible on the lower and upper surface of the slab. Cracks on the upper surface also included the floor layer. The directions of the cracks were varied and their widths were up to 0.5 mm. The largest widths had cracks in the passage band. The morphology of the cracks inventoried on the bottom and on the upper surfaces of the slab is presented in Fig. 1, while the character of typical cracks is shown in Fig. 2. The course of some cracks on the bottom and upper surfaces of the floor slab was similar, which proved that the slab was cracking over its entire thickness. In the cracks, which were visible on the bottom slab surface, numerous effects of intensive salt crystallization were found. Cracks on the upper surface of the slab were visible on the resin floor layer, which was made directly on the reinforced concrete structure. Some of the cracks showed visible traces of earlier repairs.

Fig. 1. The morphology of cracks on the bottom and on the upper surfaces of the slab.

The width of cracks, which were inventoried in the garage slab, were greater than the limit value adopted in the project of 0.2 mm. Some cracks in the slab had a width of 0.5 mm, which causes, that the requirements of serviceability limit states in terms of limiting the width of cracks are not met. A part of the cracks was created on the slab before making the floor layers and by using the structure as it had been intended. These cracks were created as a result of thermal-shrinkage stresses. The creation of these cracks was fostered by the method of execution of the floor slab and the method of its reinforcement. The slab has been concreted with a thickness of 250 mm, and then, by the wet-on-wet method, the declines to the drains were shaped. In the slab, almost on 90% of its area, the bottom reinforcement consists of bars with a diameter of 10 mm, spaced every 200 mm or every 150 mm. The area of the bottom reinforcement is therefore 393 mm² of the spacing of 200 mm and 524 mm² of the spacing of 150 mm. No upper reinforcement was designed in the spans of slab. Upper reinforcement in the spans of the slab was also not found in the 6 tested core samples extracted from the slab structure. Taking into account the values listed in Table 3, it can be stated that the minimum reinforcement, due to thermal-shrinkage effects, was too small to limit the width of cracks up to 0.2 mm.

Removing the damaged and leaky floor layer made of synthetic resin and then implementing a systemic injection of cracks was recommended. The injection should be made with the materials, which, on the one hand, will seal cracks, and on the other hand will allow slab deformations. The injection materials based on polyurethane were suggested. As the last stage of the repair, making a new floor layer on the slab by using a material that has proper ductility for transferring the cumulative strains, which will be occurring in the region of the slab cracks was recommended.

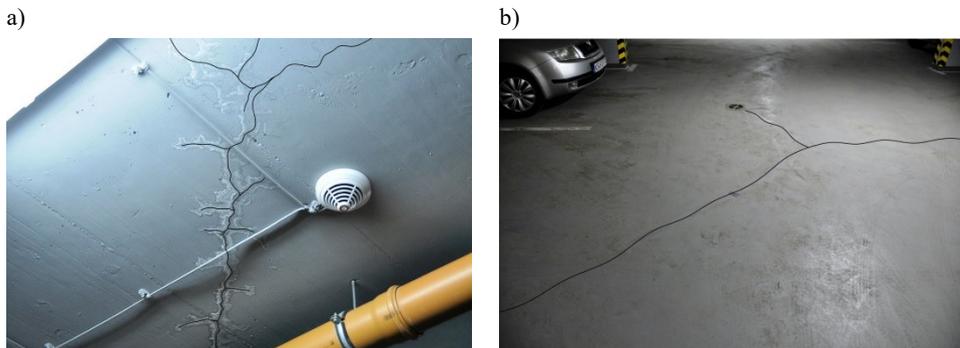
Fig. 2. Examples of floor cracks visible on its bottom (a) and upper (b) surfaces.

Cracks on the upper surface of slab were covered during the resin flooring. Some of these cracks appeared after the floor was made and were visible during the research. This proved the activity of the process of cracks developing during the use of the slab as a garage parking plate. As it was demonstrated by the structural analysis of the slab with applied loads and loads, which had not been assumed in the project but had occurred during the execution works (a load of a light truck) the calculated crack widths also exceed the limit value of 0.2 mm.

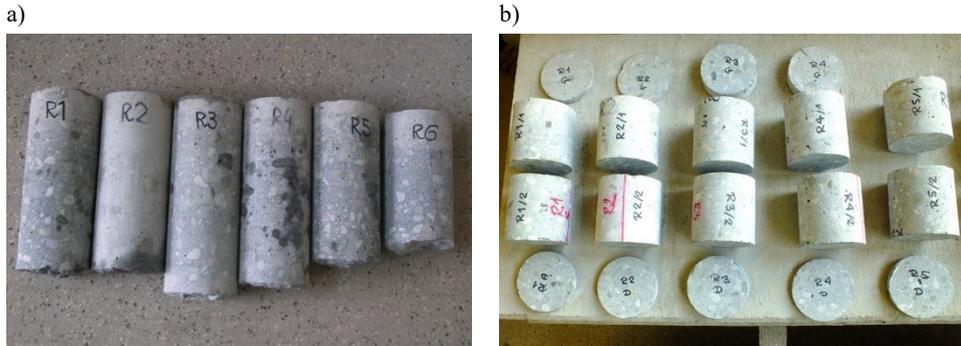
Fig. 3. Cylindrical samples cut from the RC slab - view of samples before cutting (a), samples after cutting (b).

In the R6 sample, the crack ran all over its height and had a similar width at the top and bottom of the sample.

No reinforcement bars were found at the upper edge in any of the tested core samples. On the basis of traces of bottom reinforcement in the core samples, it was found that the diameter of the bottom reinforcement bars was 10 mm and it was compatible with the bar diameters assumed in these locations in the project.

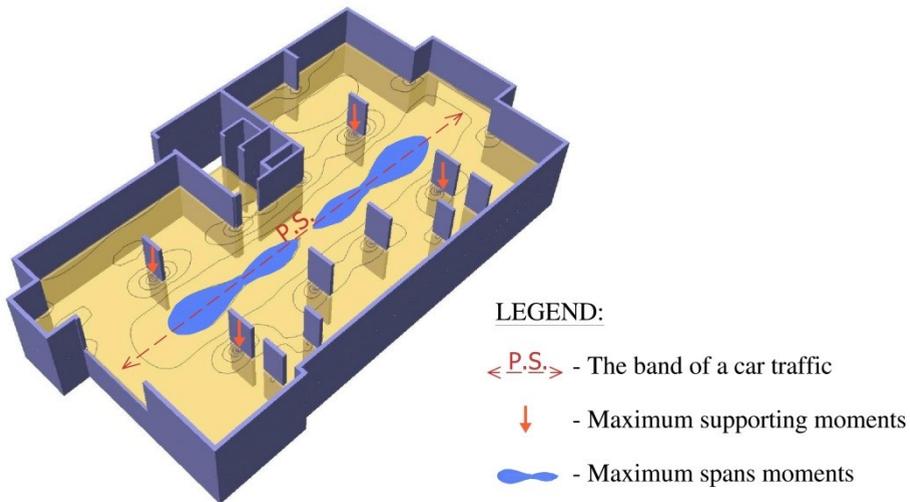
Fig. 4. Structural model.

Based on the calculations, it was found that there is no safety risk resulting from insufficient slab load capacity. The biggest cracks, caused by the combined effect of permanent and imposed loads, are located in the passage band of the floor slab (marked as P.S. in Figure 4). The value of crack widths calculated in accordance with the PN-EN 1992-1-1 [3] standard, did not exceed 0.25 mm. Slightly smaller values of crack widths (about 10%) were obtained on the basis of a comparative analysis in accordance with the PN-B-03264: 2002 [5] standard. The obtained values of crack widths should be treated as an estimate. From the technical documents, it was not possible to recreate the location and form of cracks, which had occurred in the slab in the execution period. Cracks of this type affect the rigidity of the floor slab and influence results of static calculations.
