Analysis of stabilisation method of gable walls of a barrack located at the section BI of the former KL Auschwitz II-Birkenau

Abstract. The subject of the article is an analysis of the stabilisation method of the western gable walls of a barrack with the inventory number B-123, situated at the section BI of the former German Nazi concentration and extermination camp Auschwitz II-Birkenau. The barracks of the former Birkenau have a documentary and historical value and are subject to protective conservation. A barrack with inv. no. B-123 had been erected in the last months of 1941 as a residential barrack, then it was used as a hospital facility. The barrack walls are characterised by low stiffness, because with the building's plan of 36.17 m × 11.39 m, the walls are only 0.12 m thick. Gable walls have been greatly deformed, as a result they have detached from longitudinal walls and their deflection is up to 120 mm. The construction of the walls is at risk, because a bad-quality wall is loaded with horizontal and vertical forces transmitted from the roof, on the eccentricity reaching 120 mm. Deformations are progressing as a consequence of such forces and the walls must be stabilise

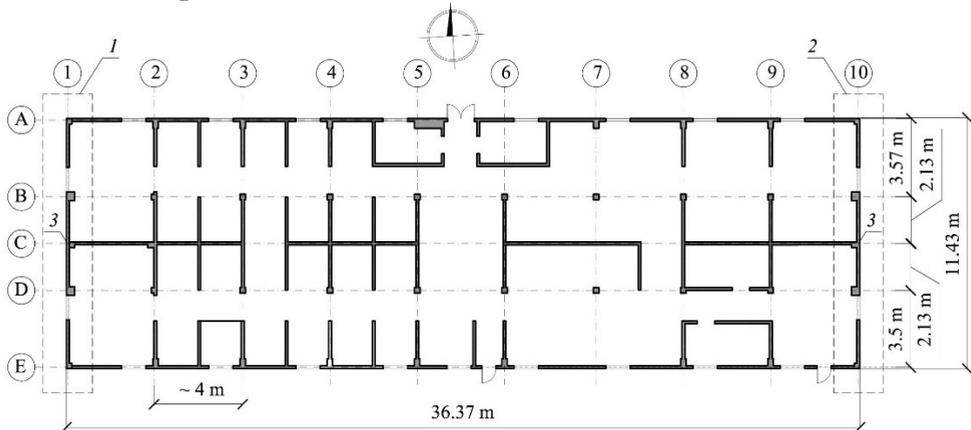
Fig. 2. View of residential barrack with gable walls marked: 1 – western wall covered with original plasterwork, 2 – eastern wall locally converted (after 1945), 3 – bending of gable walls and their detachment from longitudinal wall in the axis C.

The walls in the axes 1 and 10 have detached from the axis C inner longitudinal wall (Fig. 3). Moreover, the walls have been deformed to such an extent that their bending in the out-of-plane direction, at mid-way along their length, is characterised by the deflection u_{\max} of 120 mm (Fig. 4b). It should be noted that the lower edge of the walls supported by foundations, has not been displaced. The upper edge of the eastern gable wall is slightly displaced towards the inside of the building. Generally the upper edges of the gable walls are restrained by the purlins and by the ridge beams of the rafter framing.

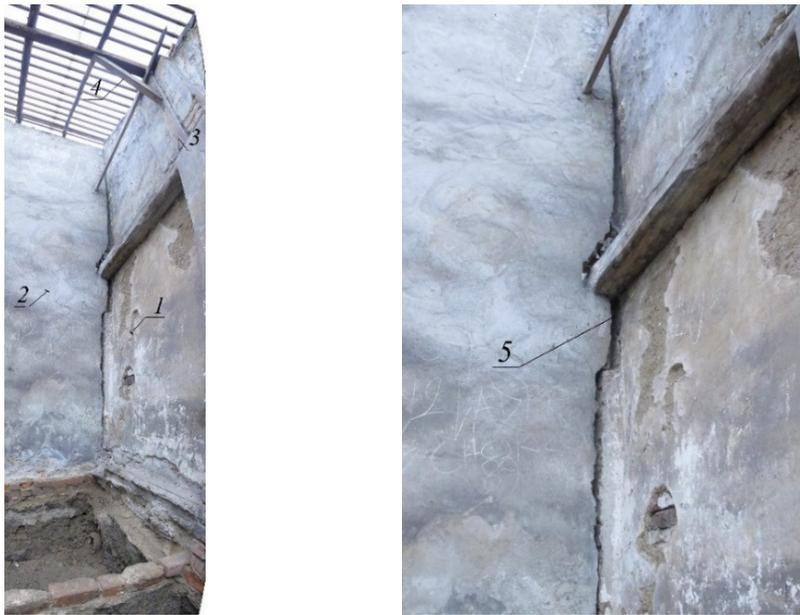
The primary cause of the gable walls' damage are second-order deformations. The deformations were initiated by horizontal load applied the wall through the rafter angle braces (4 Fig. 3). The deformed wall was exposed to vertical loads transmitted eccentrically from the roof rafter posts (3 Fig. 3). The rheological effects are taking place in the wall material as well. All this created the secondary static system of the gable walls after their detachment from the longitudinal walls (5 Fig. 3). As a consequence of the advancing rheological processes, eccentricities are increasing, under the influence of the vertical forces, thus with the increase in eccentricity, increase of the out-of-plane deflection of the wall accelerates.

Fig. 3. The residential barrack of inventory no. B-123. Connection of longitudinal wall with gable wall and rafter framing components: 1 – deformed gable wall, 2 – longitudinal wall, 3 – rafter framing post, 4 – rafter framing brace, 5 – detachment of gable wall from longitudinal wall.

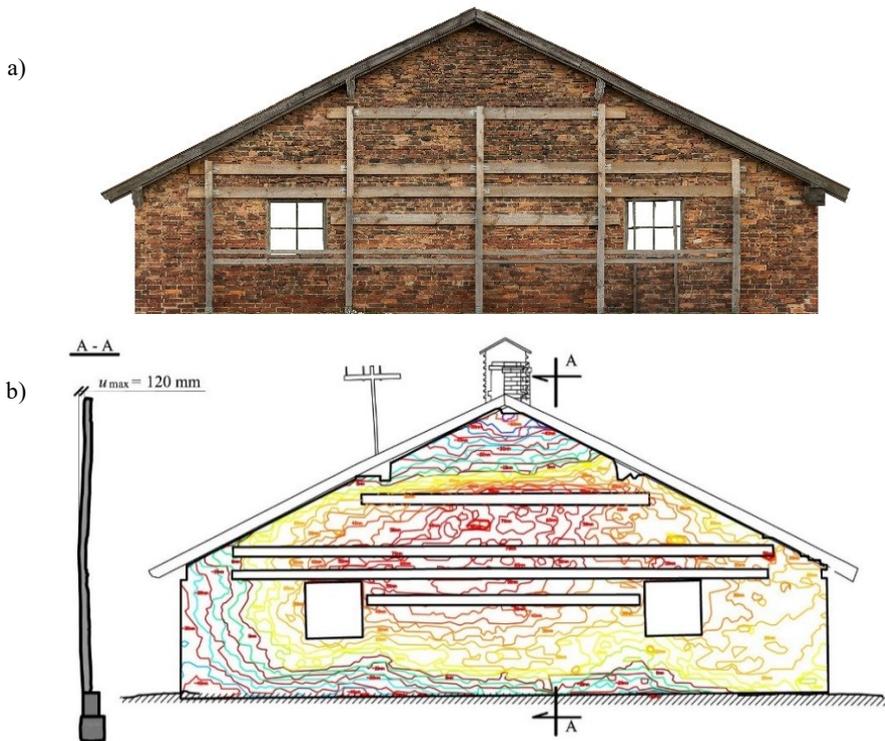
Fig. 4. The residential barrack of inventory no. B-123 .Western gable wall (wall in axis 1 in Fig. 1):
a) view (wall supported with temporary wooden framework – state before conservation works),
b) isolines of horizontal displacements obtained based on laser scanning.

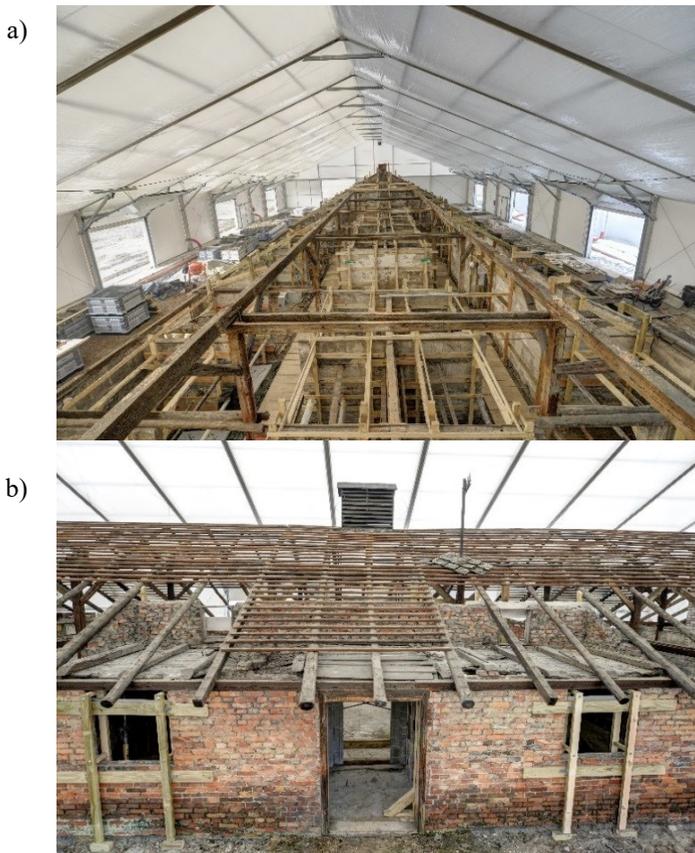
Fig. 5. The residential barrack of inventory no. B-123 during conservation works: a) barrack interiors and tent spread over the barrack, b) south, longitudinal wall (previously rectified).

The works were started by repairing and securing the foundations, a perimeter drainage was made, longitudinal walls were rectified and stabilised (Fig. 5b), the roof rafter was renovated and conservation of the roof covering was performed. A number of typical conservation works were carried out at the same time such as consolidation and strengthening of plasters, and reinforcement of the paint layers, etc.

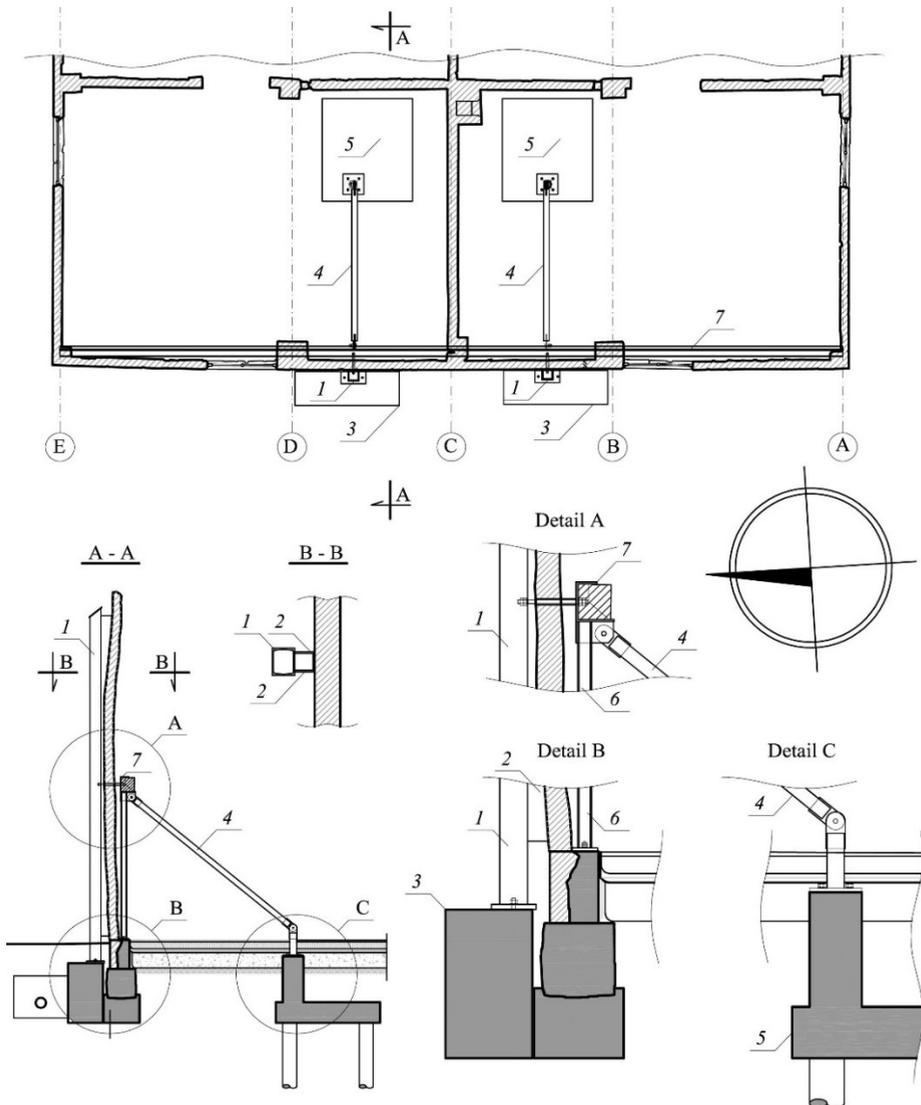
Fig. 6. Structure of the eastern gable wall's support: 1 – steel component supporting the wall, 2 – metal plates with the shape adapted to the profile of the wall cut-out, 3 – reinforced concrete foundation outside the barrack, 4 – stretched steel strut, 5 – reinforced concrete foundation inside the barrack, 6 – steel post, 7 – steel beam.

Sanitary facilities were located in the rooms contiguous to the western gable wall when the camp was functioning. There is original plasterwork on this wall and on part of the contiguous longitudinal walls A, C, E (Fig. 2), and the plasters should be preserved in a possibly unchanged condition. The purpose of conservation works is to reinforce the construction in such a way that the reinforcement elements interfere as little as possible with the existing original walls and plasterwork. It was thus decided to strengthen the existing walls by supporting them (Fig. 6) and at the same time a reinforcement was introduced to bed joints to a minimum degree, only in the external part of the walls, allowing to protect historical plasters inside (Fig. 6).

It was proposed that the steel components running in the vertical direction would be installed in the outside face the wall (*1* in Fig. 6). Their task is to reduce the progressing wall deformation in the form of a distinct bend in the horizontal direction. Due to the fact that the wall is strongly deformed, it was assumed that metal plates would be welded to rolled profiles (*2* in Fig. 6), whose shape will match the deformed wall. A vertical reaction of the elements *1* will be transmitted onto a reinforced-concrete foundation (*3* in Fig. 6), made directly by the wall outside the building. The element *1* will be connected with a stretched strut (*4* in Fig. 6), whose task is to reduce the span of the steel component supporting the wall (element *1*). The strut will be mounted to a foundation (*5* in Fig. 6) made in the centre of the barrack. It is planned to construct reinforced concrete piles under the foundation to ensure that the foundation is transmitting the tensile forces transferred by the strut. It was also assumed that the posts (*6* in Fig. 6) increasing the structure stiffness and a steel beam (*7* in Fig. 6) would also become part of the presented system. This beam acts as a tie beam of the wall and reinforces a wooden tie beam.

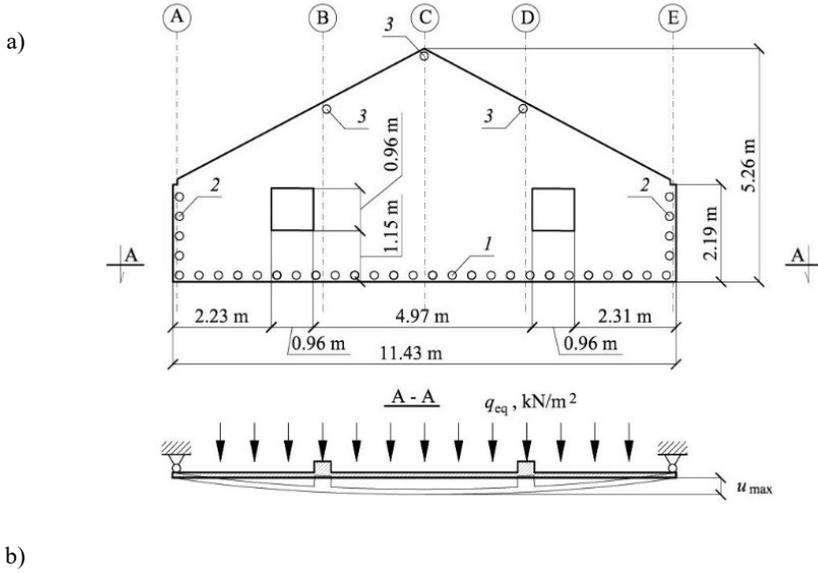
The following procedure was applied to estimate the value of the load acting on the steel components supporting the wall (*1* fig 6). It was assumed that an eccentrically applied load, a horizontal load and the existing wall imperfection, in the form of a distinct bend, would lead to higher wall deformation over the successive years of the building's usage. It was assumed that the deflection would manifest itself as a virtual increase in wall deflection in the middle of the wall length by the next $u_{\max} = 120$ mm. The reinforcement should therefore transmit the horizontal reaction q_{sup} resulting from such increase in deflection. A numerical model of a lateral wall was created to determine such reaction. The model's line supports correspond to the support of the wall on the foundation (*1* Fig. 7a) and to the support ensured by the walls in axes A and E (*2* Fig. 7a). On the other hand, local supports (*3* Fig. 7a) correspond to the roof structure horizontal elements (purlins in axes B, D and a ridge board in axis C). It was also assumed that a modulus of elasticity of the wall made of the low-quality brick and mortar, subjected to destruction processes, equals to 1 GPa. A substitute uniform surface load q_{eq} (Fig. 7a) was applied to the model. The load value was increased until reaching a maximum wall displacement in the horizontal direction of $u_{\max} = 120$ mm (Fig. 7b). The so obtained substitute load $q_{\text{eq}} = 8.71$ kN/m² corresponds to the effect of all forces and phenomena causing the deformation of walls. This load, in particular, corresponds to the existence of a horizontal load transmitted by rafter angle braces, to the second-order effects caused by an eccentric load on the walls by the roof structure components and to geometrical and material imperfections of the wall itself.

Fig. 7. Determination of substitute horizontal load q_{eq} causing horizontal displacement u_{max} of the wall: a) scheme of wall, b) model deformation corresponding to the displacement $u_{max} = 120$ mm.

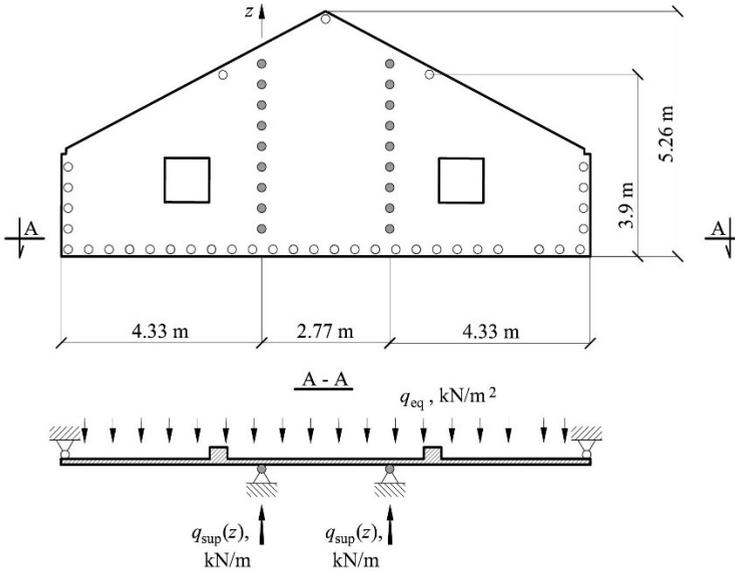
Fig. 8. The scheme assumed for determination of the load q_{sup} of steel components supporting the wall.

The load q_{eq} , determined this way, was applied to a model of the reinforced wall (Fig. 8). The model considers the existence of additional supports such as steel rolled profiles. The reaction q_{sup} , transmitted by such supports, depends on the coordinate z and varies between -5.10 kN/m and 36.24 kN (Fig. 9a). The average value of this reaction $q_{\text{sup,m}}$, understood as the integral of $q_{\text{sup}}(z)$, divided by the support's length, is 32.63 kN/m (Fig. 9b). Such a load value was a basis for dimensioning the elements of the reinforcement construction (Fig. 9c).

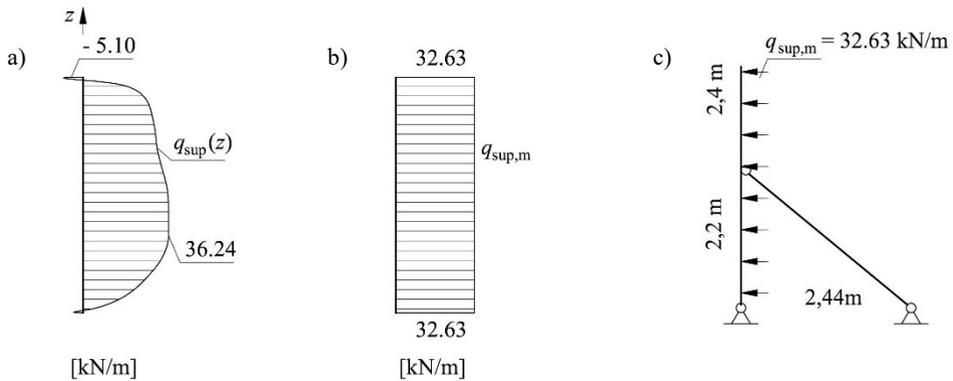
Fig. 9. a) distribution of load q_{sup} , b) average value $q_{sup,m}$ of load q_{sup} , c) scheme adopted for dimensioning the elements of reinforcement.
