The TLS technique as a way of identification and measurement of damaged elements of a historic sacral building

Joanna A. Pawłowicz^{1,*}

¹ Institute of Building Engineering, Faculty of Geodesy, Geospatial and Civil Engineering University of Warmia and Mazury in Olsztyn, 10-724 Olsztyn, Heweliusza str. 4, Poland

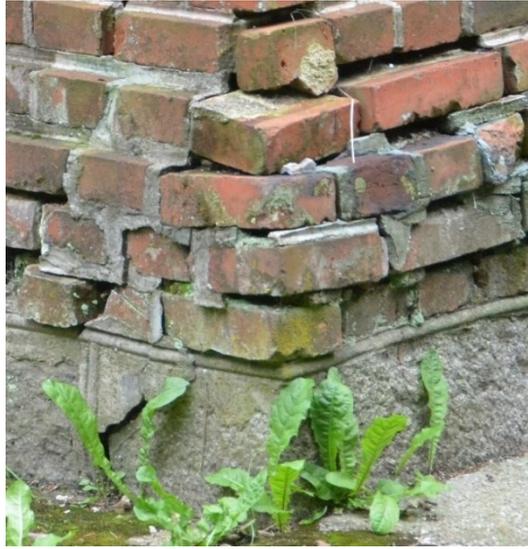
Fig. 2. Damaged corner of the building – an example of missing mortar in a wall

The inspection of the walls showed that the most often occurring damages were cracking, crumbling corners and splitting off of a part or an entirety of bricks. In the corners and on the edges of moulds there is no mortar between bricks. Figure 2 shows the result of dislodgment of bond that results in falling off bricks from walls and corners. It is due most probably to the effect of humidity which weakens the bonds between a brick and mortar as well as of a wind blowing the weakened particles away. On the walls attempts made to supplement mortar are visible (Fig. 3), which can be distinguished by different colour and density. In some especially damaged places plants took their roots and the humidity resulted in growing of algae and moss (Fig. 4).

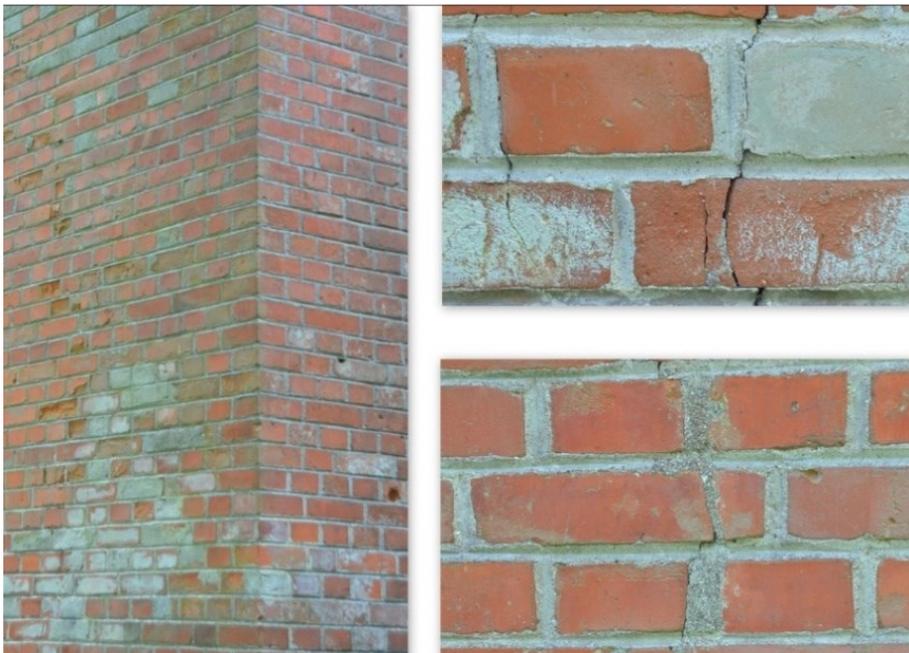
Fig. 3. Examples of damaged bricks and repairs in the form of supplementing mortar.

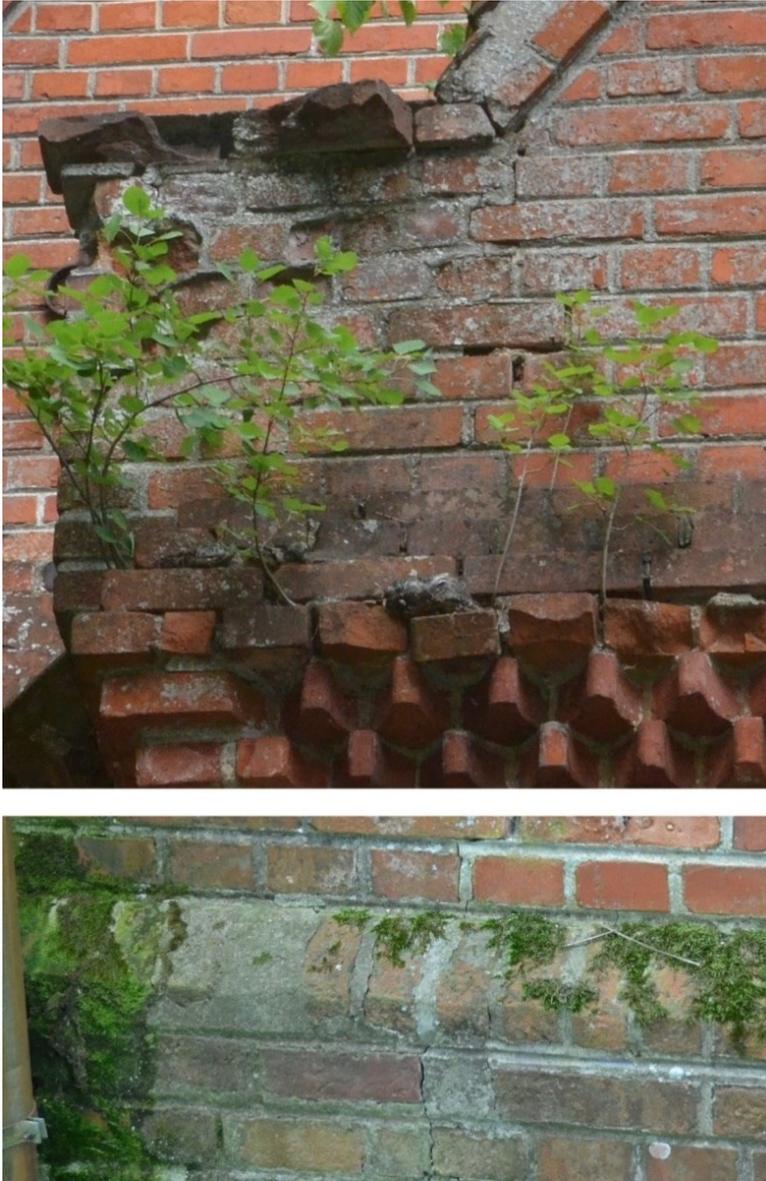
Fig. 4. Biological damage on the external walls of the chapel.

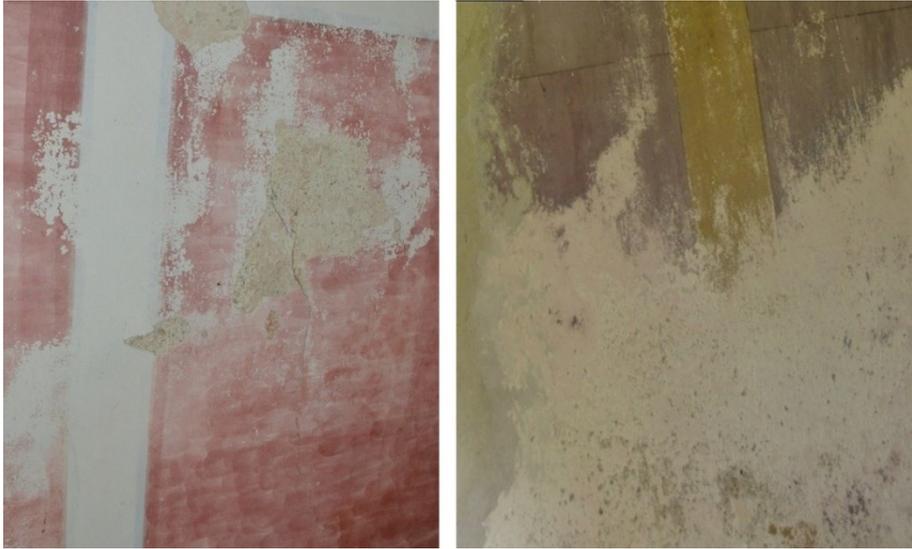
In the interior there are many cracks of the walls and plaster chipping offs as well as discolour or obliteration of paint (Fig. 5). The character of the damages speaks of high degree of moistness of the interior of the building. Distinct traces show the range of the occurrence of this problem (Fig. 6). The reason may be the damage of the walls, the roof and the window woodwork and the closure of the chapel without ventilation for a long time.

Fig. 5. Damage to internal walls: plaster chipping off and paint obliteration.

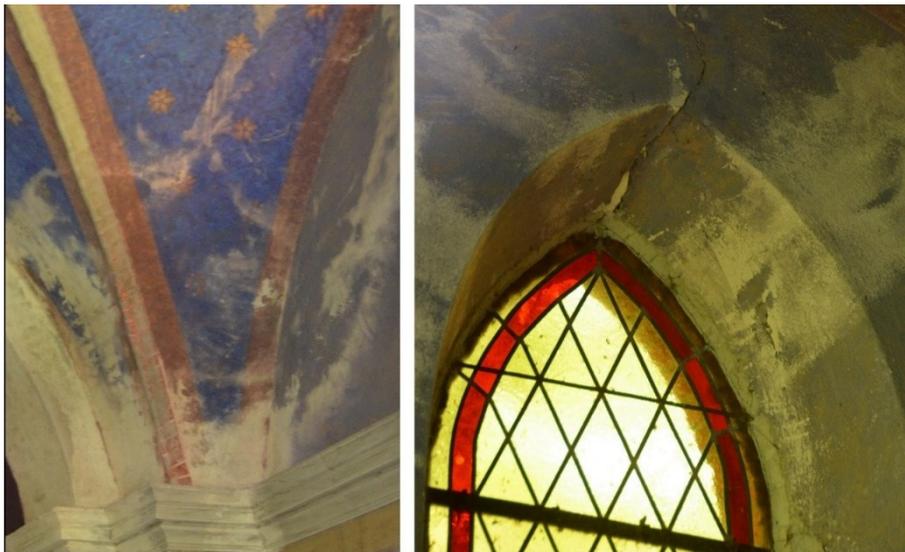
Fig. 6. The range of moisture damage to the walls.

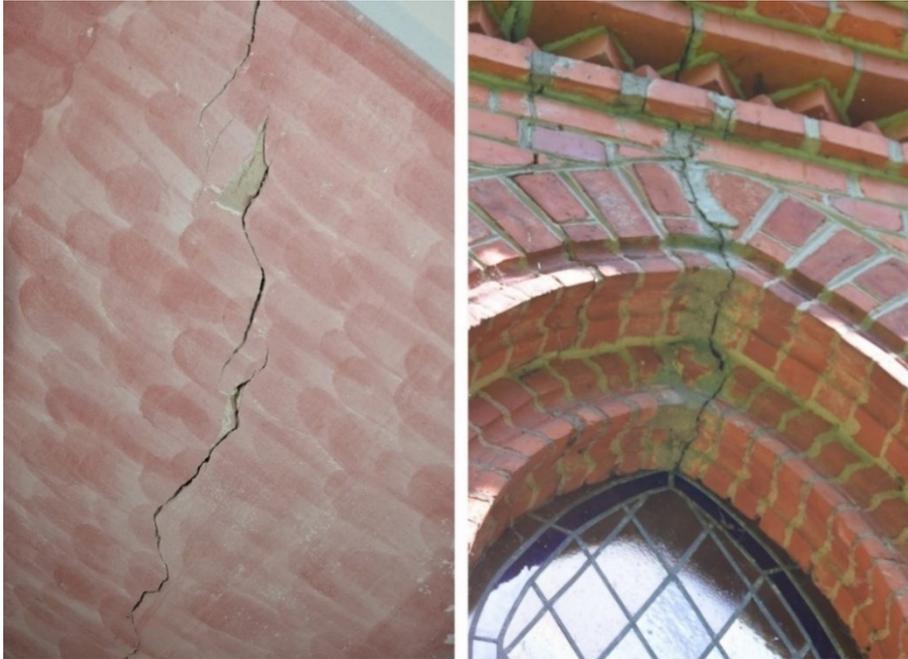
The most important from the viewpoint of the construction requirements are the cracks and chinks on the vertical and horizontal elements of the building. They are found mainly on the walls of the chapel between bricks and mortar. They are of a lineal character and they begin first of all by window openings which is shown in Fig. 7. It pertains both to the damages in the interior and outside the building. In the chapel the damages head from the windows to the centre of the ceiling. Their localisation on a big height was the reason for using a laser scanner for making measurements.

Fig. 7. Wall cracking: cracking of the internal wall and the external wall by a window opening.

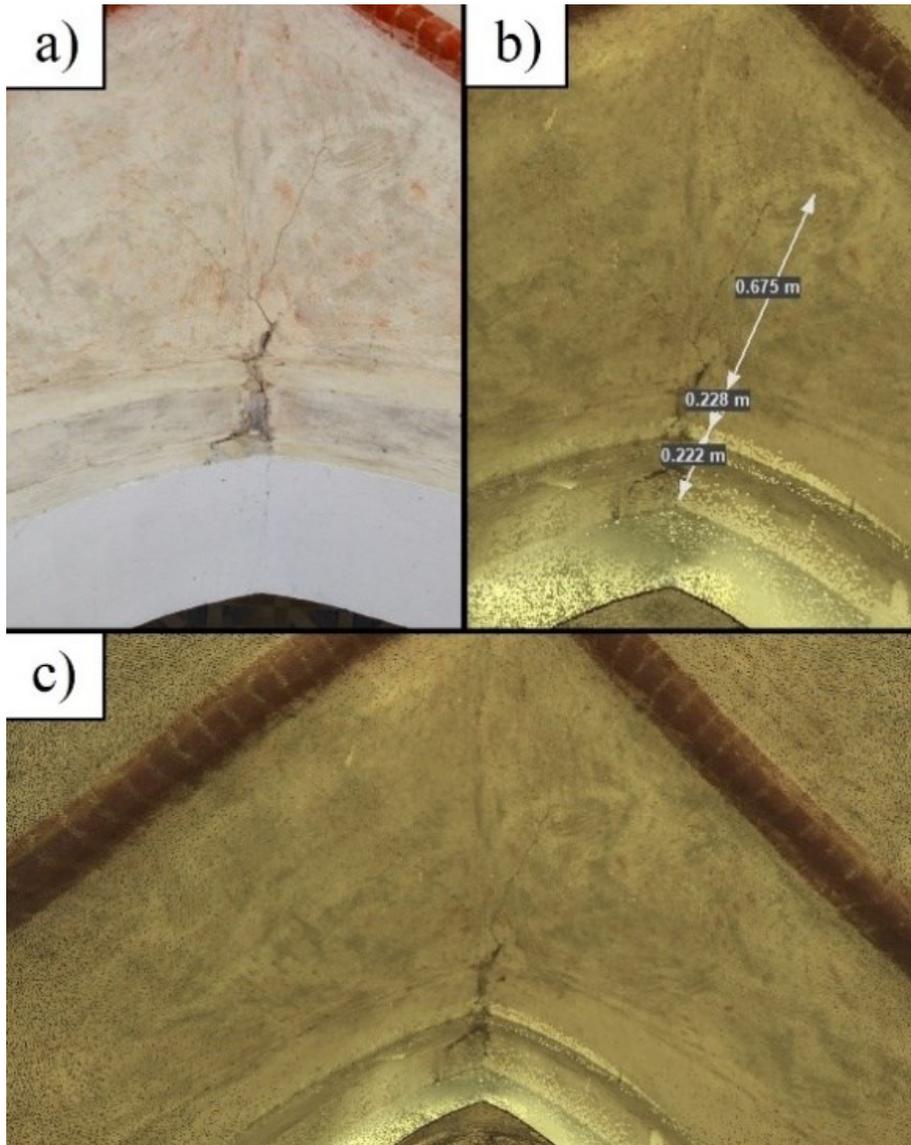
In the building over 30 places of damage occurrence were identified. In this paper a chosen example was a basis for analysis. The digital photograph (Fig. 8a) shows the damage to the middle part of the arch over the entrance to the main room of the chapel. It starts on the vault, then it crosses the arch perpendicularly to the plane of the wall. The measurement of the length of the crack was made in the cloud of points in a big magnification, when each point of the cloud can be identified. Thanks to it, it was calculated that the entire length of the main crack is 1.125 m and the width ranges from 0.003 m to 0.146 m. The surface of the part chipped off the wall was also measured and was equal to 0.028 sq m. Figure 8b, in a schematic way shows the range of measurement of the crack on the cloud of points. Figure 8c reflects the damage in the cloud of points in the normal view. In figure 9 an exemplary way of the depth measurement of a crack was shown in the cloud of points in a big magnification – in this case it was equal to 0.021 m

Fig. 8. Damage to the arch over the entrance to the chapel: a) digital picture, b) and c) cloud of points with pictures superimposed.

The damages were inventoried on the basis of the cloud of points imply that the building is being torn in two parts. The reason may be both a badly lay foundation on a swampy ground but also road works in the near proximity of the chapel. Research on the reasons behind chapel splitting is ongoing. The conclusions will be published in a next paper.

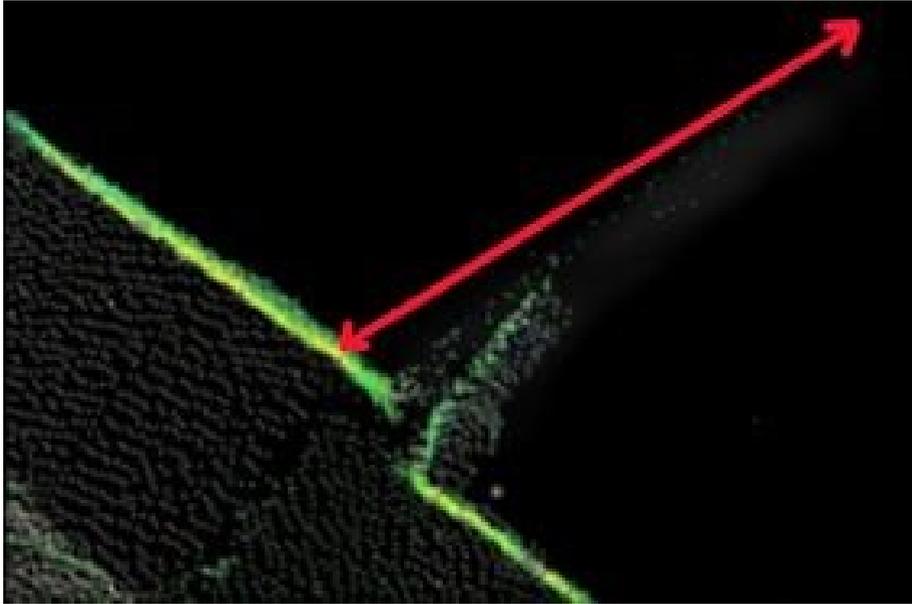
Fig. 9. Measurement of the depth of the wall crack in the cloud of points in a big magnification.
