Failure of the overhead crane runway

Abstract. The paper reports a failure of the overhead crane runway. Failures of this type often occur in industrial buildings that have been in operation for a long period of time. The reasons are dynamic, fatigue-related phenomena in crane operations, and also design and structural errors. An important issue is also the presence of geometric notches, which promote the formation of fatigue cracks, accelerating the process of degradation of the structure. Visual inspection of the overhead crane runways revealed loosening and failure of rail – beam connections, and also substantial horizontal and vertical displacements of the rails. Additionally, geodetic measurements of rail arrangement were taken. They indicated the exceeding of permissible deviations for rails spacing and vertical arrangement stated in the relevant standards. The runway damages resulted from dynamic character of the loads applied. In some cases, high crane travel speed and acceleration produced impact forces that affected the runway structure. Vertical and horizontal deformation of rails was an additional source of impact in the crane runs. Another contributing factor was inap

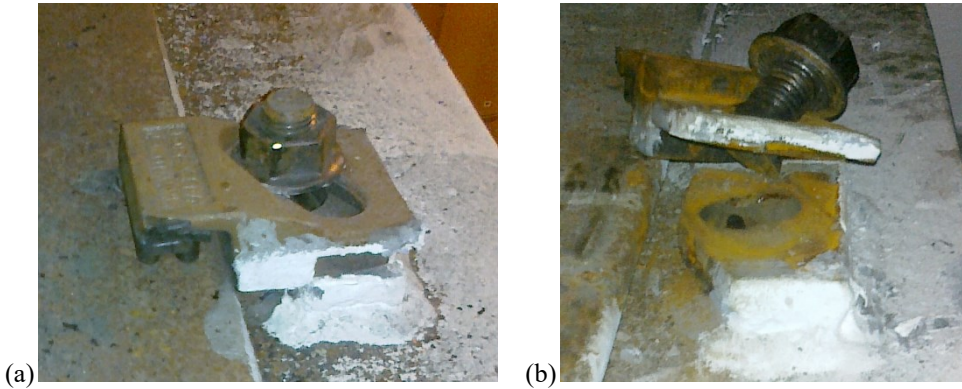
- excessive horizontal and vertical deformation of rails,
- loosening and failure of rail – beam connections.

The runway deformations, i.e. deflections of the rails, were so large that they could be seen, so it was not necessary to take specialist measurements. As a result, during the crane run, wheels hit the side surfaces of the rails, which caused vibrations in the supporting structure.

Exemplary photographs of the runway damages are shown in Fig. 4a (bolt loosening) and 4b (failure of the rail and beam connection).

Fig. 4. The view of loosened bolt (a) and damage to the rail fastening to the beam (b).

- dividing each rail with two dilations, by cutting them at an angle of 45° (in accordance with the recommendations of PN-EN 1993-6:2009P [7]),
- levelling, straightening and horizontal positioning of rails,
- repair of rail fastenings to crane girders (replacement of broken bolts),
- strengthening of rail fastenings to the crane beams by making additional fastenings, using bolts to connect rails and crane beams.

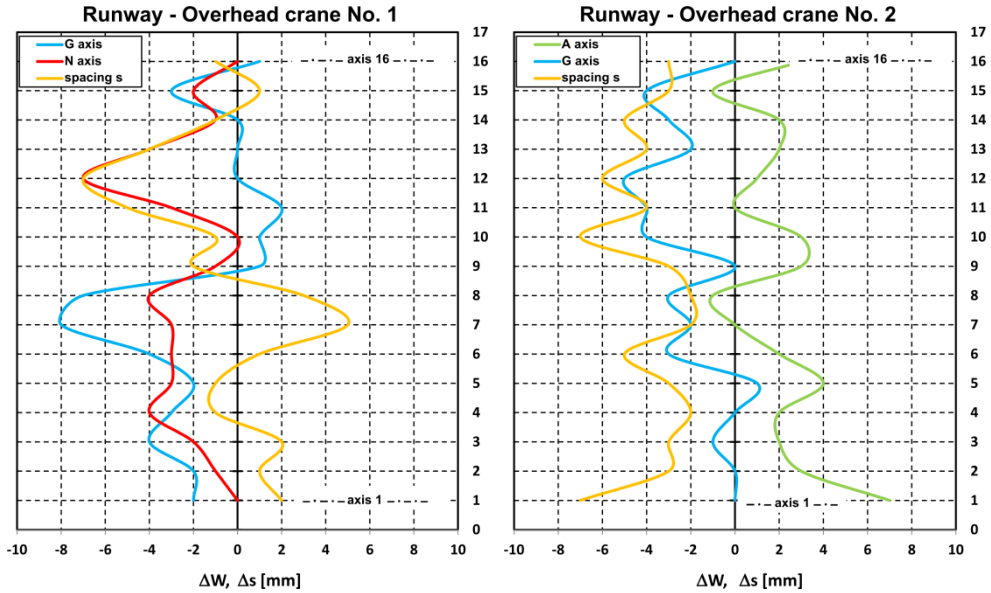
For crane No. 1, the deviation was exceeded at six points, while for the crane No. 2, at three points. The deviations ranged from -1 to 15 mm with respect to the original spacing $s = 30\,500$ mm (Table 1 and 2).

As regards crane No.1, both rails had a tendency to move in the direction of the A axis. Their spacing in the area between axes 1-8 increased, whereas in the area between axes 9 and 16, it decreased.

Fig. 5. Changes in crane runway displacements: ΔW – changes in horizontal displacements of rails, Δs – changes in the rail horizontal spacing s .

The rails of crane No. 2 moved in the direction of D axis, i.e. in the direction of crane internal work area. As a result, the rail spacing was reduced.
