Problems encountered when assessing the technical condition of some types of industrial structures on the example of coal bunkers for a power boiler

On the example of two coal bunkers (from a battery consisting of four such constructions) of one of the heat and power plants located in southern Poland, the authors want to present and discuss some problems that occurred in the assessment and analysis of the technical condition of a specific industrial structure.

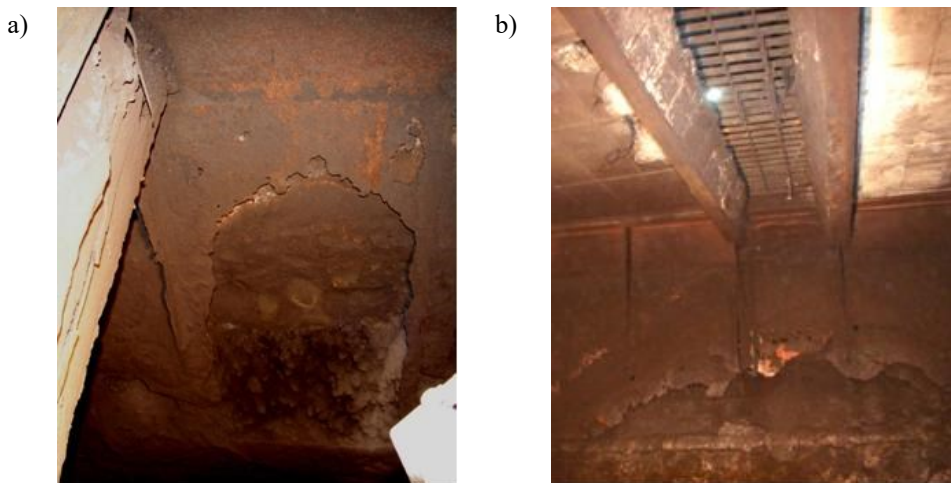
The largest damage was found on the circumferential steel beams, directly at the charging opening. Large steel sheet fragments, which protect the concrete filling wall, were destroyed. This situation was the result of the combination of two factors: the aggressive environment, which caused very strong pitting corrosion of the steel and mechanical action of the deposited material. The coal coming into the bunker always hit the same part on the wall, which was not capable of transferring such an impact force, especially when its structure is weakened by chemical interactions. The range of damage was huge, what is visible in Fig. 5a and 5b.

Fig. 5. Huge damage to the circumferential steel beam.

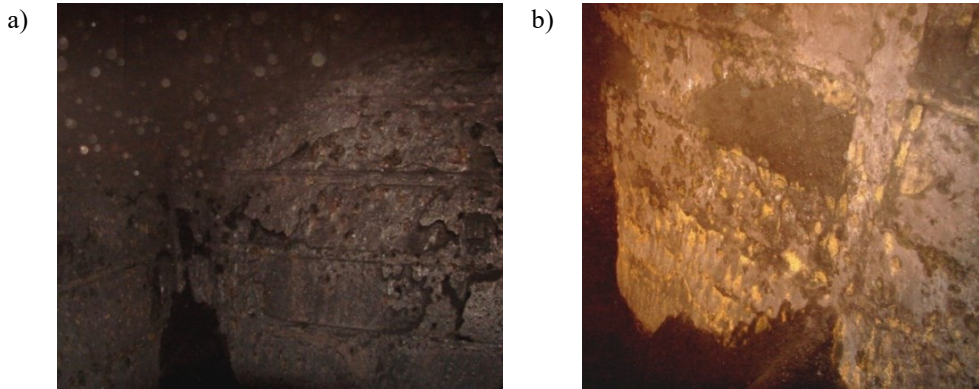
Unfortunately, for technical and technological reasons, analysed bunker was only partially emptied, and therefore only a part of the wall surface was available. Both mechanical and corrosive damage of the concrete wall was observed. There were numerous pits caused by the action of harmful factors, especially sulphate and chloride ions. These factors are usually contained in mine water [12], which is an inseparable part of the coal mining process.

Fig. 6. Damage to the concrete walls: a) mechanical damage to the surface, b) surface and pitting corrosion.

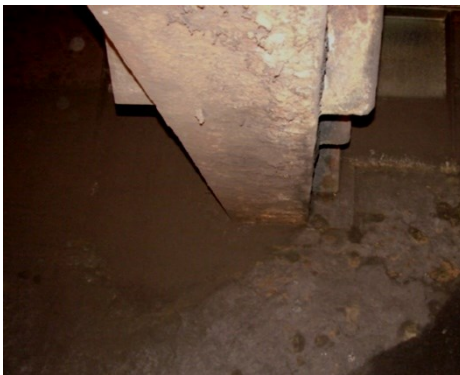
The elements of load-bearing system (steel plain girders, sheets inside the bracing) indicate damage varying in intensity. Aggressive factors contained in coal water caused most often surface corrosion of the steel in places where the extracted coal does not remain permanently in place (elements have contact with coal water only when pouring material) – Fig. 7a. Parts of the structure exposed to permanent operation of the material exhibit pitting corrosion leading to a complete destruction of the elements – Fig. 8.

Fig. 7. Surface corrosion of the plain girder.

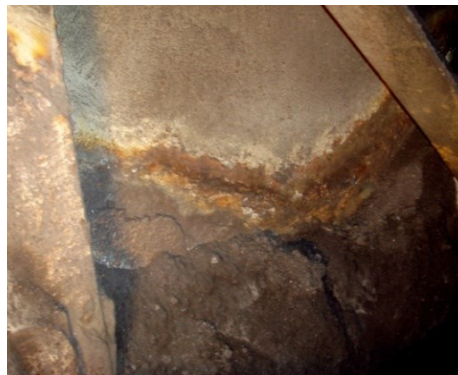
Fig. 8. Strong pitting corrosion of the steel sheet.

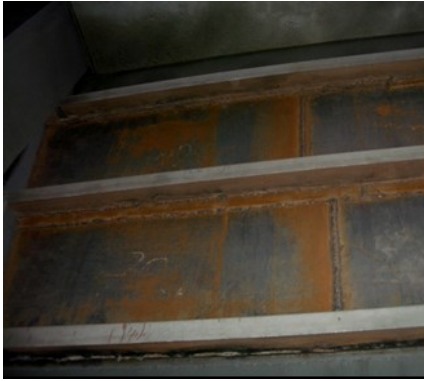
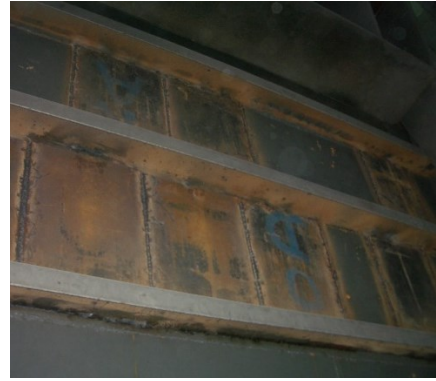
All external steel sheets and stiffening profiles have been damaged by surface corrosion, locally very strong and covering entire sheets and the line of joints (vertical and horizontal) – Fig. 9. In some places, where the corrosive damage was very extensive, new elements were welded. Unfortunately, those new elements were completely without anti-corrosion coating and corroded as first place (Fig. 10).

Fig. 9. Surface corrosion of the sheets and joints.

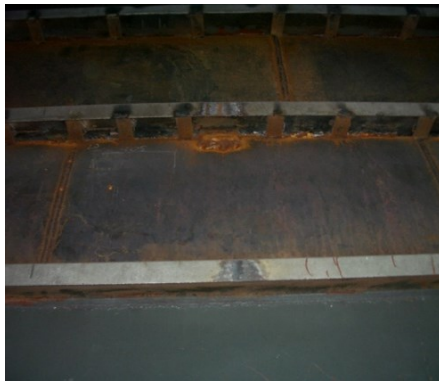
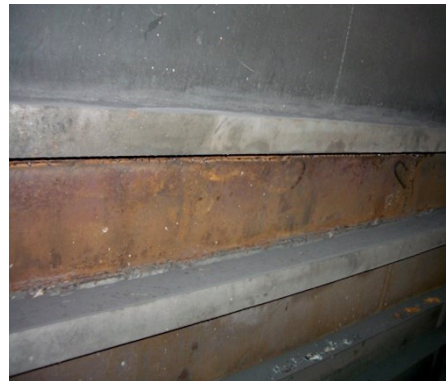
Fig. 10. Surface corrosion of new welded elements.

The third group of damage arises always during the operation of the object, which has not been subjected to adequate technical control and supervision. In the case in question, there was very serious damage of mixed nature – both mechanical (coal hits always in the same place) and corrosive, which, in a sufficiently long time, has led to the total destruction of steel beams (Fig. 5). The degree of damage is so significant that only way to repair is to build new elements into the supporting system. This and other damage (indicated below) require the object to be put out of service for a relatively long time, because the range of strengthening and repair works is huge. Other damage observed in bunkers, which results from the lack of proper inspection and periodical repairs, is strong surface corrosion on the external steel sheets (Fig. 9). To prevent this damage a prosaic action – cyclical renewal of anti-corrosion coatings – would be enough and could be carried out without emptying the bunker and stopping the production. However, an extreme case of improper control of this object is corrosion of new welded elements (in most corroded places), which have no protection against corrosion and have been damaged immediately after their application (Fig. 9 and 10).

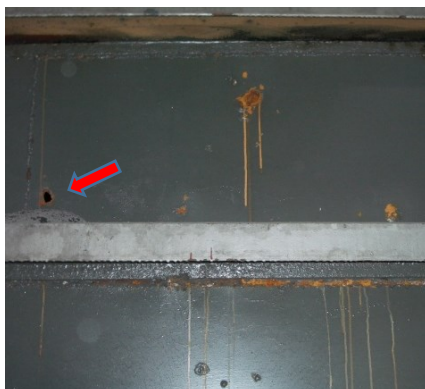
Pitting corrosion of the steel sheet – of a local nature – is also observed. In extreme cases, there are holes in the steel covering sheet (Fig. 11).

Fig. 11. Pitting corrosion and hole (marked by red arrow).

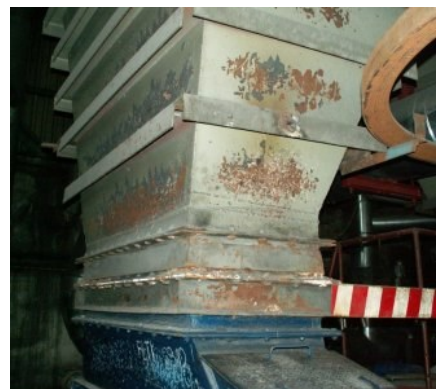
Damage within the hopper is primarily of the mechanical type with a local deformation of the surface. There are traces of hammer impact in order to break away the build-up material. These treatments caused destruction of the anti-corrosion layer, which consequently resulted in the acceleration of corrosion processes. In Fig. 12 surface and pitting corrosion is visible.

Fig. 12. Mechanical damage of the hopper's external surface.

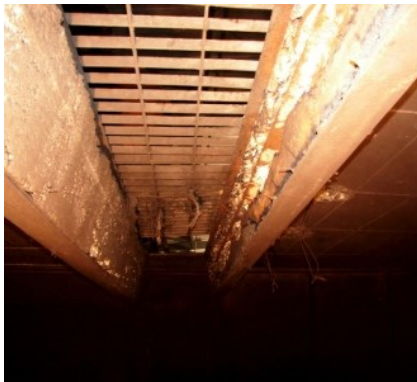
The concrete plate is supported on steel beams, which are covered with concrete in the middle part. Locally, this concrete layer is strongly damaged, mainly mechanically (Fig. 13), but also corrosive (elements exposed to direct action of coal water). Uncovered parts of the steel beams show signs of the surface corrosion.

Fig. 13. Corrosion and mechanical damage of the beams supported cover plate.

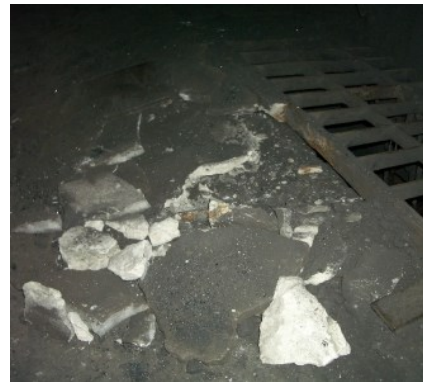
The external layer of the plate, available from the top of the bunkers, is partially completely destroyed. The loosen parts of the floor are visible in Fig. 14. This situation results from the transport near the charging opening of heavy equipment and machines (for example for repairing conveyors). These actions were not planned in the exploration of the object and not foreseen during designing of this area of the structure.

Fig. 14. Strong mechanical damage of the concrete floor.
