Anatomy of Failures: Stability Requirements in All Stages of Operations

Piotr Moncarz^{1*} and Cliff Bishop²

1 The KTVO Tower Collapse

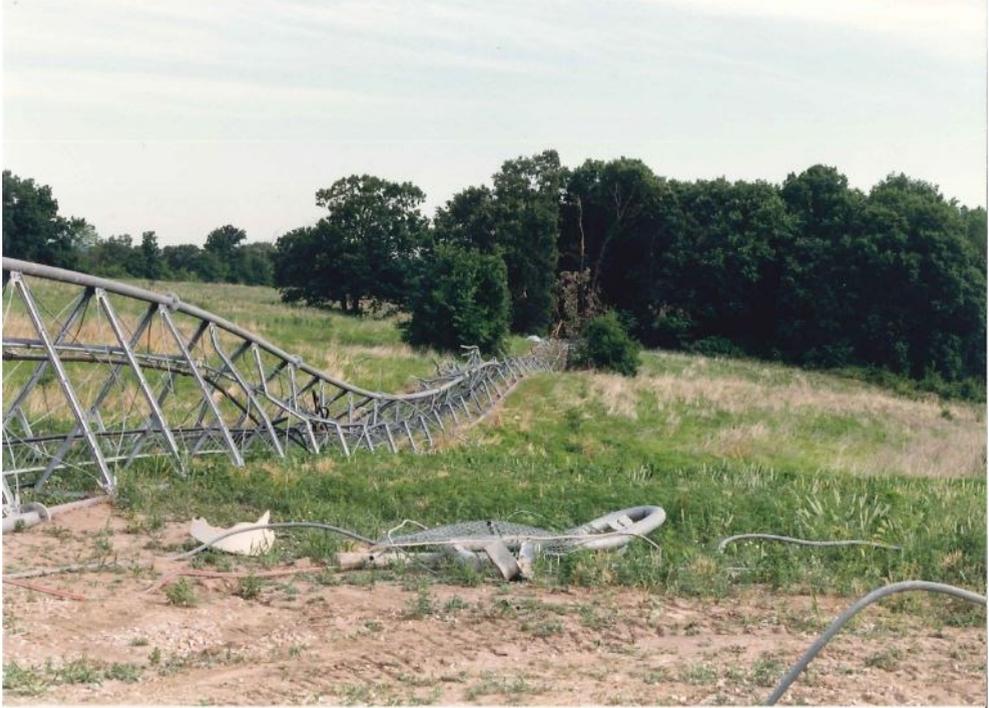
Fig. 2. Top section of collapsed Tower.

At the time of collapse, the three workers were replacing braces at approximately 150 m (500 feet) up the tower. The Tower collapsed in three distinct sections: 1) the lower 150 m section, 2) the top portion of about 150 m, and 3) the middle portion of approximately 300 m. The top and lower portions remained fairly straight while the middle section was a crumpled mass on the ground. Fig. 8 schematically shows the tower collapse sections. One of the straight sections is shown previously in Fig. 2. A portion of the crumpled middle section is shown in Fig. 3.

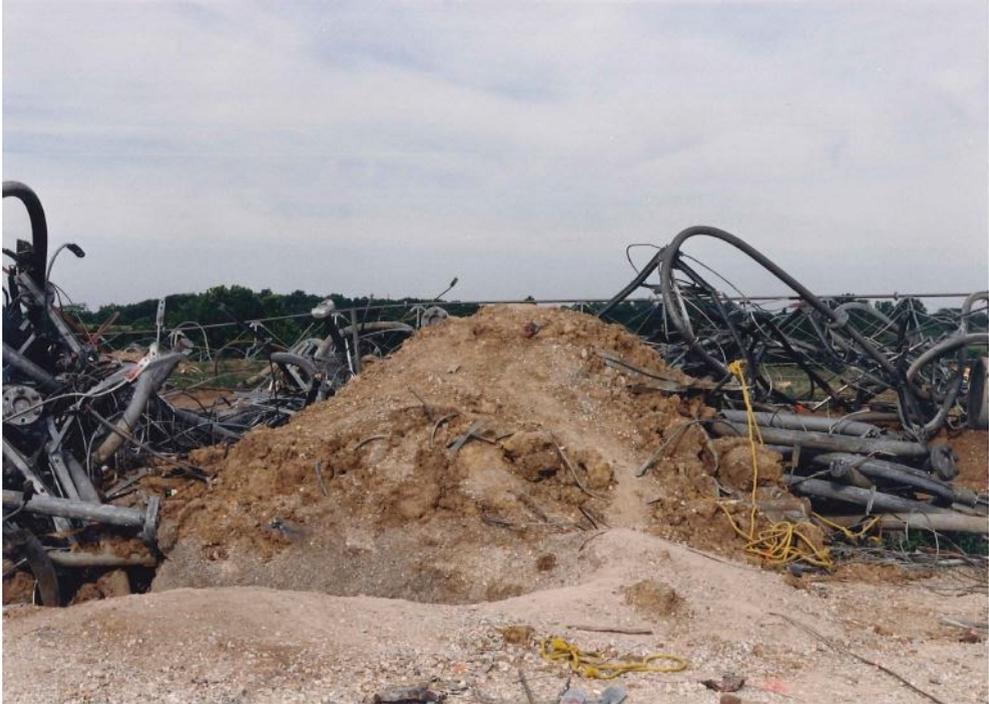
Fig. 3. Middle section of collapsed Tower.

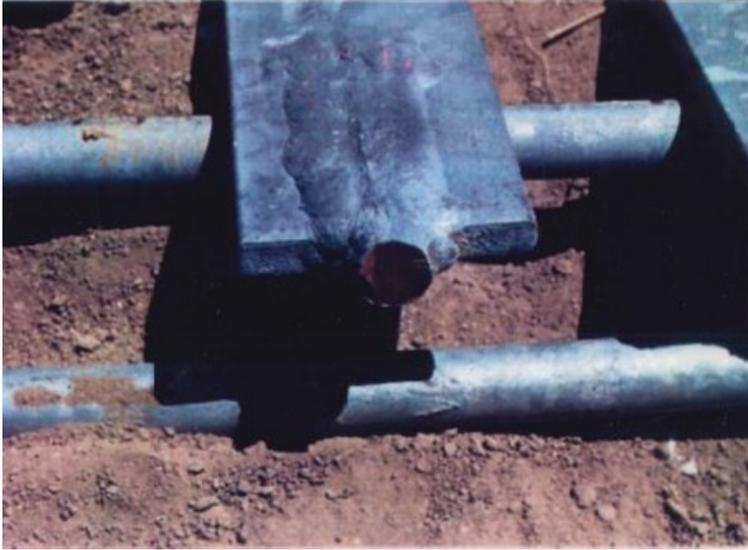
Prior to initial operation of the Tower, two diagonal rods failed at the connection tab (Fig. 7). The testing laboratory determined the failure was caused by “weld undercut and thermal shock.” Within days of operation, laboratory tests showed the 16 mm (5/8-inch) diameter diagonal brace rods have 0.32% carbon content equivalent, thus would have required special welding. Mill certificates (Table 1.) show the steel of diagonal rods installed in the tower deviate greatly from specifications (nominal yield of 345 MPa (50 ksi)). The engineering firm/builder informed the steel supplier of the unacceptable quality of the steel rods. More rod breaks occur over the next few months at the rod-to-connector plate location.

Fig. 7. Brace rod failure at the connecting tab plate.

In view of the high frequency of the diagonal brace failures and the identified endemic fabrication defects, the design-build company decided to replace all of the diagonal brace rods (over one thousand rods total, i.e. over two thousand bolted connections). The diagonal brace replacement was carried out from a platform hoisted along the tower height. In general, the replacement was carried out starting at the top of the tower and moving downwards, tier by tier. The procedure required a 3-ton capacity come-a-long to be used to substitute for the tension force the brace provided, the brace was then removed, new brace was put in place, and the come-a-long tension was released, thus pretensioning the new brace. This procedure clearly required several moves of the platform per tier being repaired and likely seemed inefficient to the three workers on the platform and the two assistants on the ground.

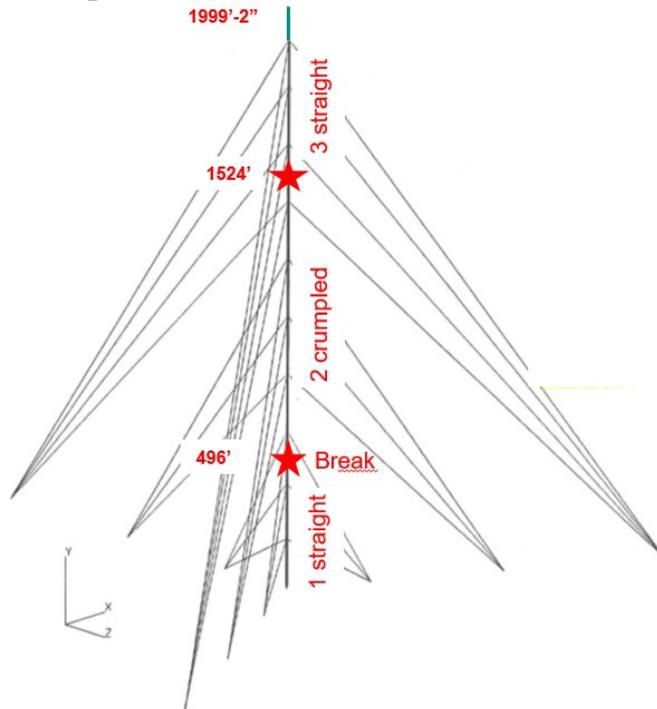
Fig. 8. Tower collapse sections.

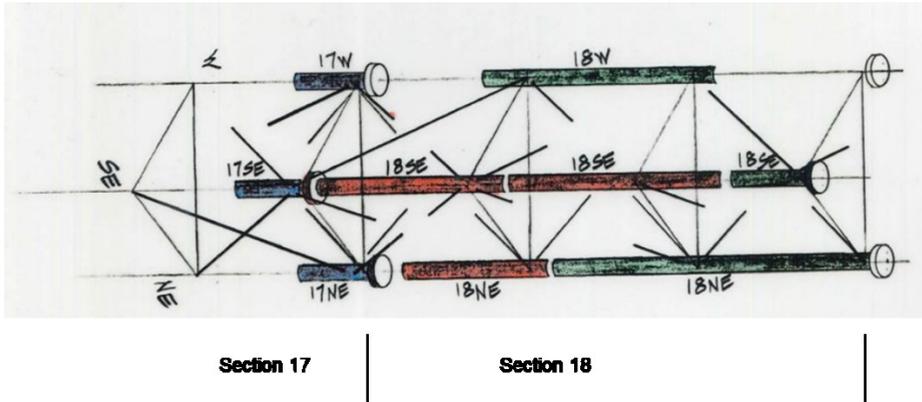
An investigation of the accident site consisted of capturing the geometry of the downed tower and recovering key sections which might help to determine the reason for the collapse. At the time of collapse, the workers were replacing sections at about 150 m height; roughly corresponding to the joint between sections 17 and 18 of the tower, which is approximately where the fatal tower break occurred. This location also was slightly below the attachment of Guy Wire #3 which occurred between sections 18 and 19. Fig. 9 schematically shows the recovered and retained tower column sections of sections 17 and 18.

Fig. 9. Recovered tower column sections.

Structural analyses, using a three dimensional model of the cable-guyed structure, revealed the tower to be stable with all diagonals intact. Removal of individual diagonals or diagonals within the same tier on one face had no impact on the stability of the tower; however, removal of adjacent diagonals on adjacent tiers, one above and one below a column splice joint, lead to opposite direction (twisting) rotation of the tower, subjecting the splice bolts to excessive shear forces. Such diagonal removal/replacement was inconsistent with the repair procedures specified. The analysis thus supported the scenario consistent with the debris layout of the tower collapse initiation through failure of a column splice joint between sections 17 and 18 caused by excessive number of braces being removed at the same time by the repair crew.

A key lesson from this tragic failure is that when repair of an existing structure is carried out, the static and dynamic conditions of the structures during the individual repair stages have to be defined and analyzed. Once defined, repair procedure may not be modified without prior approval based on appropriate engineering analysis.

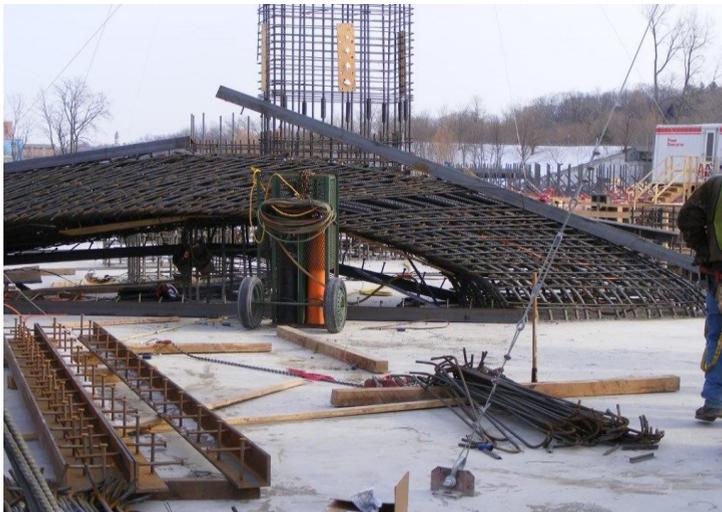
Bishop and Uriz [6] and Bishop, Uriz, and McDonald [7] studied in-depth the issues that one must consider in order to correctly utilize temporary bracing on concrete reinforcing cages. Their research was, in part, driven by a collapse of a rebar cage during construction. In the instance in question, the worker did not have a plan as how to install the formwork around the rebar cage while the temporary bracing was in the way. While hanging from the top of a nearly two-story rebar cage, the worker disconnected a brace in order to construct the formwork. Once the brace was disconnected and given the eccentric loading caused by the worker hanging from the cage, the cage collapsed upon the worker, causing serious injury. An example of a dramatic concrete reinforcement cage collapse is shown in Fig. 11.

Fig. 11. Collapsed reinforcing cage.
