Analysis of load bearing structure of selected hall buildings

Abstract. In this paper the issues associated with correct design of hall buildings has been presented. Large span roof structures require a particularly careful approach to design issues. In this paper examples of two building hall were presented. In the first example, the construction disaster occurred, while in the second of presented buildings due to the changes introduced while construction has been protected against such disaster. The first of the analyzed cause concerns storage hall, whose roof structure has been destroyed due to heavy rainfall. The main cause of this disaster was the malfunction of vacuum roof drainage system compounded by a number of design errors. Mentioned errors were not eliminated, during construction, despite the additional investor supervision, which was independent of parties involved in a construction process. The second case concerns the structure of a sports hall, which was built next to the existing school. Under construction of the hall building, the contractor and the supervision inspector, in conjunction with the designer, introduced a number of modifications of the structure to p

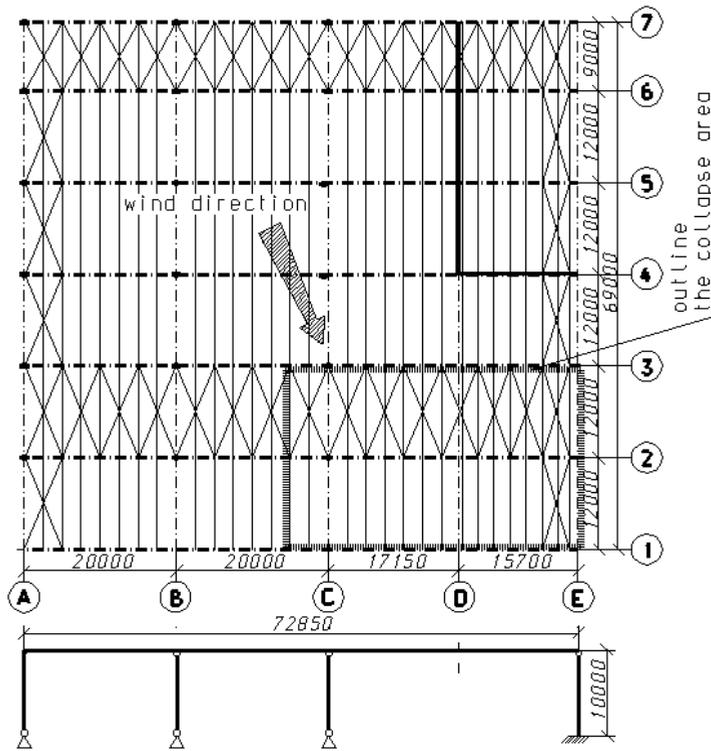
Fig. 1. Scheme of roof structure of hall building

The main load - bearing elements of the roof structure along the axes 2, 3, 5, 6 and partly along the axis 4, between the axes A and D, are plate girders with different cross-sections. Cross - sections of plate girders in axes 2 and 3 in the spans between C and E axes consist of flanges with a cross-section of 300 × 35 mm and a web with a section of 830 × 18 mm. Cross sections of the remaining plate girders consist of flanges with a cross-section of 300 × 16 mm and a web with a section of 668 × 8 mm. Cross-section plate girders are hybrid. The booms are constructed with St4S steel, while the web with 08X steel. Despite the increased cross-section, the girders in axes 2 and 3 have reduced stiffness (EI/L) in the spans between the C and E axes, due to the lack of supporting columns in the D axis. In addition, due to erroneous calculations, the designer of the hall building structure underestimated the total design loads by about 10%. It was demonstrated that the structure of girders in spans with a length of 32.85 m did not meet the requirements of the serviceability limit state, which partly affected the initiation and development of roof failure.

The collapse of the steel supporting structure of the hall building roof consisted in the collapse of a part of the roof slope after the loss of bearing capacity on the warping of the girder in the axis 2 above the column at the intersection with the C axis, Fig. 1.

The failure of the hall building roof occurred during heavy rainfall, compounded by a strong wind, that caused the flow of the rainwater from the large area of the roof towards the area that has collapsed afterwards, Fig. 1. The disaster was caused by the load associated with the weight of rainwater lying in the lake's basin created due to excessive local deflection of the roof. Assessment of the wind direction, and thus the direction of rainwater flow, variability of wind speed and increase of rainfall intensity during the failure, was possible due to the image recorded by the industrial camera.

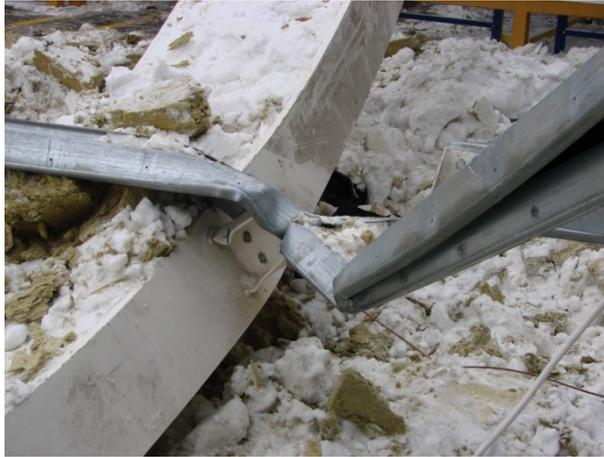
In the central part of the roof, where the failure occurred, under the influence of permanent loads a basin was formed, in which rainwater has been accumulated, due to the disability of the vacuum roof drainage system. The supporting structure of the roof covering is the roof purlins system (parallel to the A, B, C, D and E axis) with $Z300 \times 95 \times 87 \times 3$ cold-formed Z-section made of St4S steel grade. Spacing of the roof purlins is varied, with a dominant span of 2.5 m. In the roof purlins, within the analyzed area of the roof, all externally located supports should be treated as rigid in terms of vertical displacements. Internal supports that were constructed as girders are flexible supports. Due to the lack of internal columns in the D axis, the support in axes 2 and 3 in the central part of the area contained between the axes C and E, is particularly semi rigid. The results of numerical calculations had shown, that omission of significant deformability of girders, resulted in lowering of the calculated values of stresses in purlin beams by up to 30%. In the global analysis, static schemes of continuous purlin beams with fixed support, were assumed. It was compounded by replacement of steel grade of purlin beams by the contractor. Steel with a yield point of 250 MPa instead of the designed 320 MPa was used. Theoretically, the roof purlins of cold-formed Z-section should be articulate based on plate girders with the possibility of rotation in the vertical plane in a structurally acceptable range [4]. Due to the rigid connection of the girder with roof purlins, the range of their rotation over the supports has been limited to the minimum, which result from the torsional susceptibility of the roof girders, Fig. 2. Significant differences between the deflections of next two spans of the roof purlin had to create torsion plate girder.

Fig. 2. Connection of the roof purlin with the girder (after failure)

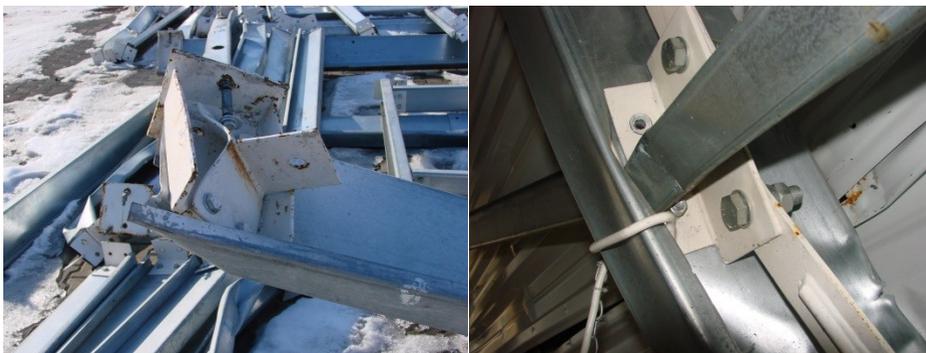
Roof braces were designed in the form of an X-type grating constructed of round bars with a diameter of 22 mm made of St3S steel. Due to the lack of pre-tension, in computational terms, it is a N-type grating. The fixing of the ends of bracing tendons at the theoretical grid nodes, was made using the deformable bracket connectors, that aim to support the roof purlins on the girders of the upper booms or at the ring beam of the masonry gable wall. As bracket profiles, C180 hot rolled steel channel shapes were used. The connection of roof purlins and gusset plates with the bracket was made on four M20 bolts of 8.8 classes. The crossing of intersecting bracing tendons was faulty constructed. Due to the location of the tendons, in the middle of the height of the roof purlins' profile, the tendons were divided into two parts and attached to the web of the roof purlin by gusset plate. This connection does not ensure axial transmission of the tensile force from one part of the tendon to the other which causes additional bending of the roof purlins in a horizontal plane, Fig. 3. Furthermore, the deflection of the roof purlin causes an automatic increase of the tensile force in the tie rods and thus the torsional rotation of the girder. Sloping roof braces, instead of stabilize, cause destabilization the main girders, due to their faulty construction [5].

Fig. 3. Damaged bracing elements

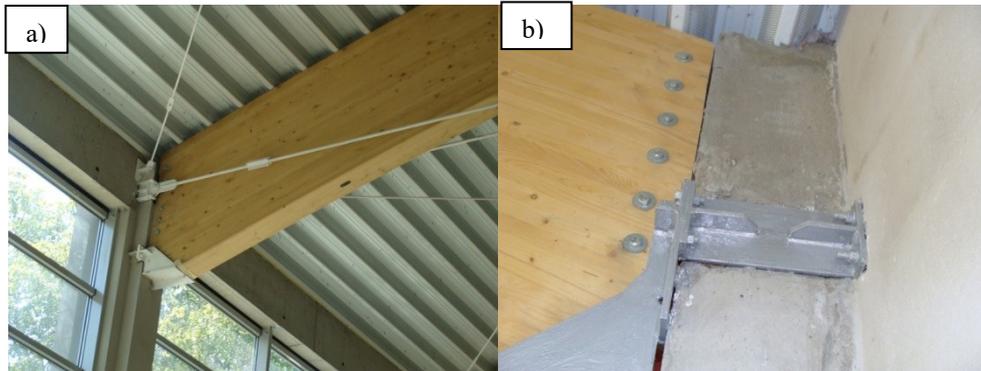
Fig. 4. The method of attaching the timber roof girder a) to the reinforced concrete column in the axis 10, b) to the reinforced concrete column in the axis 5

The first of the assessed elements of the sports hall structure were roof timber girders [3]. According to the building permit design, the structural material of the girders was GL30 glued-laminated timber, while the GL32h class timber was used. Fixing the girder to the reinforced concrete structure of the hall building was designed as eight M16 bolts of 8.8 classes, which pass through the girder and gusset of a thickness of 12 mm and were mounted in reinforced concrete columns. This fixing was additionally changed while constructing steel support. This solution applies to both the mounting in the 10 axis as well as the mounting in the axis no 5, Fig. 4.

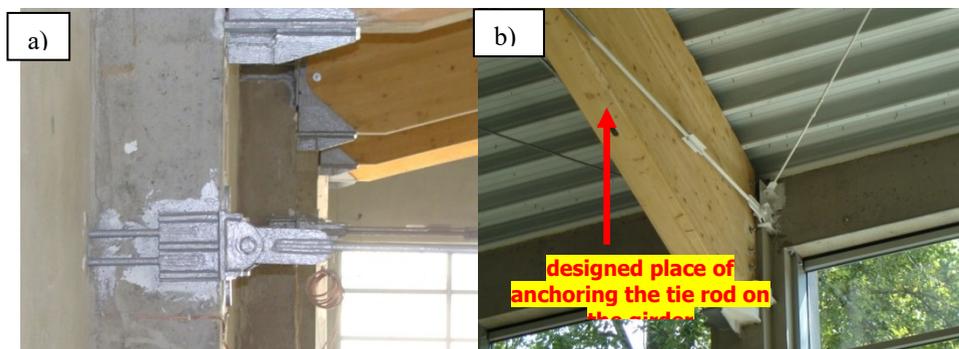
Fig. 5. Fixing the tie rod of laminated timber roof girders, a) in axis 5 b) in axis 10

The layout of fixing of the girders tie rod has been completely changed. Originally in the axis no. 5, the fastening was designed as a butt plate with four HAS-E M16x125/20 dowel bars HIT HY 150, the tie rod fastening on the opposite side was designed in the form of a steel structure mounted in a timber girder within 2852 mm of the axis 10. Mentioned structure was mounted in a timber girder using four M16 grade 8.8 bolts. The whole structure of the tie rod and its fasteners was designed of St3S steel. In fact, the fastening both on the axis 5 and axis 10 sides were made as steel clamps of reinforced concrete columns, where 18G2 steel was used, Fig. 5 [3].

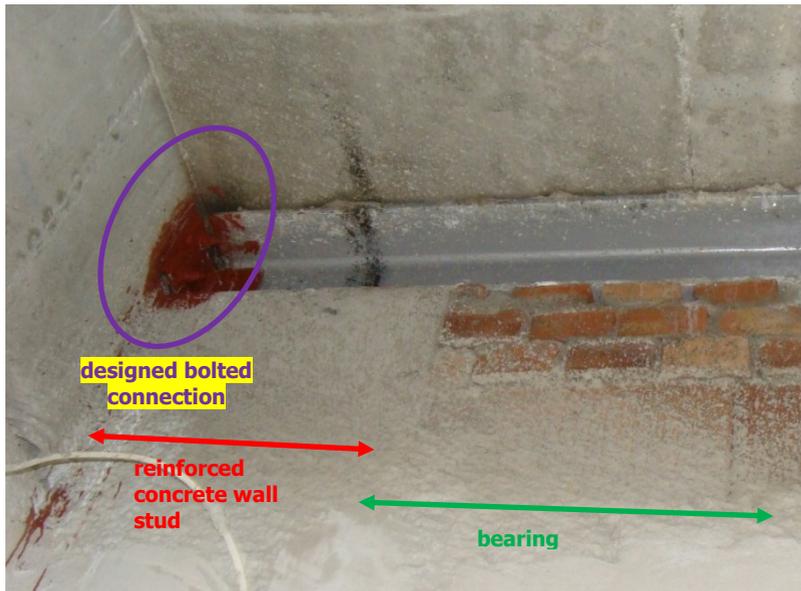
Steel girder was designed as a double-span beam with a span of 5.1 m and 4.8 m in the ceiling above the floor in the B axis between the axes no. 6 and 8 with a steel section HEB 240. Supporting of the binding girder on two supports was designed as a steel wall studs. On the third support, the support was designed as a butt fastening to the reinforced concrete binding joist. Originally, they were designed of a gusset plate joined to a steel binding joist using three M16 bolts, grade 5.8, and a reinforced concrete binding joist using HIT HY 150 HAS-E M16x125 / 38 adhesive anchors - in axis no. 8. The support proved to be ineffective, despite moving the partition wall under the binding joist and replacing it with the load-bearing wall (construction designer's entry in the construction site book was classified as non-significant change), the investor's inspector additionally recommended to the structural designer to check the bolted connection and suggested additional support in form of the wall stud. The designer agreed to the suggestion of the investor's supervision inspector by proposing an additional support in the form of a reinforced concrete bolt under the connection, Fig. 6.

Fig. 6. Additional support of the binding joist in the form of a reinforced concrete wall stud
