# Corrosion as a cause of the failure of the pipeline steel supporting structure

**Abstract.** The article describes the failure of the steel supporting structure of the pipeline caused by corrosion. The structure in question is a three-span steel bridge with truss girders. The structure was erected in the 1960s and is located above the railway track. Due to the specific shape of the hinges, which join the middle span with the rest of the structure one of them was damaged by corrosion, which caused it to break off. That led to situation where the middle span was retained by only three joints. To achieve proper safety of the structure it was additionally supported and strengthened. Due to the necessity of quick repair (there was a real threat of a collapse), some of the works performed had a provisional character. The article presents a description, detailed causes for failure and all the works, which were carried out in order to protect and repair the structure. The analysis of this case showed that, despite adequate protection of structural elements against corrosion, improper design resulting in retaining water led to serious failure.

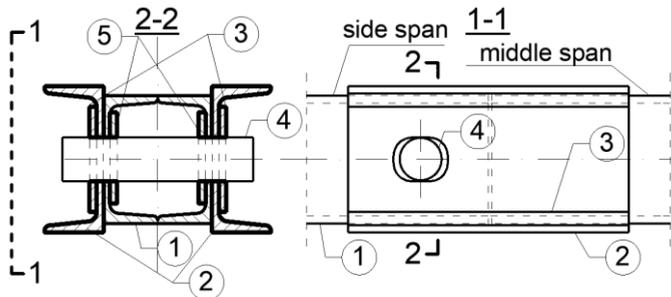
a) hinge design

**Fig. 3.** Hinge design (a) and failure mechanism (b, c).

A diagram of the structure is shown in Fig. 1 and Fig. 2. All three spans are right-angled. The main girders are formed by postless trusses of type W with parallel chords [2]. The axial spacing of the main girders is 2300 mm, which means that the transverse axis of the bridge and the axes of the hinges of the suspended span run at an angle of 45° to the axis of the steel bridge. The steel bridge has three spans (Fig. 1 and Fig. 2), which are connected by hinges as seen in Fig. 3 a).

In addition to the load influence, the safety of the structure is also determined by the material factors. In case of considered structure, corrosion was spotted on parts of the hinges supporting the middle span of the bridge. The corrosive spots were however hidden from the sight during a standard maintenance inspection. The designer correctly assumed an increased effect of the loads occurring in the hinges, adding strengthening strips  $t = 8$  mm. The strips were added both on the inner surfaces of the C140 webs that form the bottom chord and on the outer surfaces of the C160 webs which are the extensions of the bottom chord of the middle span. However, there was no section closing the face of the complex cross-section of 2C140 forming the lower chords of the main girders. As a result, corrosion occurred, the effects of which could not be suppressed by carried out standard anti-corrosion measures. The lack of the correct shelter of the internal part of the hinges should be classified as a design error.

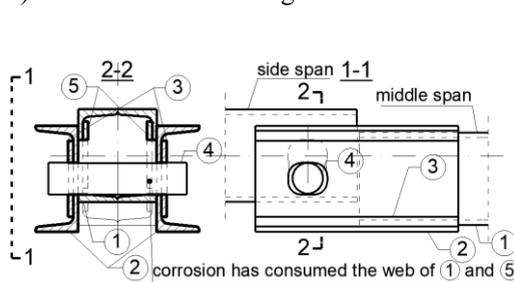
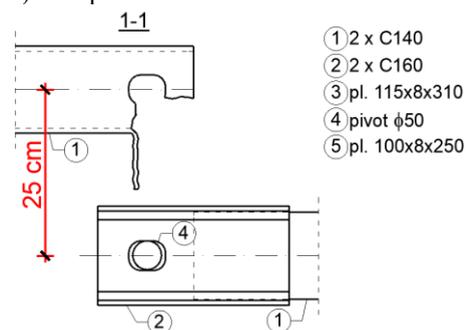
b) destruction of the strengthened web

c) collapse

The failure of the structure occurred as a rupture of the southeastern hinge (W-E) of the middle span (Fig. 4). The layout of the compass directions used in this description is in accordance with Fig. 1. The material belonging to the bottom chord of the eastern girder have been torn out from the southern span. The pivot responsible for hinge operation remained in the C160 channels that were fixed to the lower chord of the middle suspended span. The size of the structural displacement in the broken hinge reached 25 cm. The mechanism of hinge damage is shown in Fig. 3 b) - c).

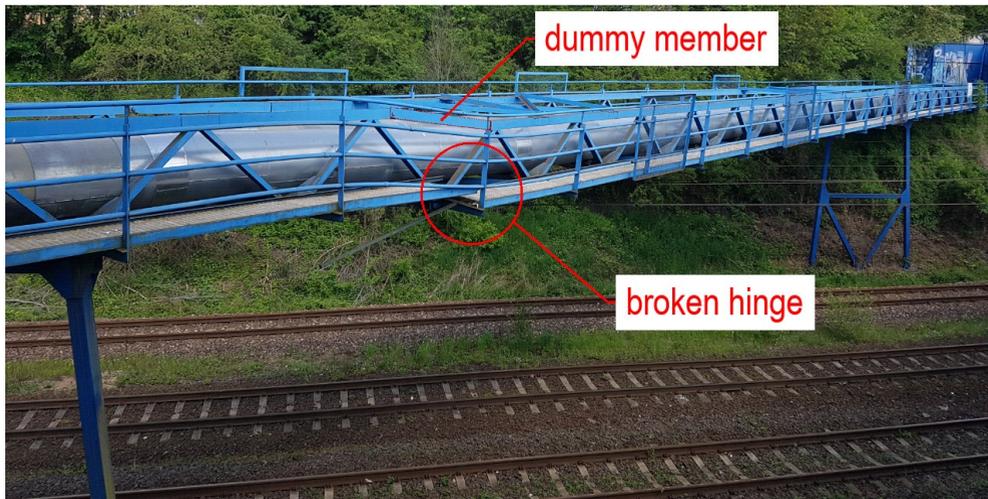
The incident occurred on Sunday in the early morning. A passerby heard a suspicious sound and noticed visible damages to the steel bridge (Fig. 4). Immediately the city officer on duty was notified. On the same day, a visual inspection was carried out, which allowed preliminary to determine static scheme of the structure, the extent of damages and the threat level. Direct action was taken to secure the superstructure of the bridge.

**Fig. 4.** Structure at the time of failure.

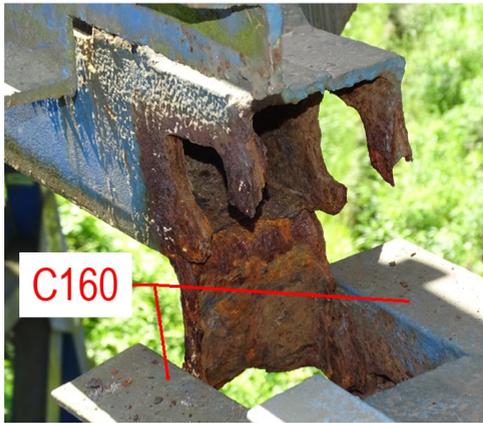
a) torn webs of the lower chord

A closer inspection of structure allowed to determine that four bars of the upper chord were dummies added for aesthetics and security, but they did not transmit internal forces in the structure (Fig. 5). This means that the middle suspended span works as a simply supported system. As a result the whole structure works as a double hinged gerberian beam with a skewed system of supports and joints. As a statically determinable system, the structure did not have a load-bearing capacity reserve. The spatiality of the system, including its skewing and redundant number of hinges, protected the structure from total failure. An additional factor protecting the structure was the stiffness of the pipelines.

**Fig. 5.** Rupture of the hinge.

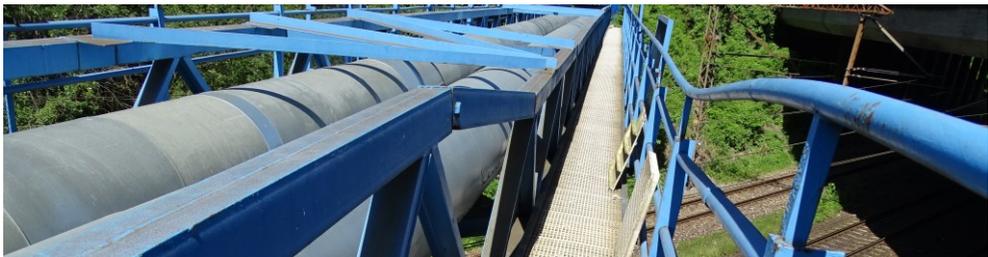
Despite the undeniable dynamic effect associated with the sudden displacement of the middle span, the load was transferred to three remaining hinges that managed to retain the bearing capacity. It is worth to notice the effect (show in Fig. 7a) of the slippage of the pivots in the remaining hinges to the level of the lower flanges of the hollow 2xC140 section of the lower chord. The dummy members acted as a special type of dilatation that isolated the deformations of both main girders upper chords. As a result, the main elements of the load-bearing structure were not damaged. On the other hand, the pipes  $d = 40$  mm used for the external railings were fixed in the posts through, thanks to which they retained the continuity of deformation without being a subject to permanent damage (Fig. 6).

**Fig. 6.** The dummy-member (bar on the left) and the deformation of the railings.

The horizontal displacement of the upper chord of the eastern main girder which appeared in the dummy strut did not cause permanent deformations in the superstructure.

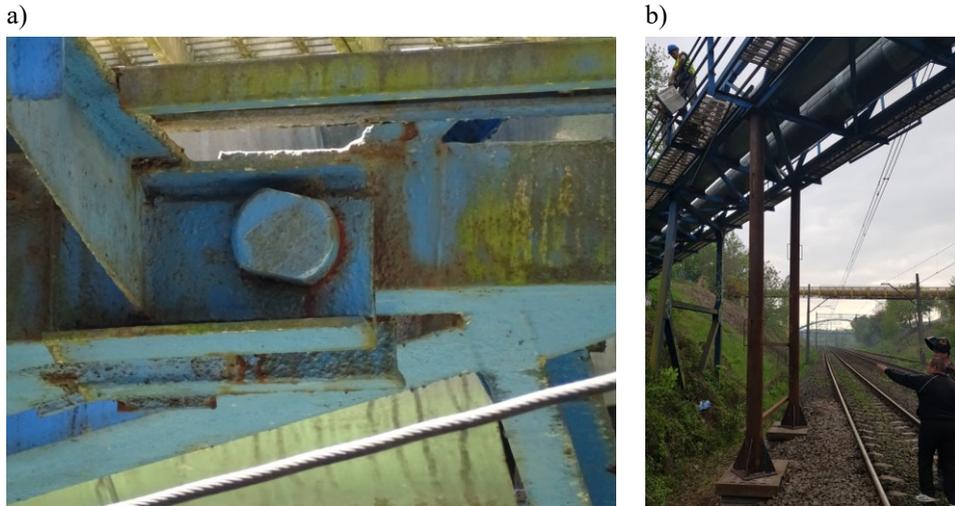
**Fig. 7.** a) slippage of the pivot in the hinge; b) provisional support during construction stage.

Initial, most crucial task was to support the middle span at the location of the broken hinge. The temporary support, considering available materials, was erected in the form of two columns consisting of  $\text{Ø}244.5 \times 8$  steel pipes with height of 5.62 m (PP-S support in Fig. 1 and Fig. 7 b)). The column heads were placed at the level of the lower chords of the middle span. The top of the eastern column was thus at the level of the chord, after it had been torn off. The base of the columns were made of 500x500 mm base plates with a thickness of  $t = 20$  mm and stiffened with four ribs ( $h = 450$  mm,  $a = 190$  mm,  $t = 10$  mm). The column bases were placed on five 14 cm thick reinforced concrete slabs. The slabs are enclosed in C140 frames. The column heads were permanently welded to the structure of the supported span. The column bases were not fixed to the concrete slabs. Instead, the slabs were covered with railway gravel from three sides. Temporary supports were installed directly to the east, outside the railway clearance gauge of track no. 1 (Fig. 1). Installed columns provided protection from span collapse, however the span was not in a safe distance from catenary wire.

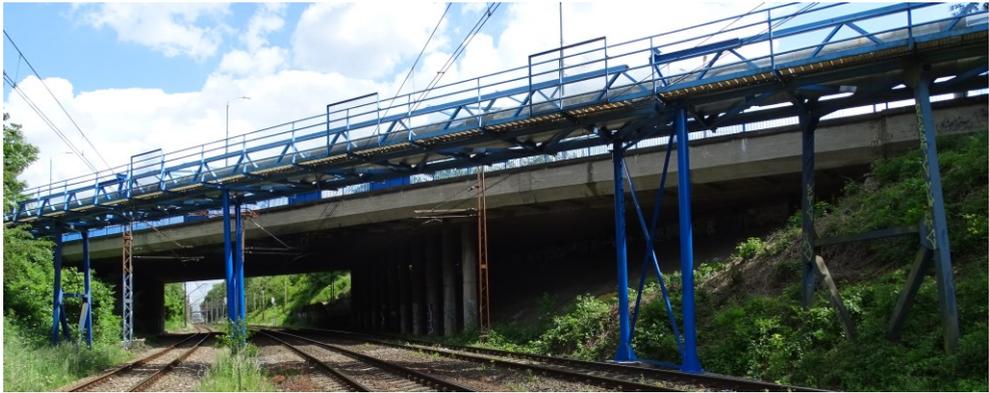
**Fig. 9.** Structure after strengthening by provisional supports (view from the south-west).

The leveraging was carried out using a 1000 kN hydraulic lift. The traffic stopping was necessary for this operation. The new position of the middle span, corresponded to the previous height of the S-E hinge and was stabilized using hangers. The span was supported with the east column of the south provisional support. Moving the middle span to a safe distance from the overhead contact wires allowed to enable the train traffic. Achieved condition was agreed to be sufficient to return the water mains to operation. The southern hinges of the middle span were fixed to the southern span by hangers and simultaneously were supported by the columns (Fig. 9). The northern hinges of the middle span were suspended on hangers while both main girders of the middle span were supported by columns located near the northern hinges.
